# Select Inspect

Property Consultants, LLC

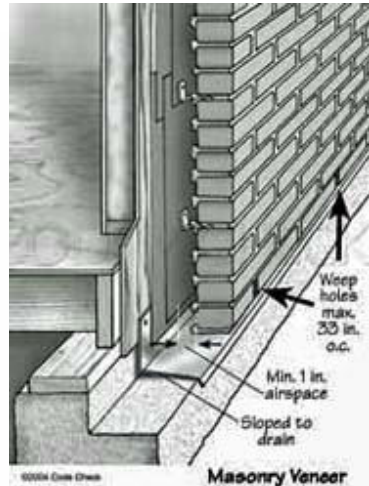
**Other Structural Related:**

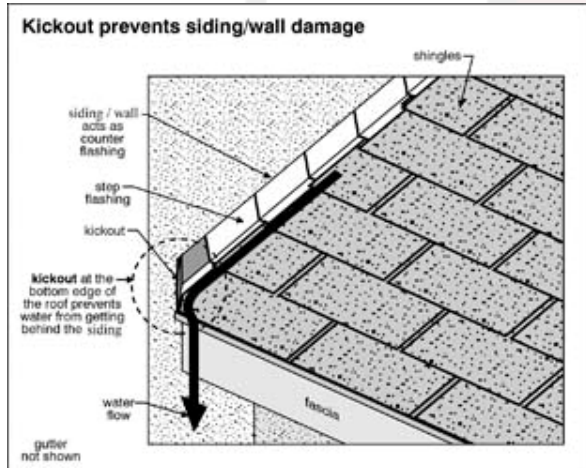
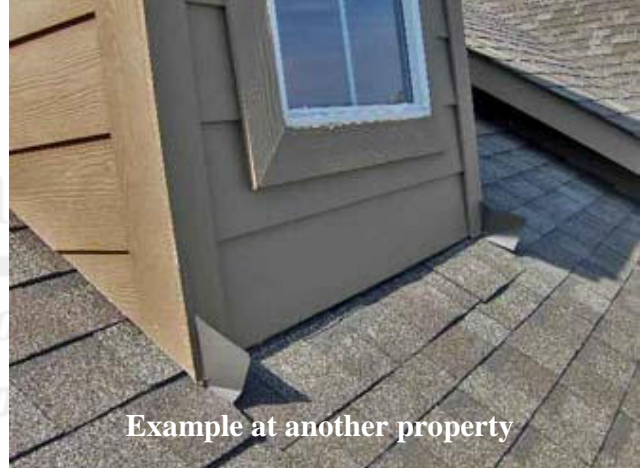
- NOTE: Suspected hail/weather damage evidence and some suspected related damage was noted at the roof surfaces. Check with your insurance company prior to closing, to ensure the roof will be accepted pending any repairs they may require. It would be prudent to ask for the seller's insurance to examine the roof prior to closing as well.

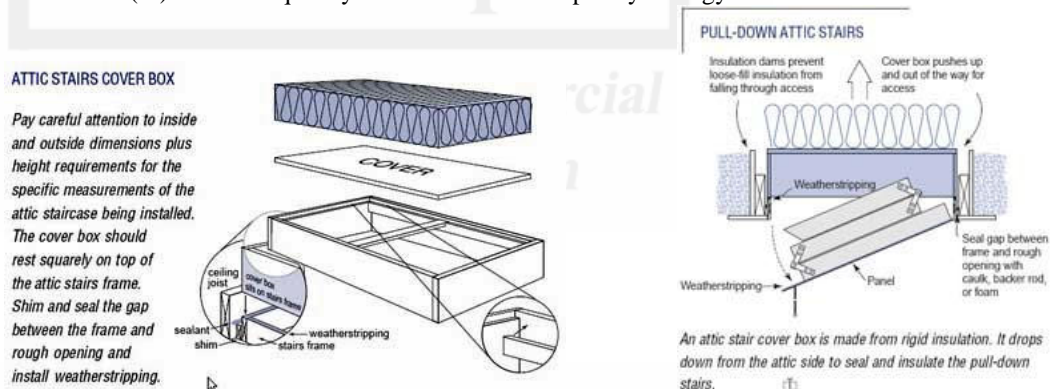
#### SCUTTLE HOLE COVER

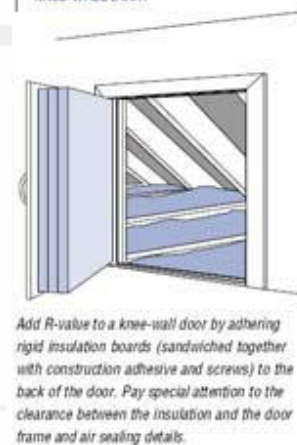
#### Attic Structure: Deficient

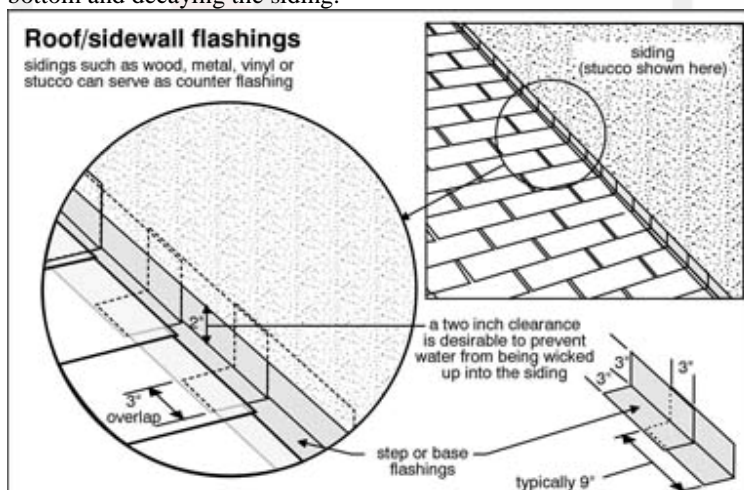
- ✦ NOTE: "Hard-board" type siding and or trim was noted at some or all exterior locations. Some of these "pressed wood-fiber" products have been involved in litigation, due to the propensity of this material to absorb moisture and subsequently decay. These products must be kept well caulked and painted to prevent moisture intrusion and failure. You should keep all foliage trimmed that it does not touch the siding / trim. It is recommended to keep lawn irrigation adjusted to not directly spray the siding / trim. Recommend repair of conditions including:

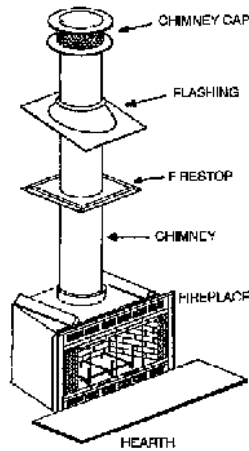
**Fabricated Fireplace**

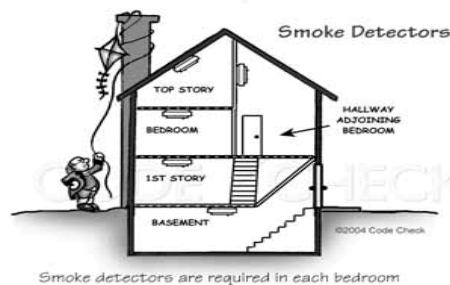
Select Inspect © 2002

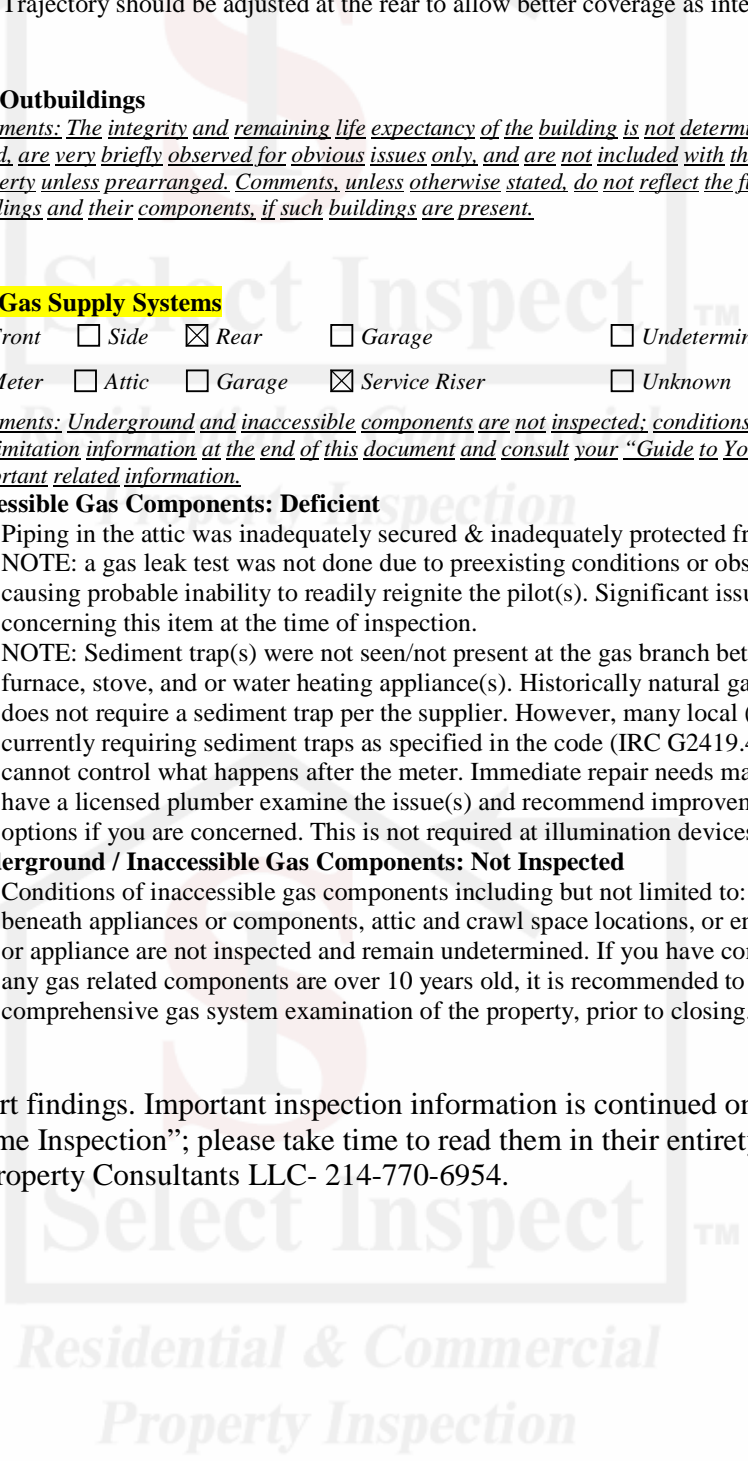
## LIMITATIONS, EXPLANATIONS, & DEFINITIONS

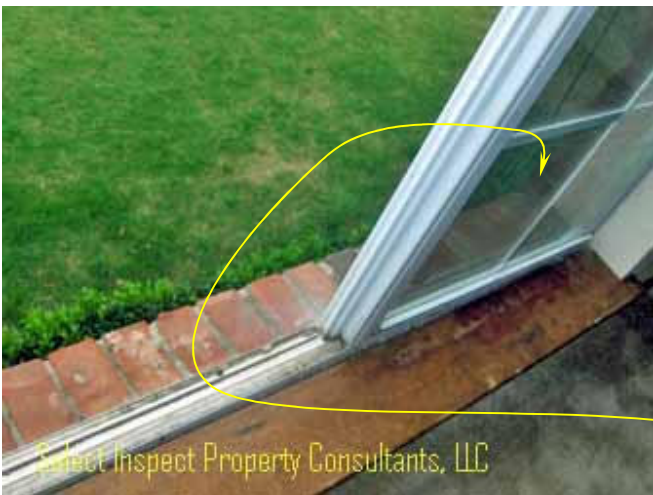
↑ moisture staining & worn mortar example at upstairs window

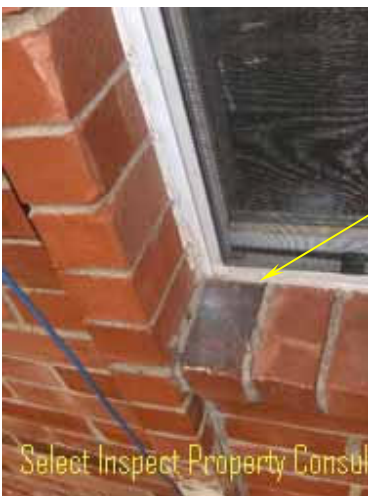
↑ worn mortar; openings

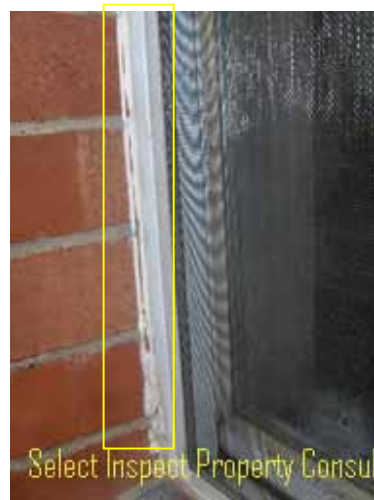
↑ example window separation

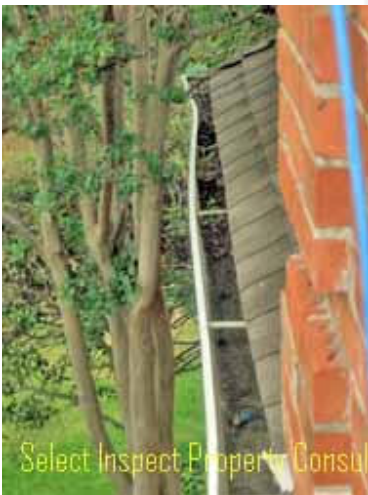
↑ example deficient guttering

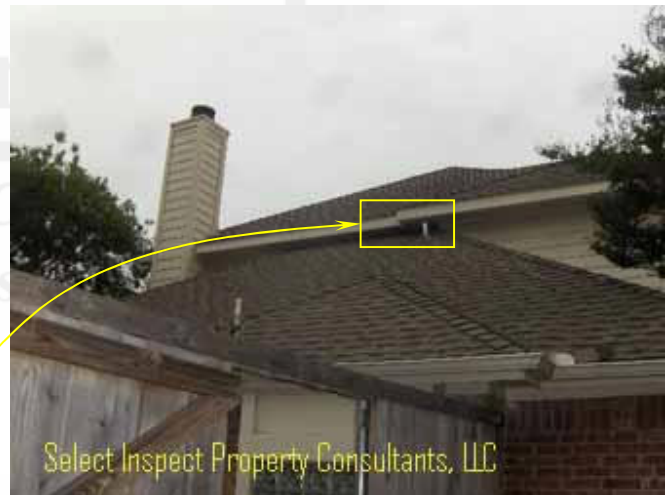
↑ moisture intrusion; moisture damage

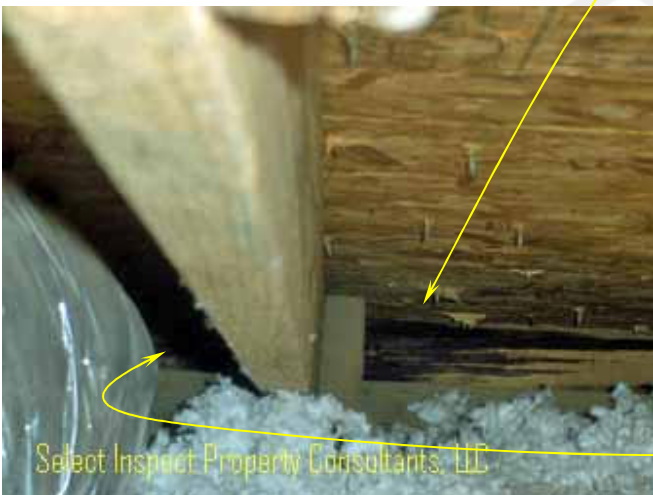
↑ moisture damage/rot in attic; adjacent the image above right

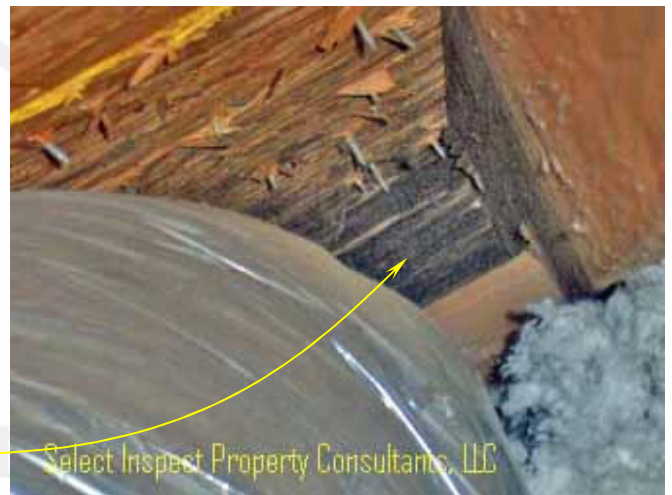
↑ close view of image at left- related images at top of page 38

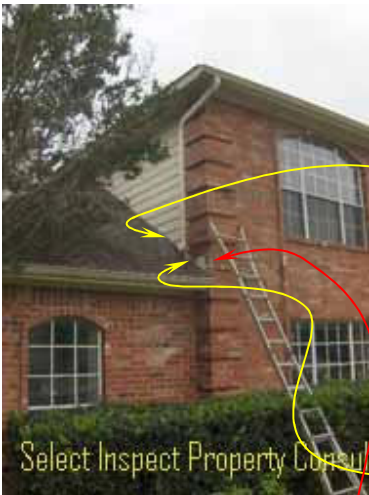
↑ low siding; deficient flashing; openings

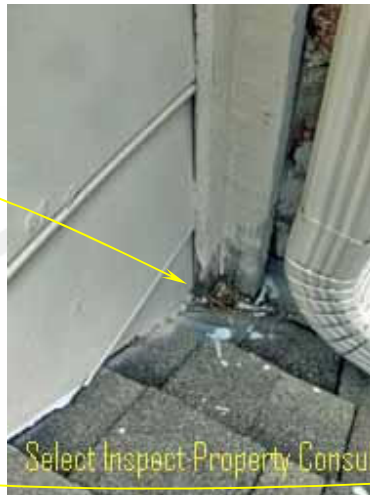
↑ close view of image at left; moisture damage, inadequate converging valley slope

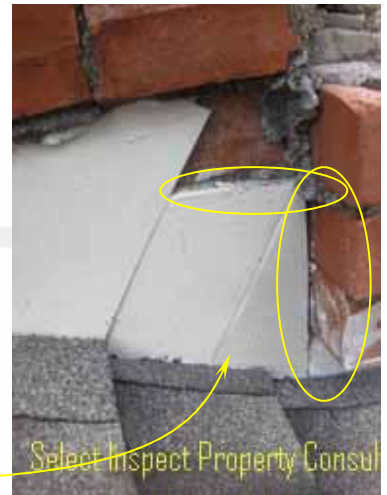
↑ unworkmanlike flashing; openings

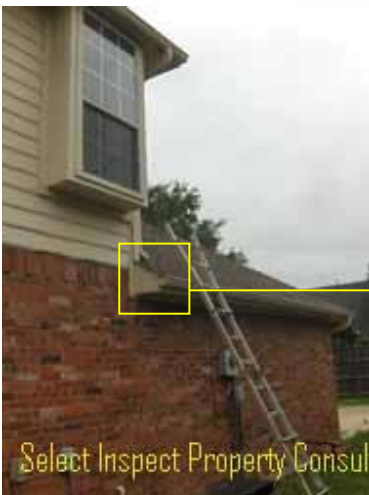
↑ moisture damage at roof deck; missing kick-out-flashing

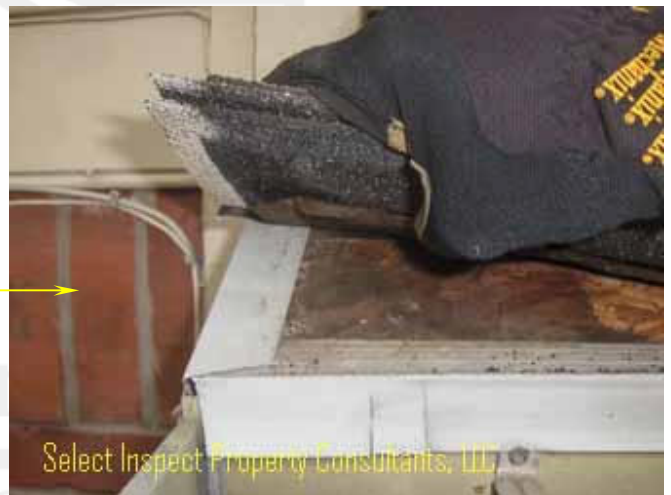
↑ close view of image at left; rotting roof deck

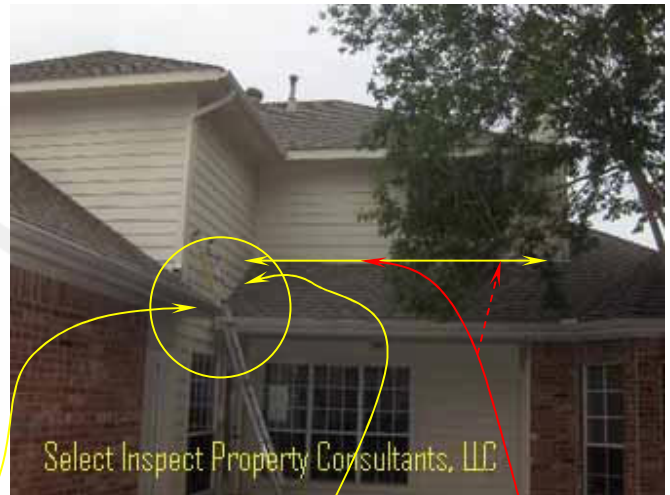
↑ multiple deficiencies

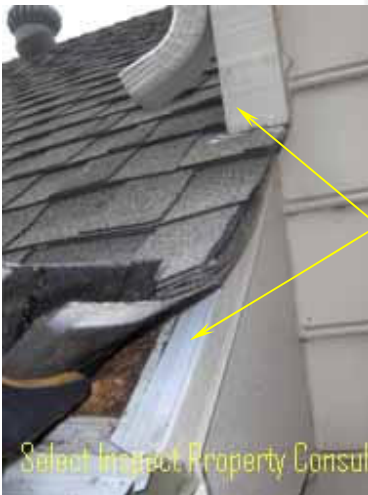
↑ missing kick-out-flashing; rotting deck

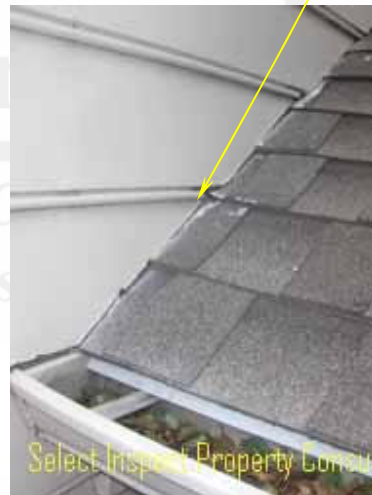
↑ low siding; missing kick-out-flashing; rotting siding below eave

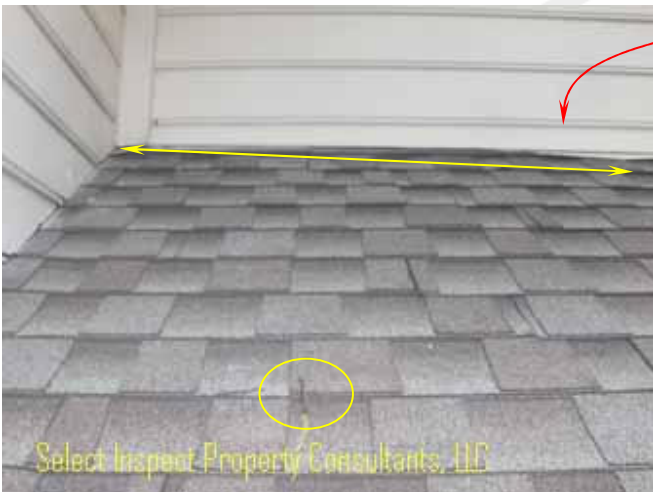
↑ inadequately secured flashing & nail

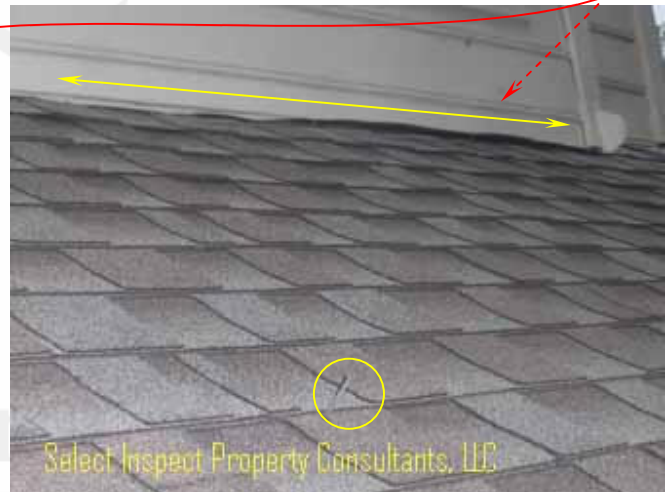
↑ inadequately secured flashing & nail

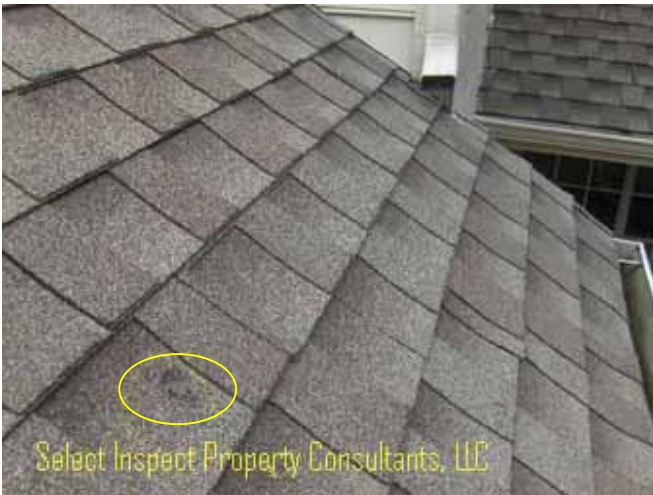
↑ impact damage at garage east

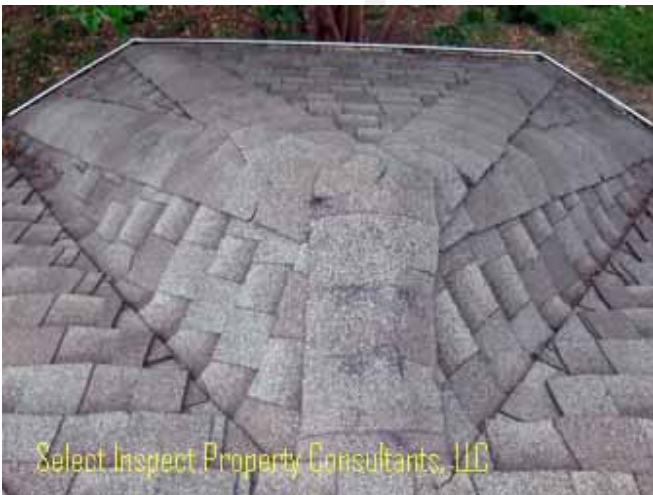
↑ tree damage, impact damage, & wear at master roof

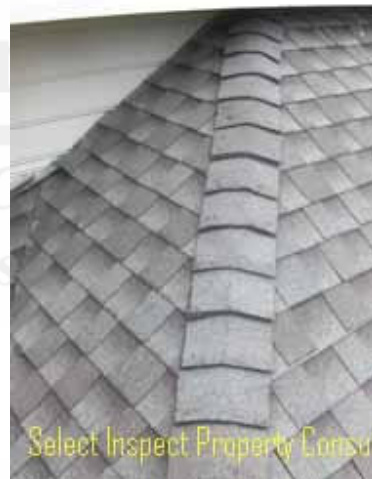
↑ damaged roof ridge near chimney

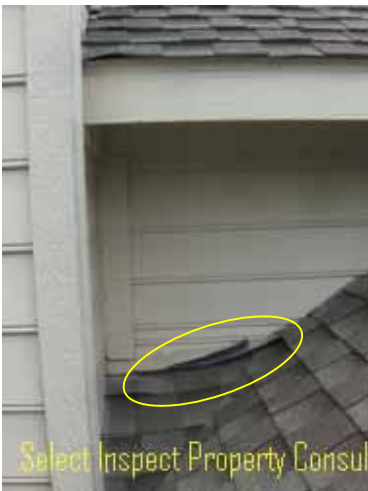
↑ deficient flashing behind chimney

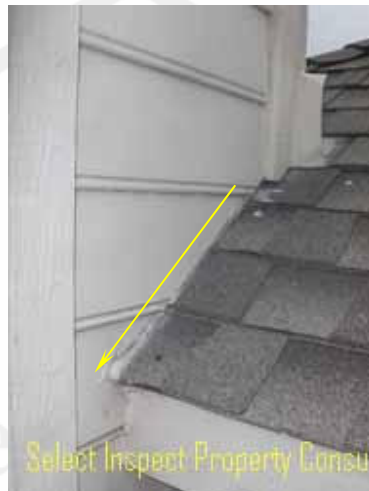
↑ missing kick-out-flashing; chimney north

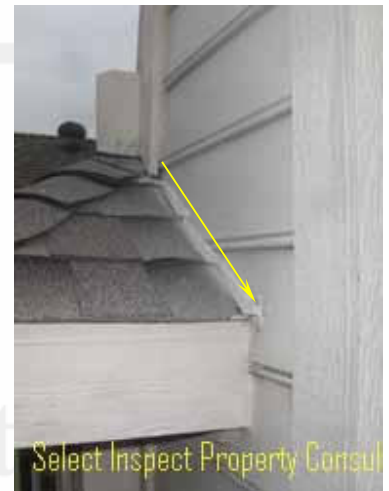
↑ missing kick-out-flashing; chimney south

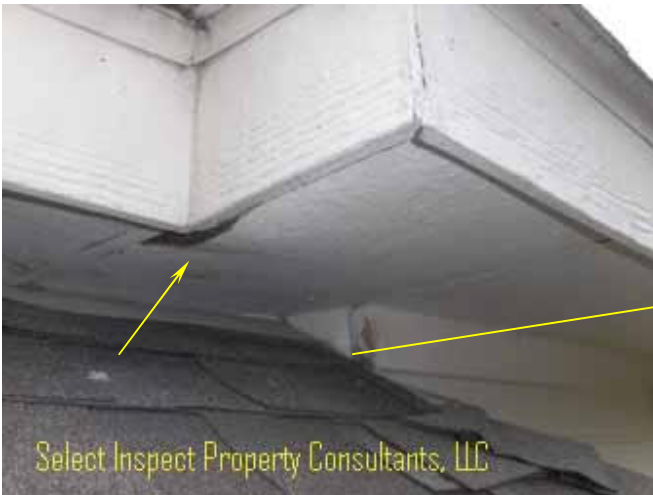
↑ moisture damage; east eave

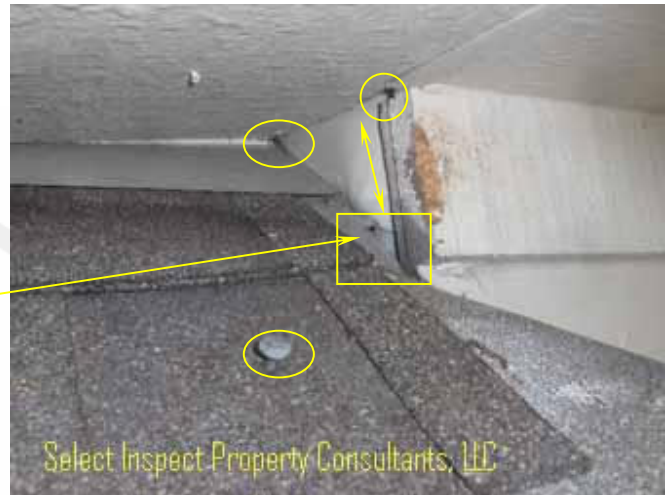
↑ uncaulked, exposed fasteners & unworkmanlike flashing; openings; & rodent gnawing evidence

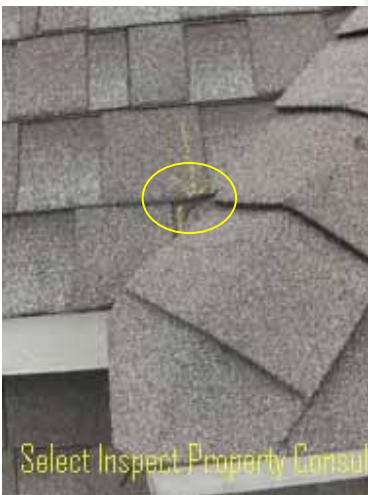
↑ damaged shingles at valley over image pictured above

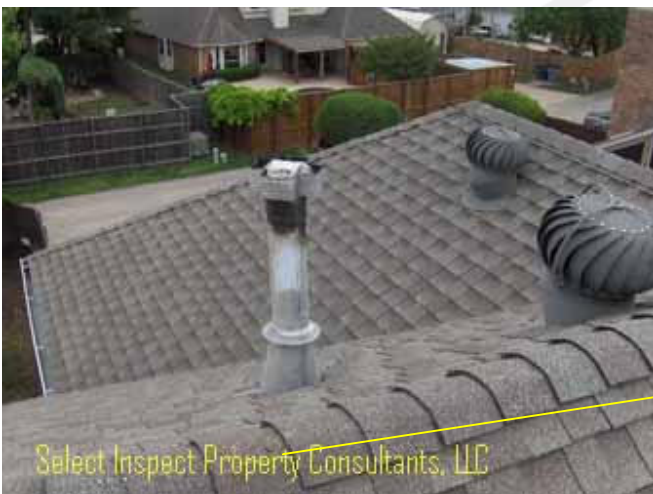
↑ soot at furnace flue & damaged shingles

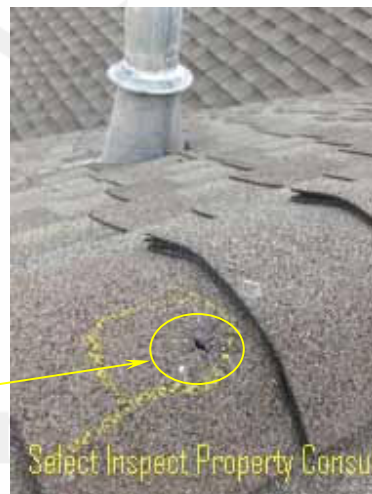
↑ opening at shingle; example

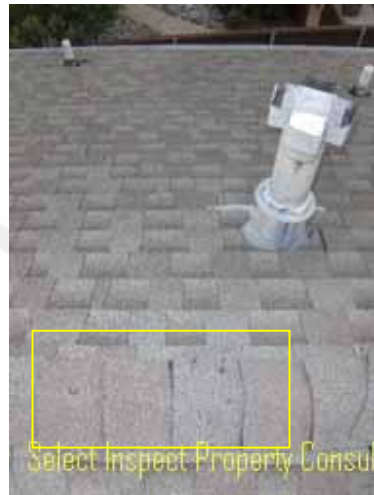
↑ impact damage at shingles & flue cap & openings at shingles; example

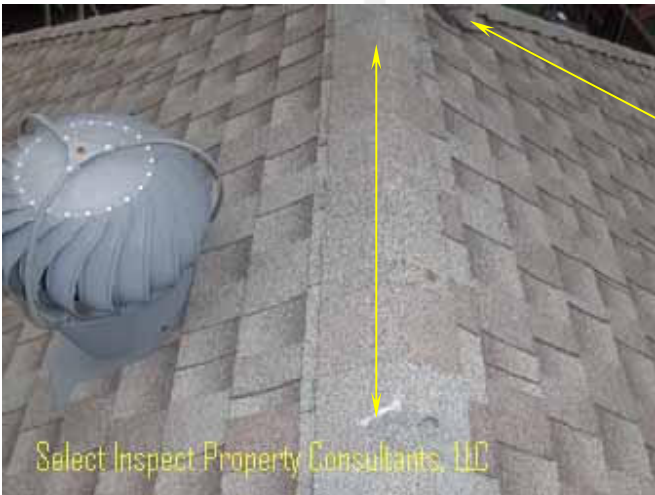
↑ impact damage example

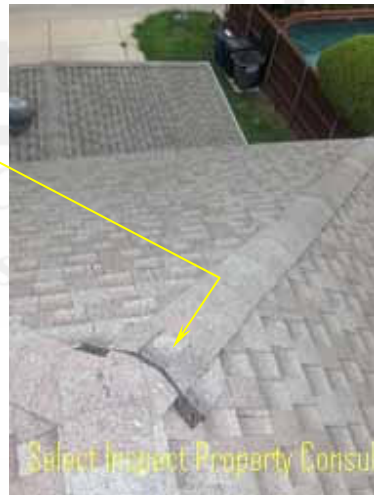
↑ unusual full shingle tab at ridge; upper southwest

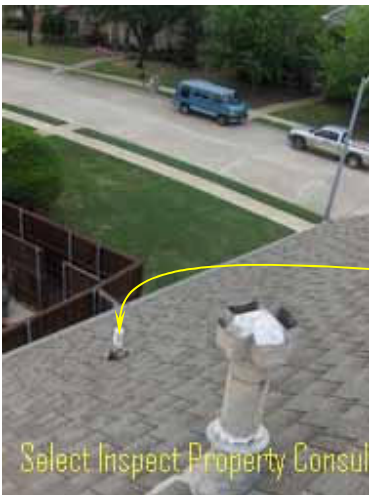
↑ example deficient plumbing vent collar; moisture intrusion point

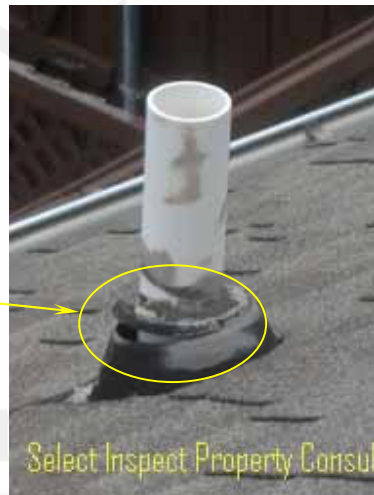
↑ close view of image at left; openings

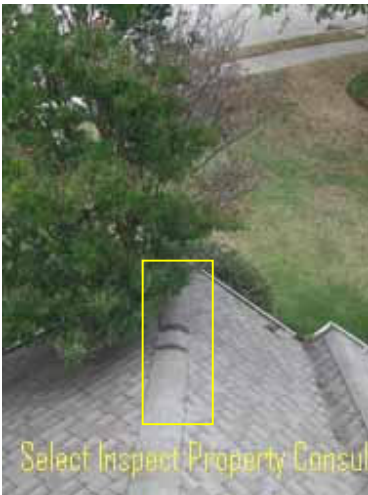
↑ deficient ridge shingles; northeast

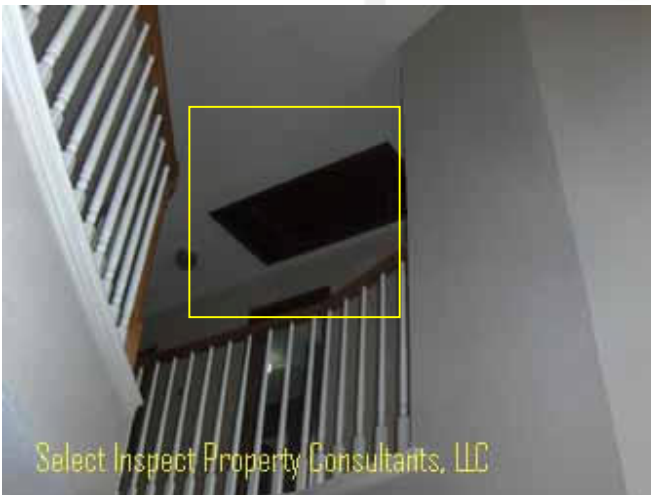
↑ energy loss at attic accesses; example at ladder

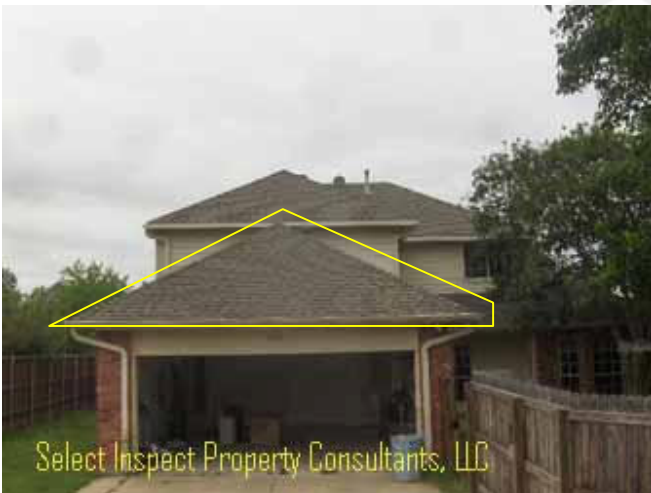
↑ missing access to this attic space; Conditions in not readily accessible/inaccessible locations remain undetermined; ie. Water heater flue, moisture stain source, electrical, framing, etc

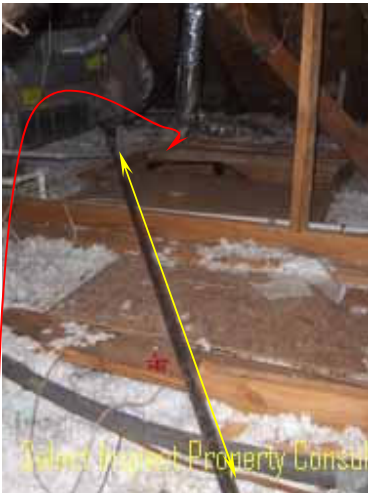
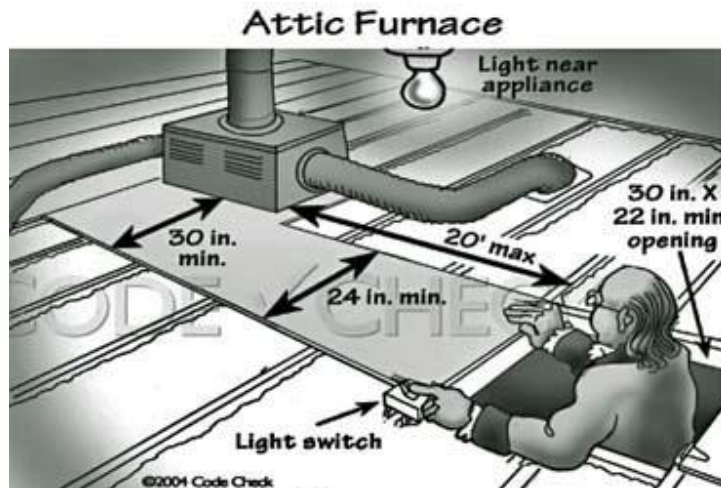
↑ there should be a minimum 24" pathway to the HVAC from the top of the access & 30" unobstructed service area, with no gaps or obstructions & this gas pipe section was inadequately secured

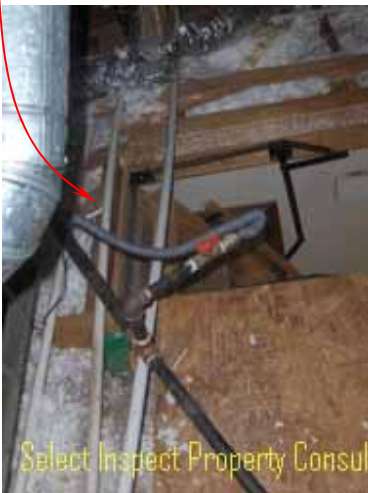
↑ unprotected gas components & HVAC drain piping & flue impeding attic access; unworkmanlike & unsafe

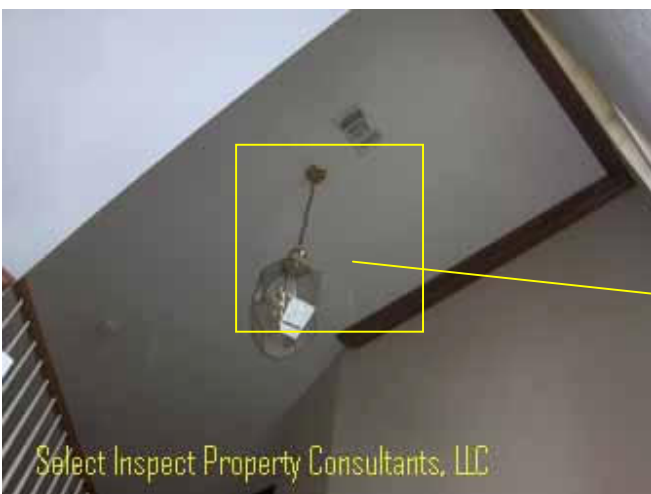
↑ Thermal imaging shows energy loss & or moisture evidence above the foyer

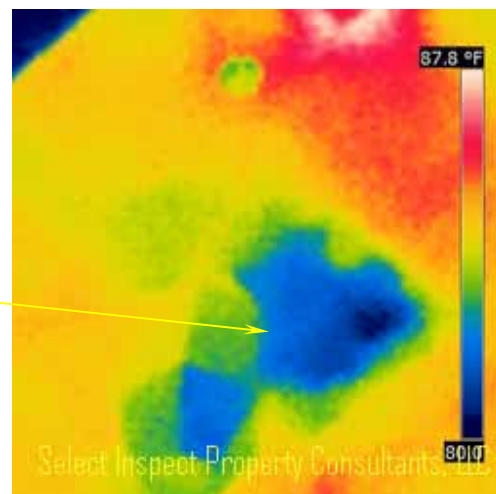
↑ Thermal imaging from square at left

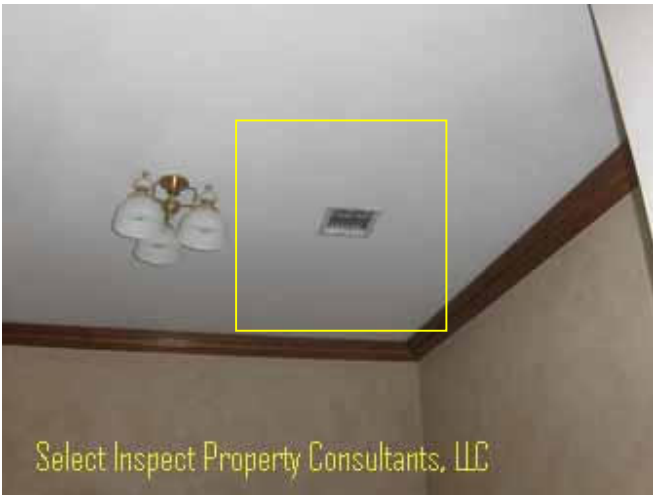
↑ suspect inadequate seal at HVAC register/boot/duct- study

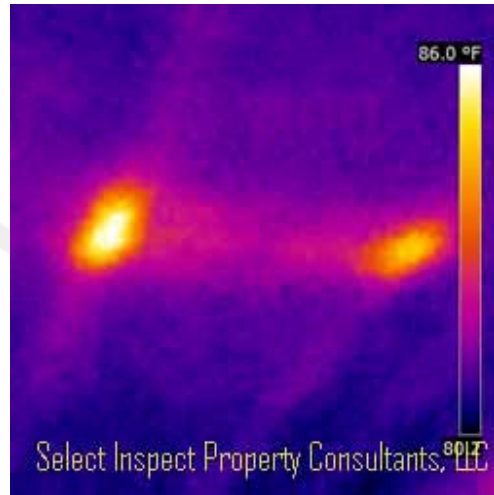
↑ Thermal imaging from square at left

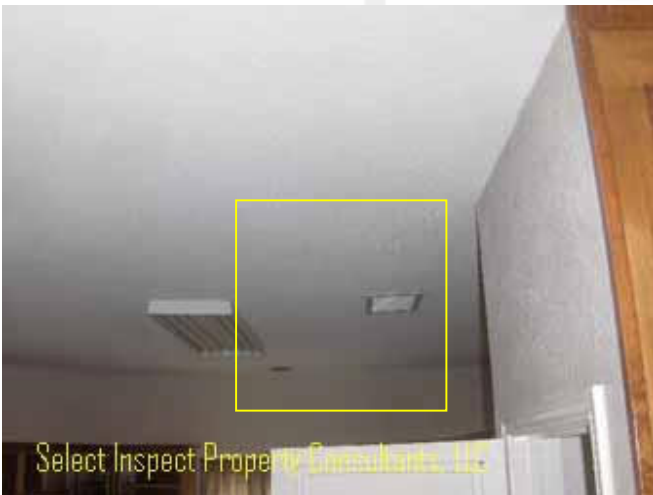
↑ suspect inadequate seal at HVAC register/boot/duct-kitchen

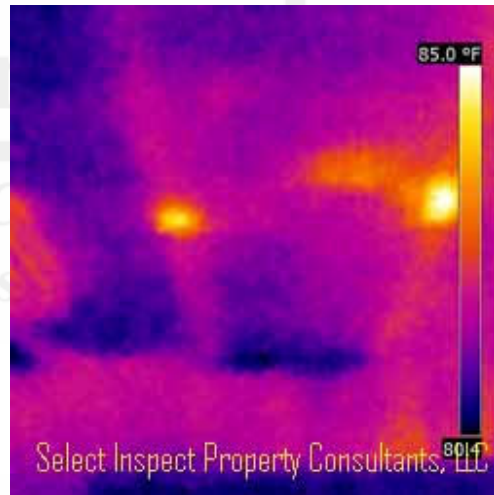
↑ Thermal imaging from square at left

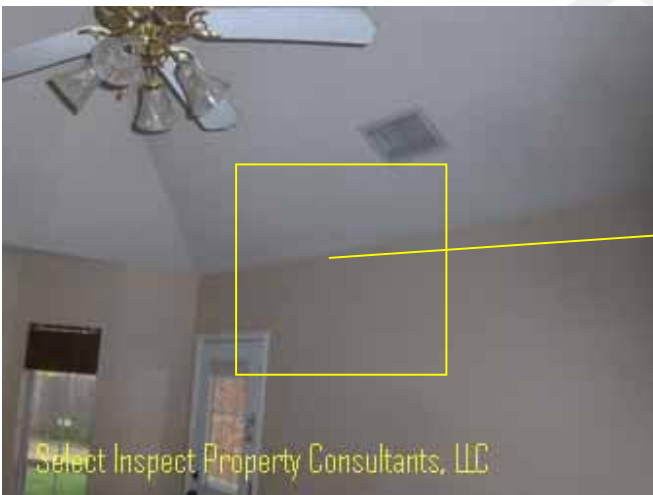
↑ Thermal imaging implies energy loss or moisture intrusion (staining & repair evidence discovered at this location) at master

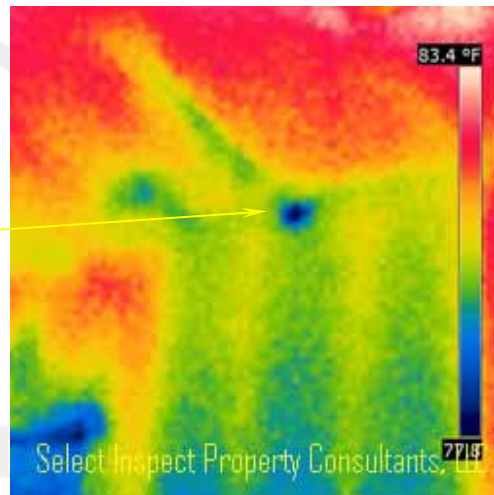
↑ Thermal imaging from square at left

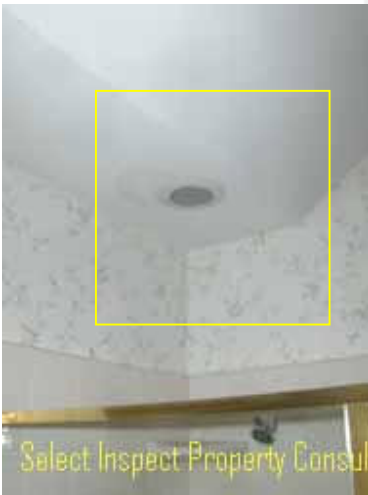
↑ Thermal imaging implies energy loss & or moisture at master bathroom (staining present during the inspection); deficient plumbing vent discovered above at roof

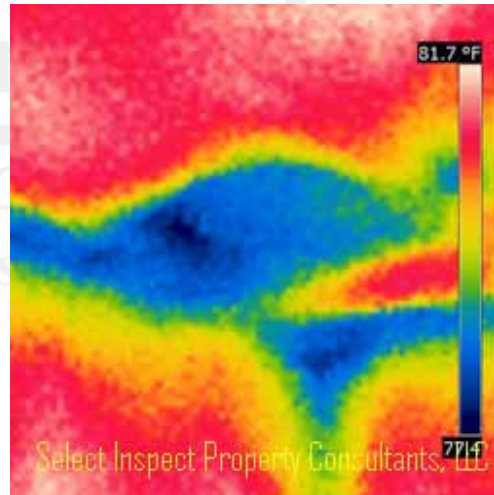
↑ Thermal imaging from square at left

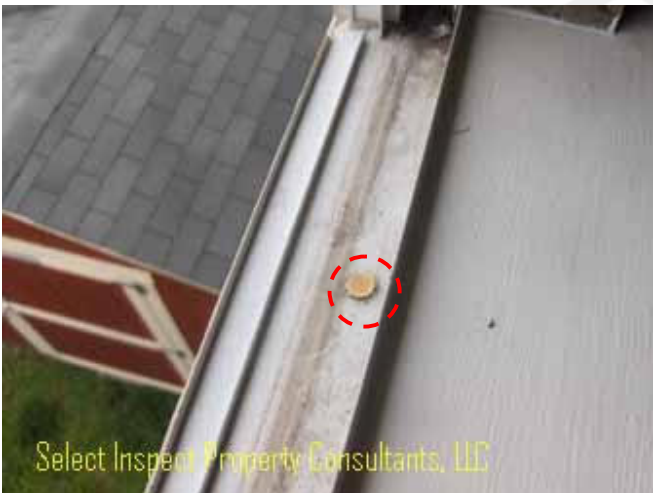
↑ Alarm holes at the lower portion of the window may allow moisture intrusion; caulk and monitor

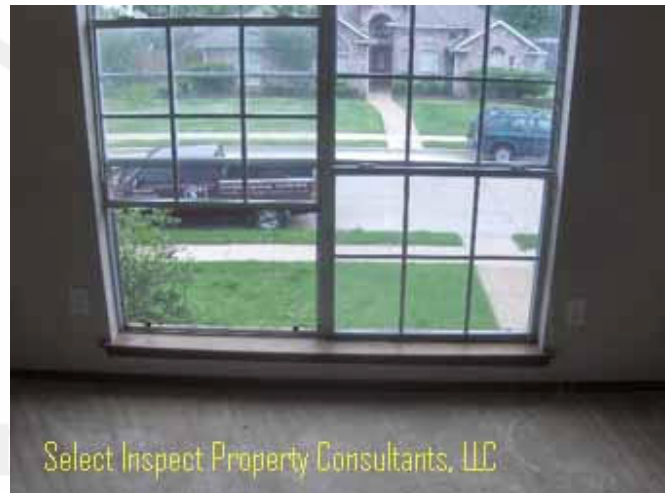
↑ window(s) lower than 24" interior & higher than 72" exterior; example

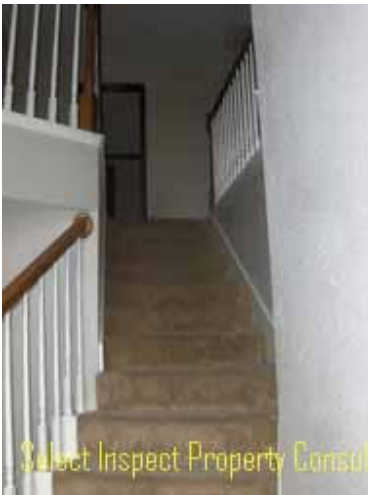
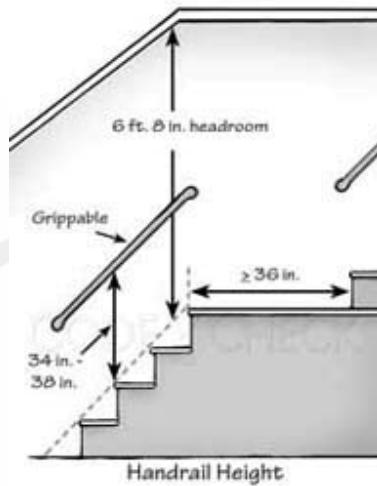
↑ missing handrail at upper stair section

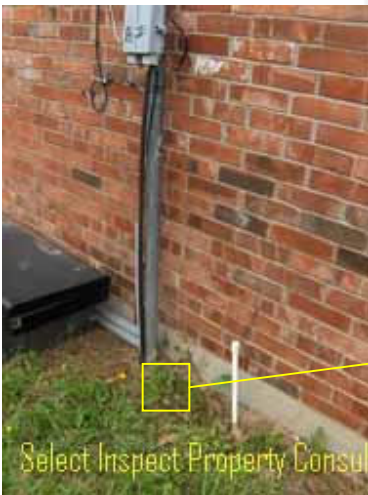
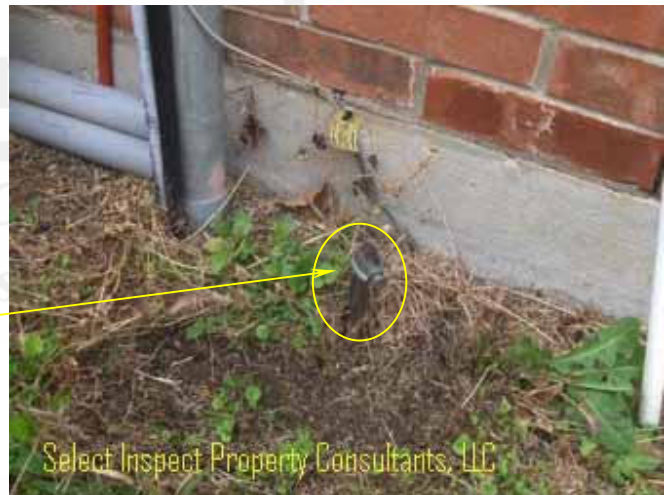
↑ grounding electrode protrudes grade; deficient

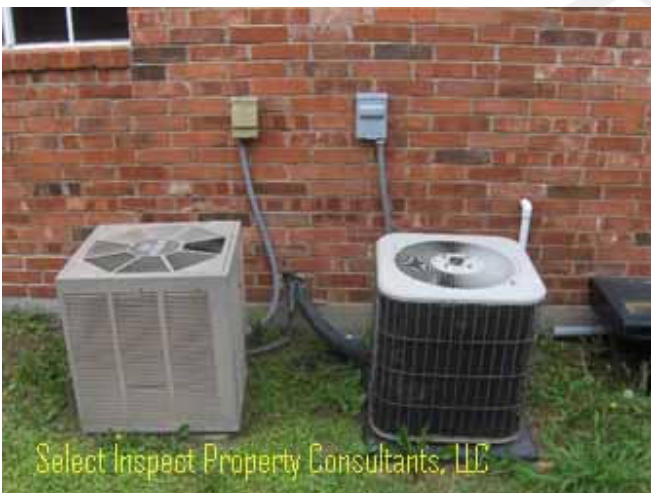
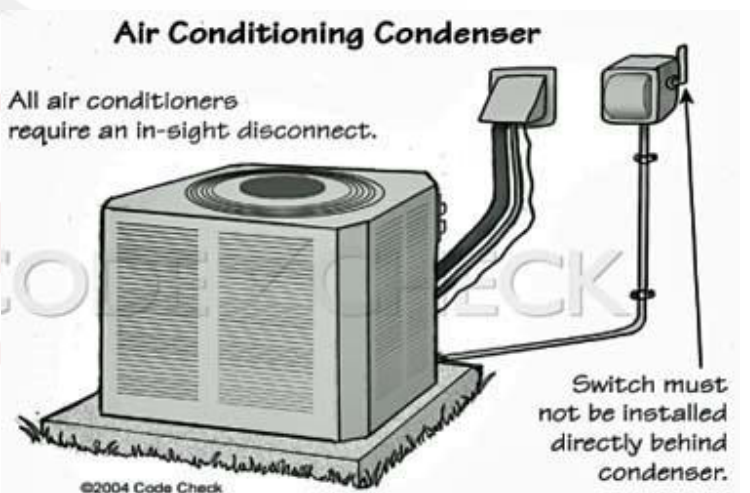
↑ incorrect location of air conditioning condenser(s) service disconnect; inadequate clearance of electrical panel for service personnel; old condenser is low & corroded; right condenser has hail/impact damage

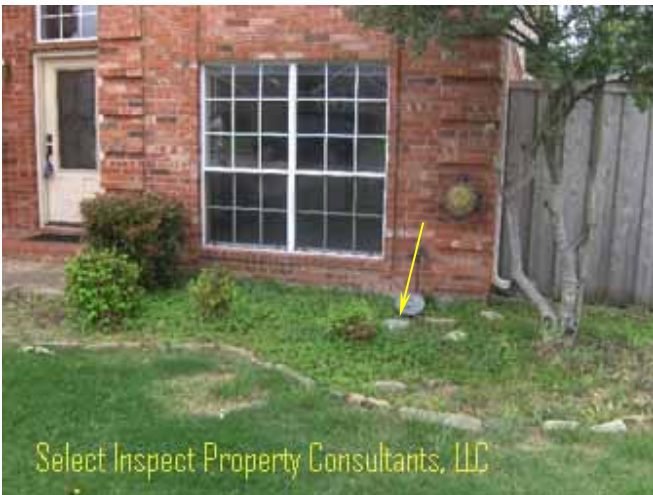
↑ high water pressure at home & buried components at front garden

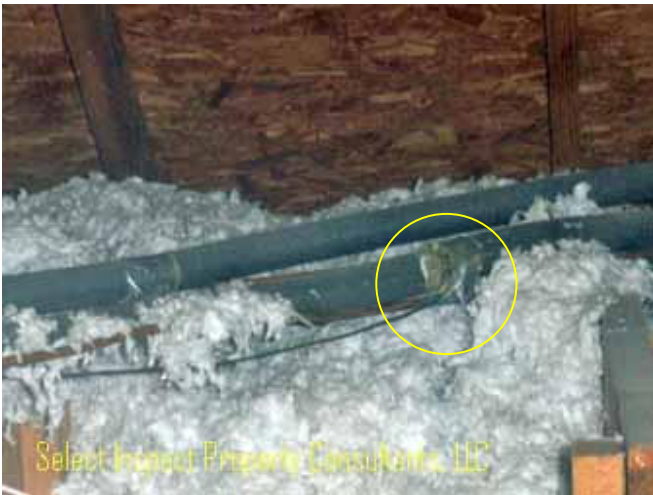
↑ deficient refrigerant insulation joint & leakage evidence above moisture staining at southwest bedroom

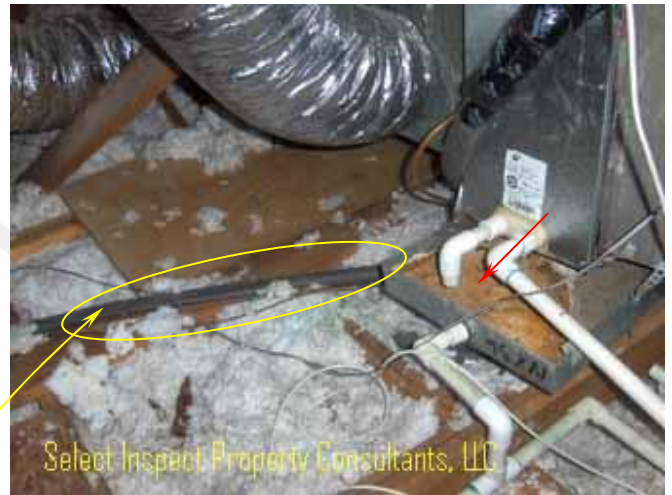
↑ corrosion at auxiliary pan & deficient refrigerant insulation; air conditioning primary condensate drain should be insulated; upstairs HVAC

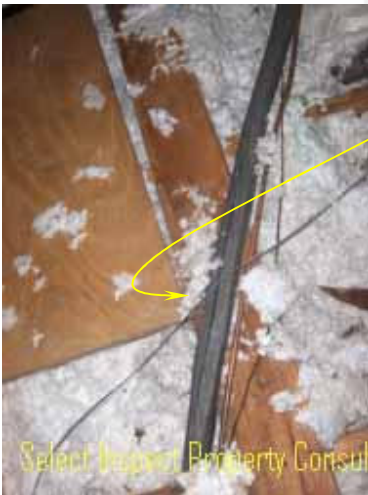
↑ close view of image above right; moisture staining at attic insulation

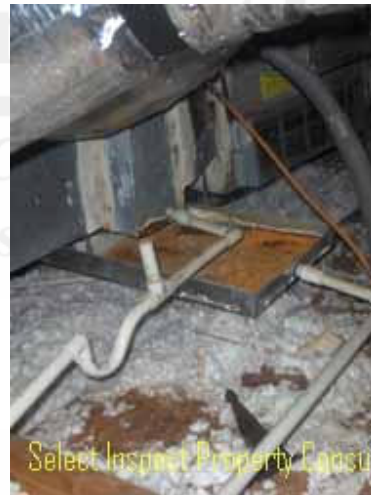
↑ air conditioning primary condensate drain should be insulated; moisture staining at floor & attic insulation; corroded evaporator(s) & auxiliary pan; inadequately sealed joints- downstairs HVAC

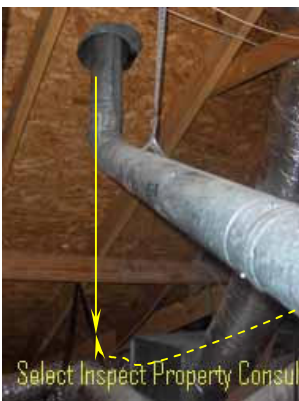
↑ both flues did not meet clearance requirements to combustibles & moisture intrusion from roof

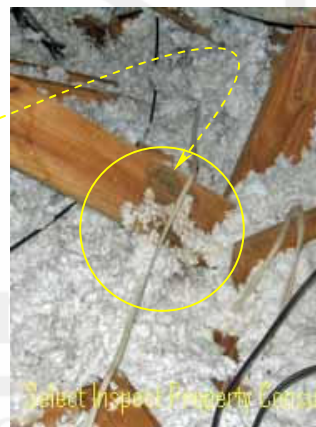
↑ moisture staining at insulation & framing; moisture staining at east bedroom ceiling below this location

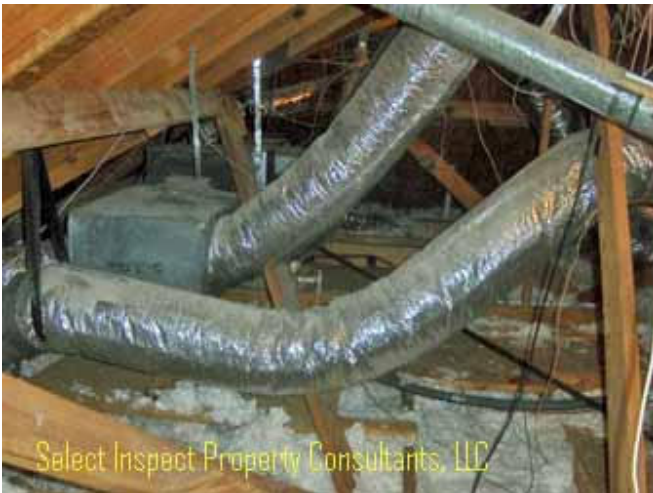
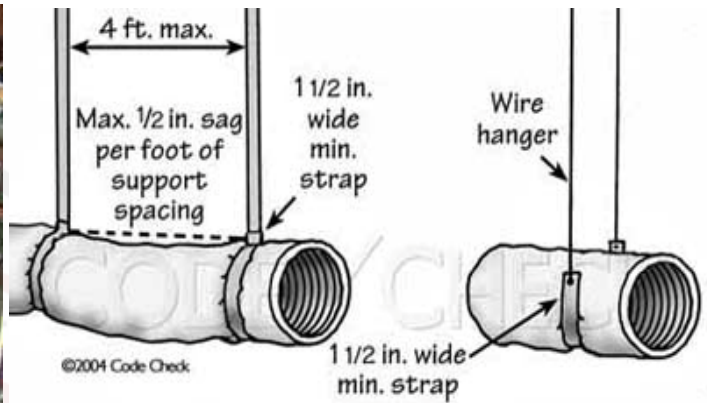
Manufactured Duct Support

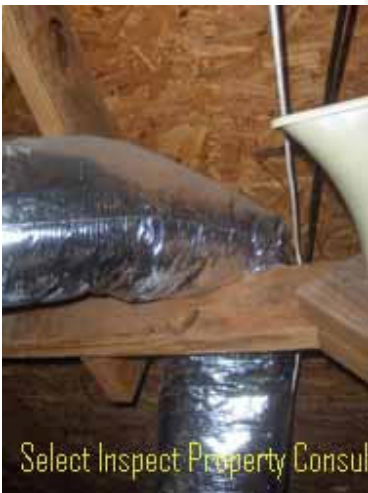
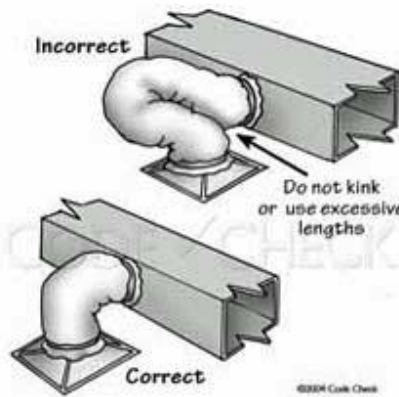
Stretch Manufactured Ducts

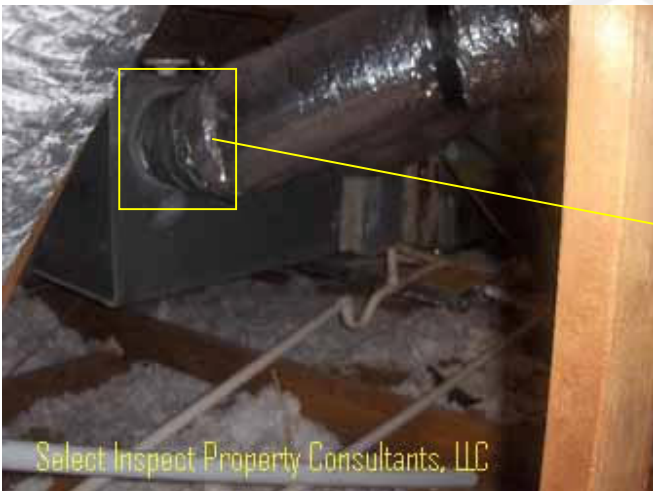
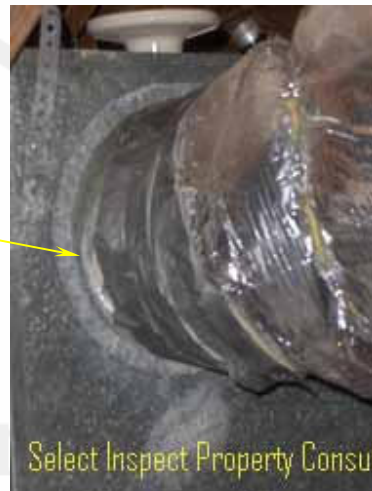
↑ inadequate insulation & seal, & inadequately secured air duct to plenum; example at downstairs HVAC

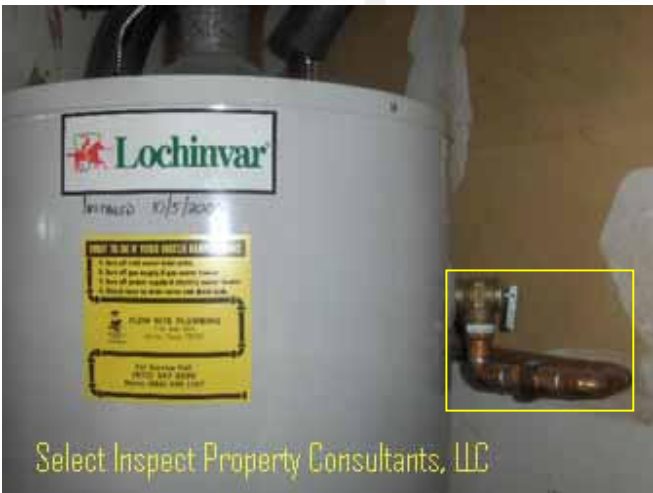
Select Inspect Property Consultants, LLC

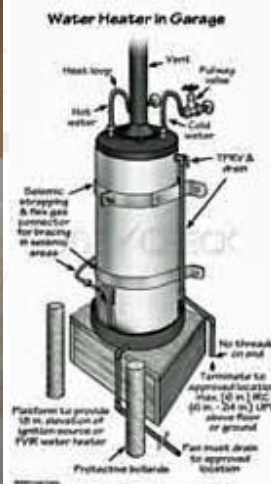
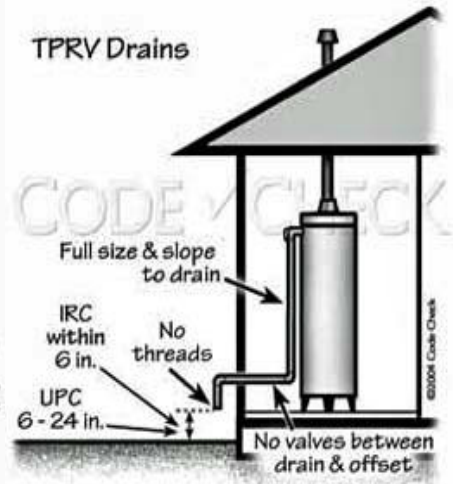
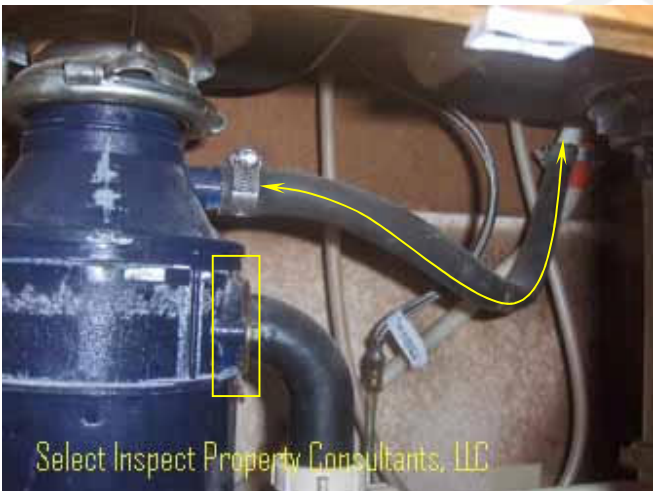
Select Inspect Property Consultants, LLC
