# Select Inspect

Property Consultants, LLC

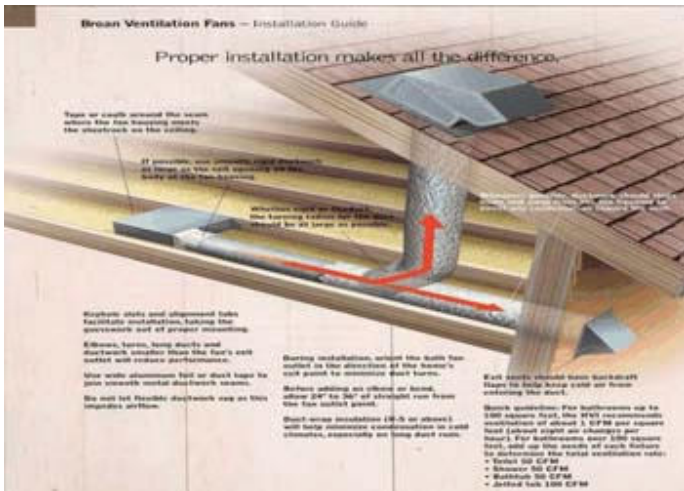
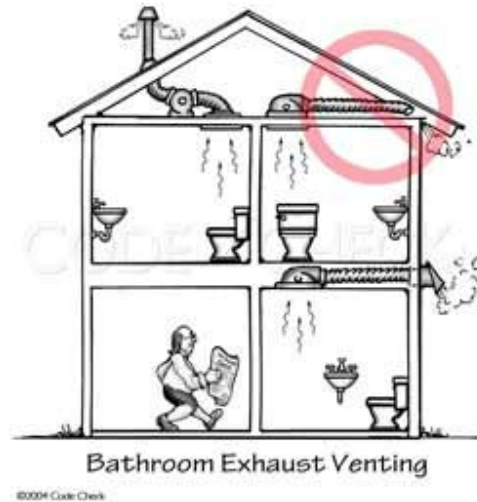
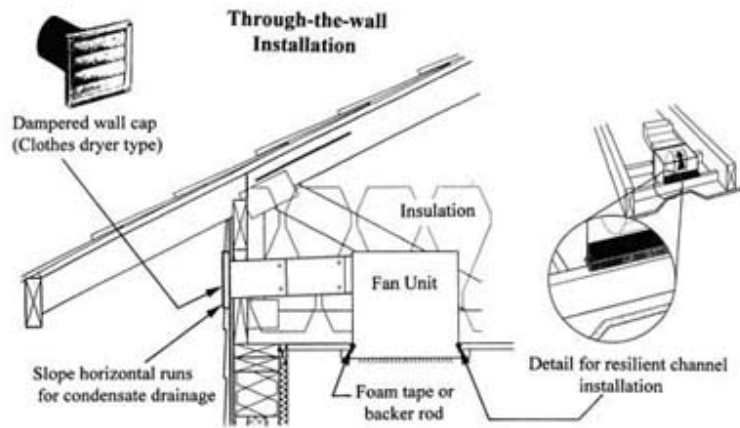
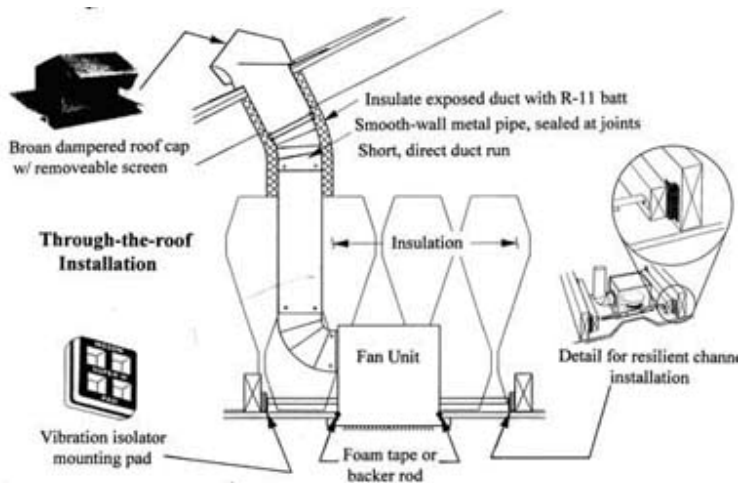
Report Identification 123 street; Allen, TX

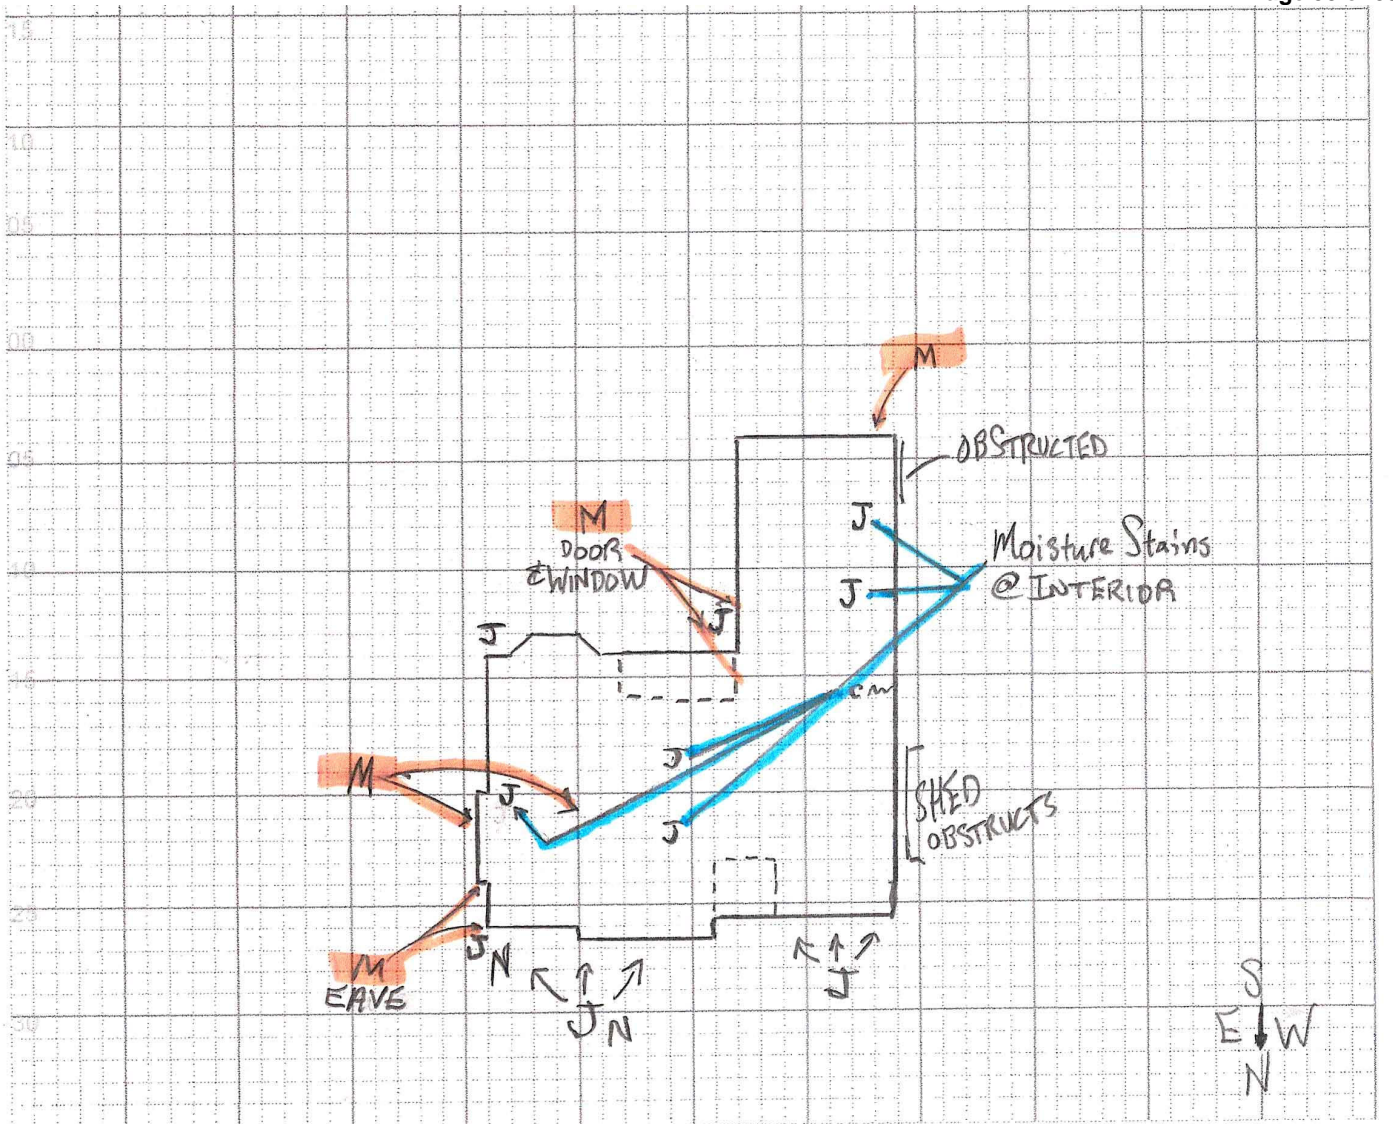
- G= WOOD-on-GROUND      I= FORM Board / Stake      J= MOISTURE      K= WOOD Debris      L= HIGH SOIL      M= WOOD DECAY
- N= DENSE FOLIAGE      O= SOIL Filled Planter      Q= WOOD PILE      R= FENCE Touching Bldg      T= INADEQUATE VENTILATION
- A= ACTIVE      P= PRIOR (EVIDENCE)      S= TERMITES      H= CARPENTER ANTS      B= OTHER WOOD-BORING INSECT
- ⊗ = treatment evidence; bait, drill, trap, etc      □ = 2 - 3 FEET      ~ = Visual slab/concrete crack
