# SELECT INSPECT PROPERTY INSPECTION REPORT

Prepared exclusively for:  
**Select Inspect Client**

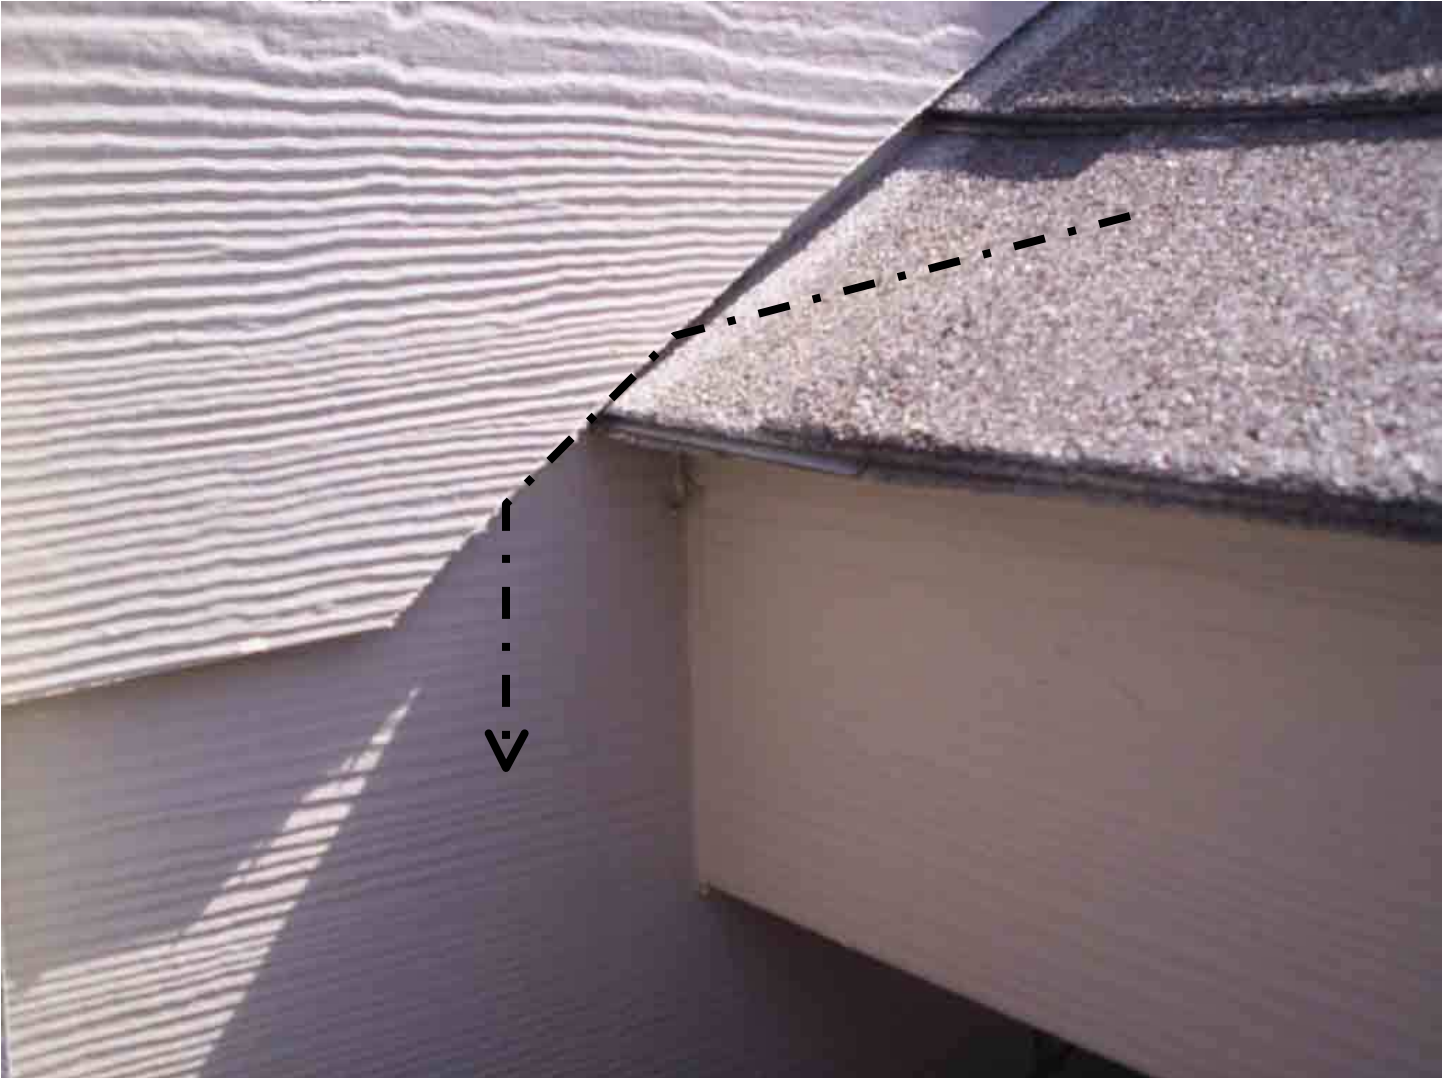
↑ correct flashing- west side of chimney- rain will be directed out / away from the interior structure.

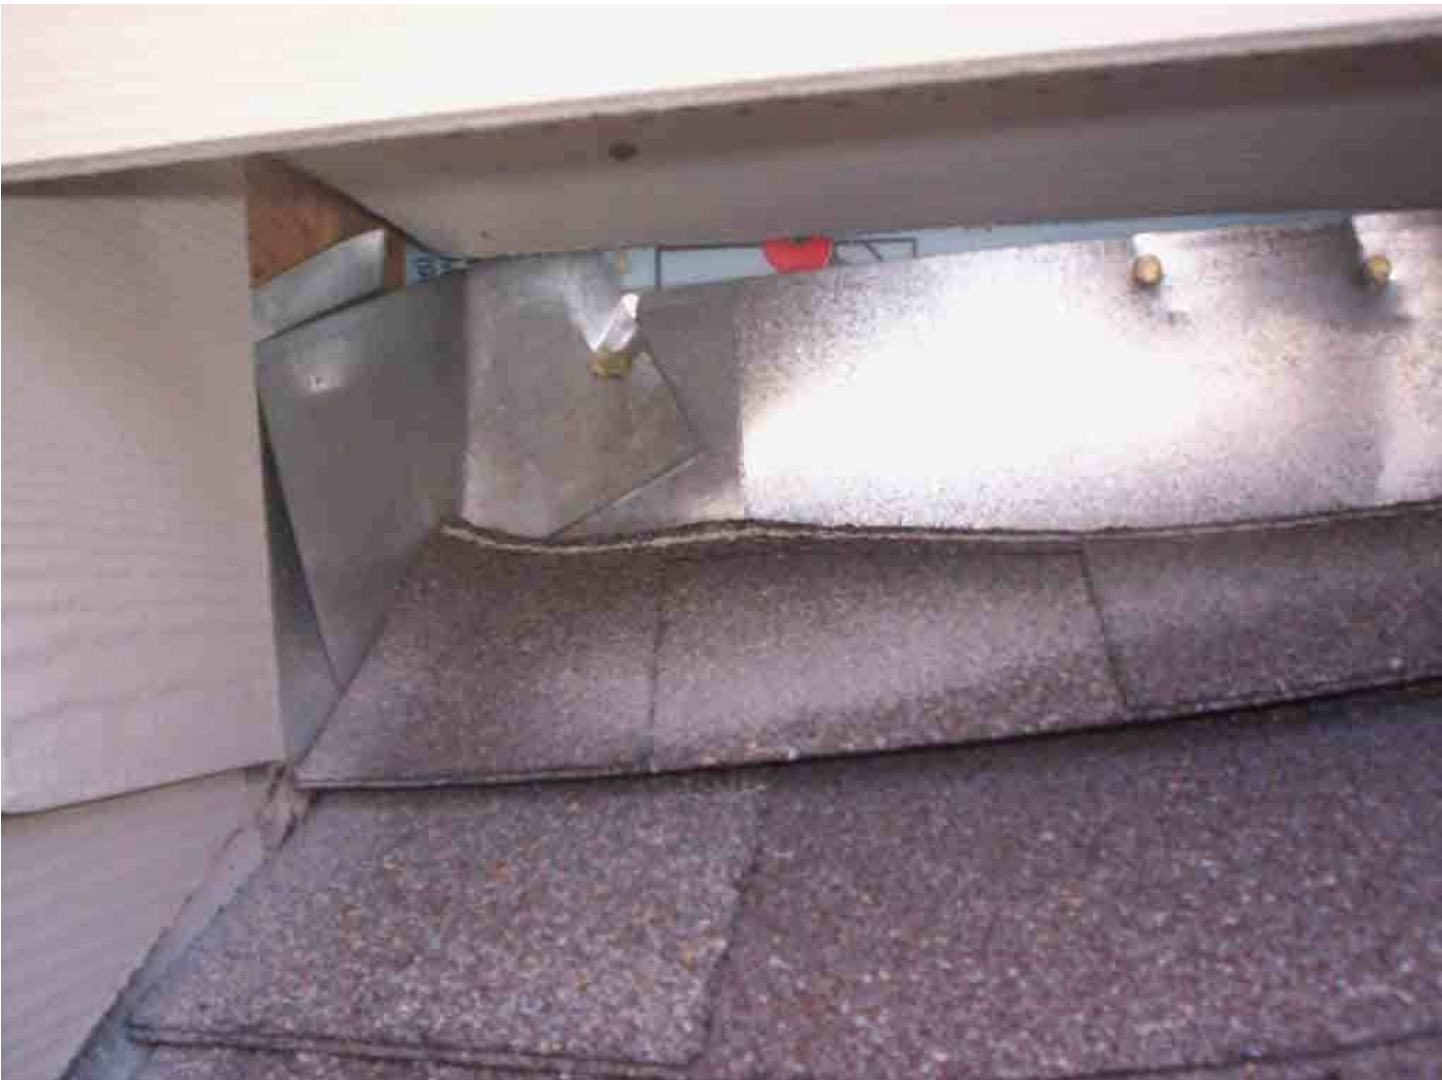
↑ eave under west side of chimney remains amiss / deficient.

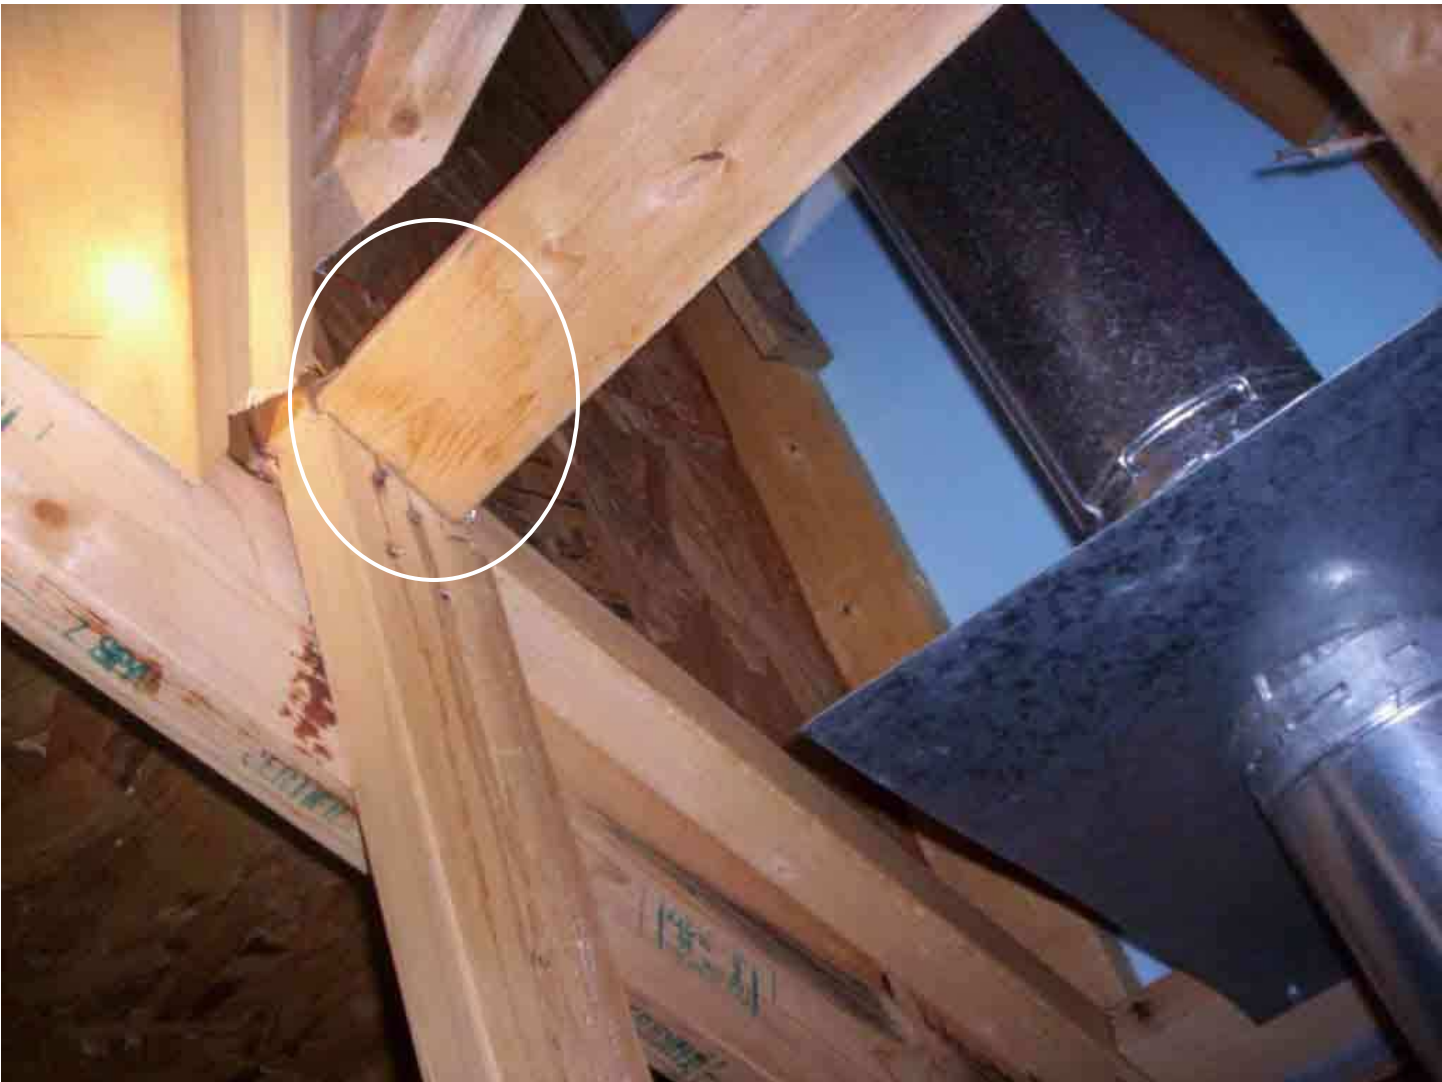
↑ slight staining at chimney framing in attic- when the condition occurred or if it is ongoing is undetermined.

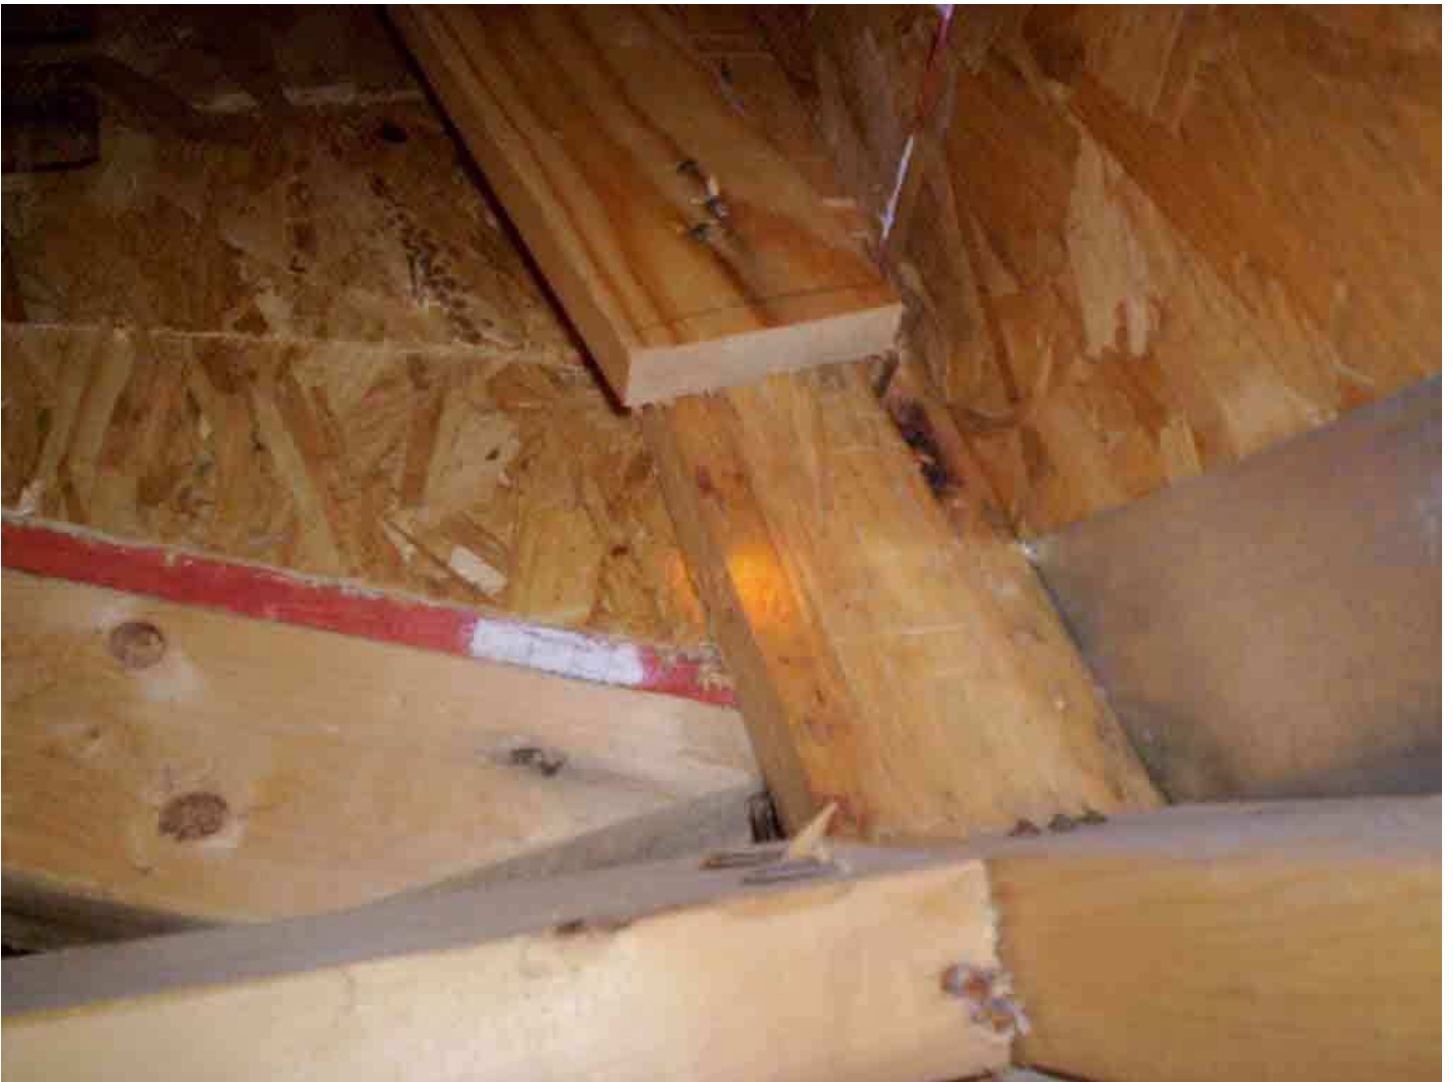
↑ interior view of chimney chase adjacent amiss eave location.

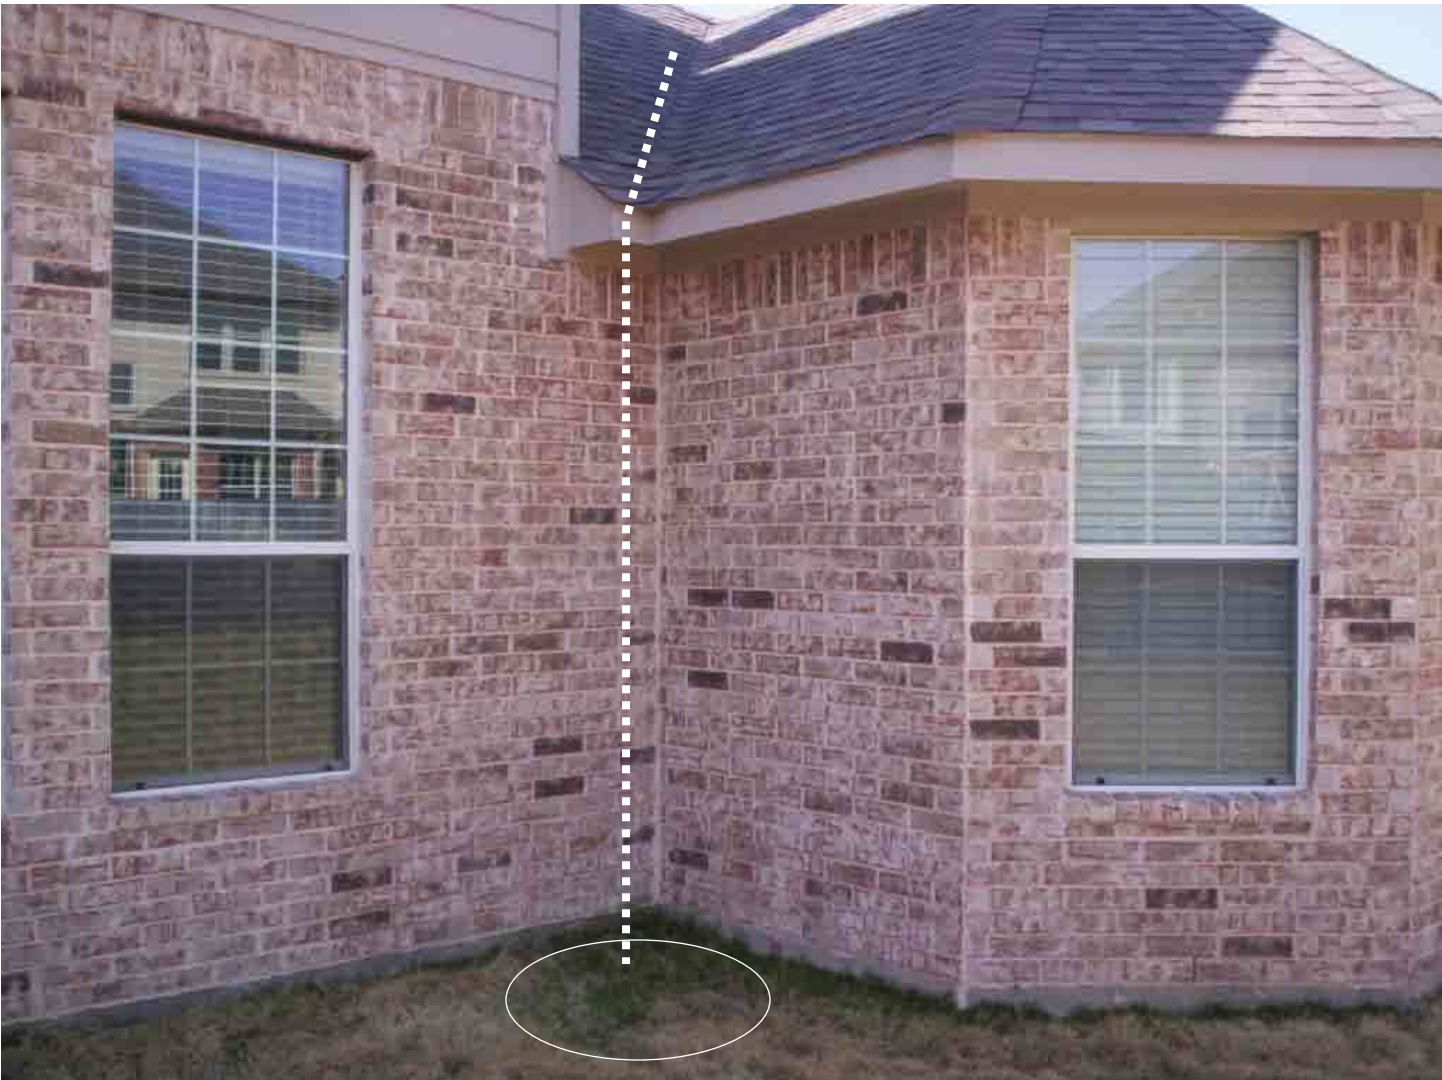
↑ area of erosion noted in the drainage section

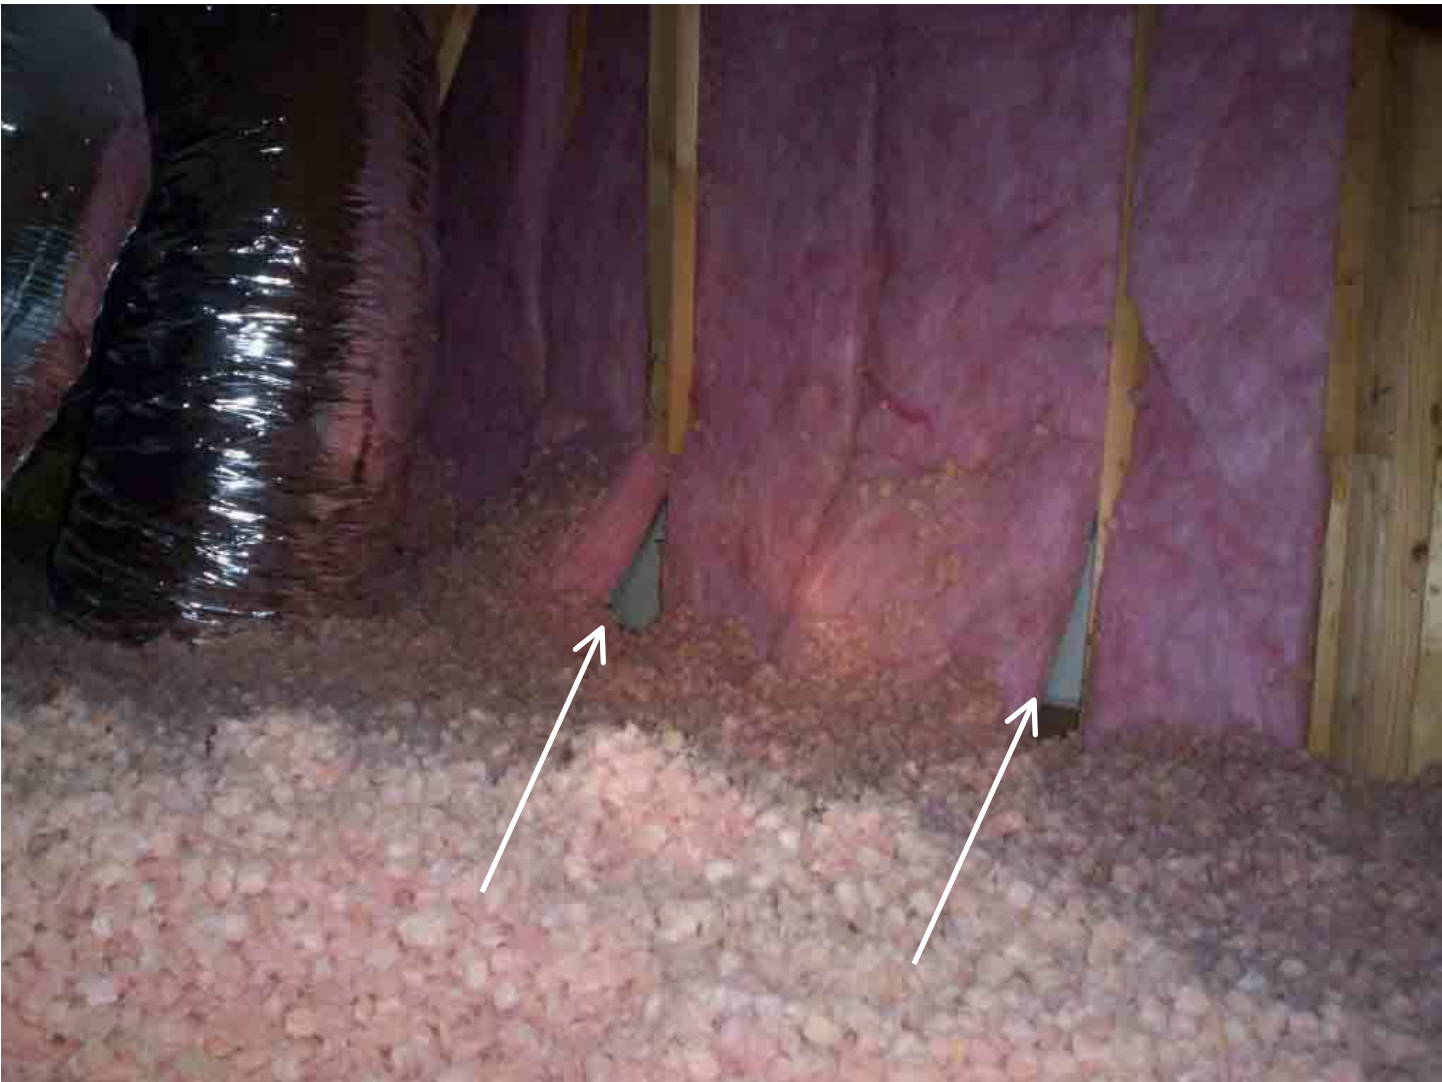
↑      amiss insulation at garage attic –example

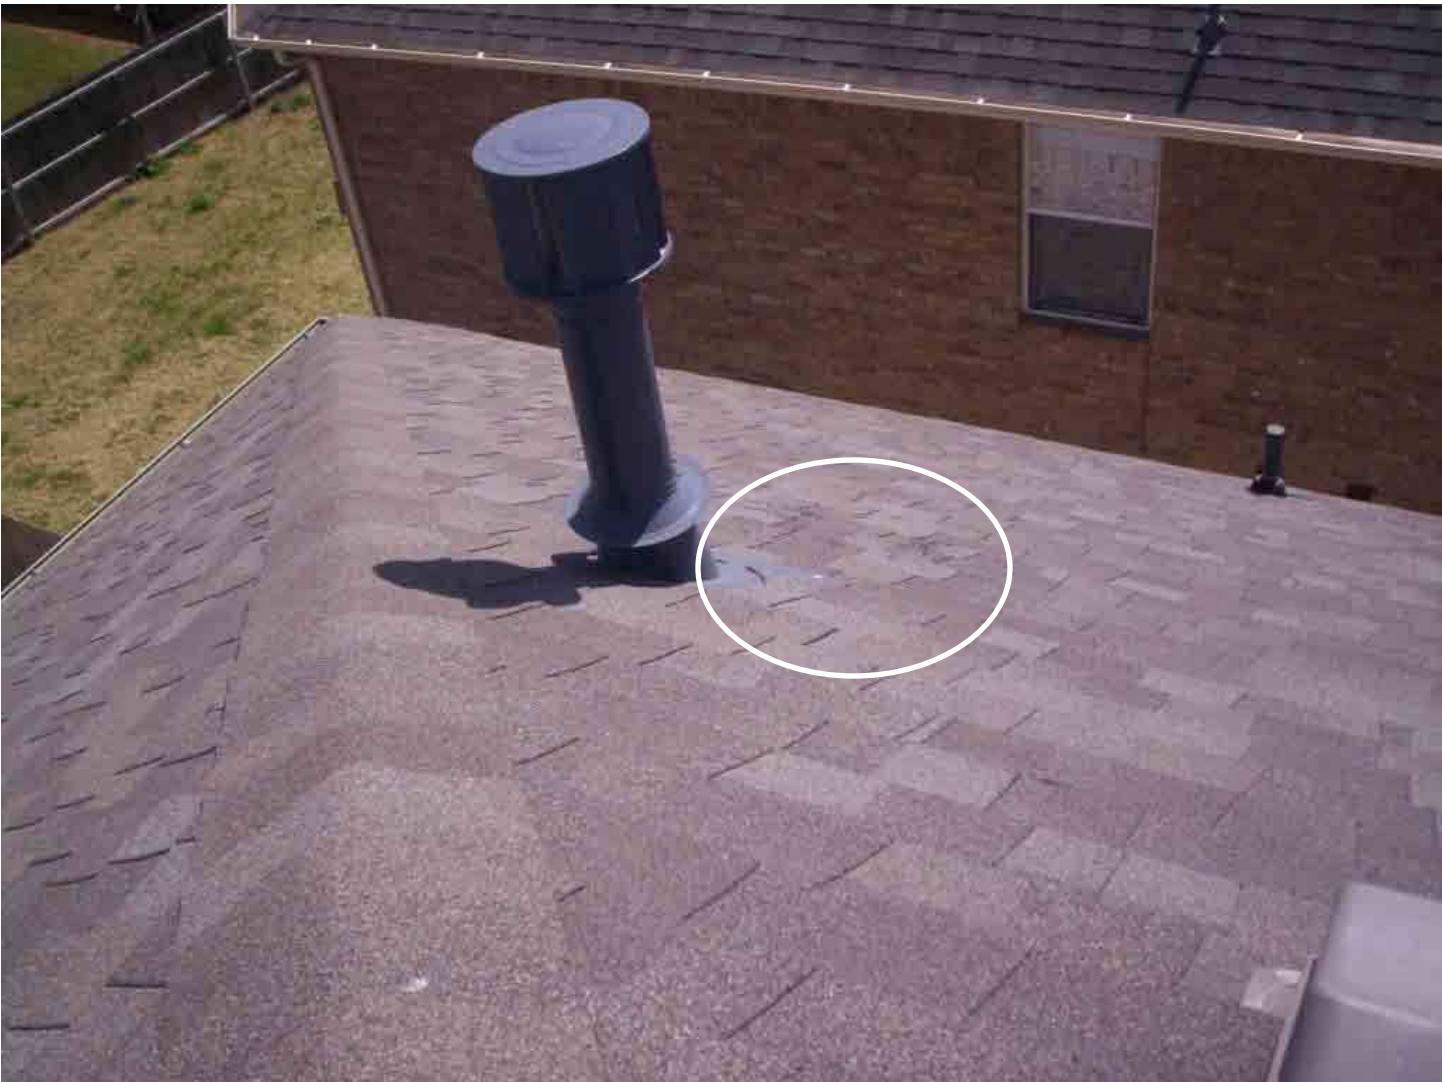
↑ slight worn area at southeast roof. Repair needs were not discovered at the time of inspection.

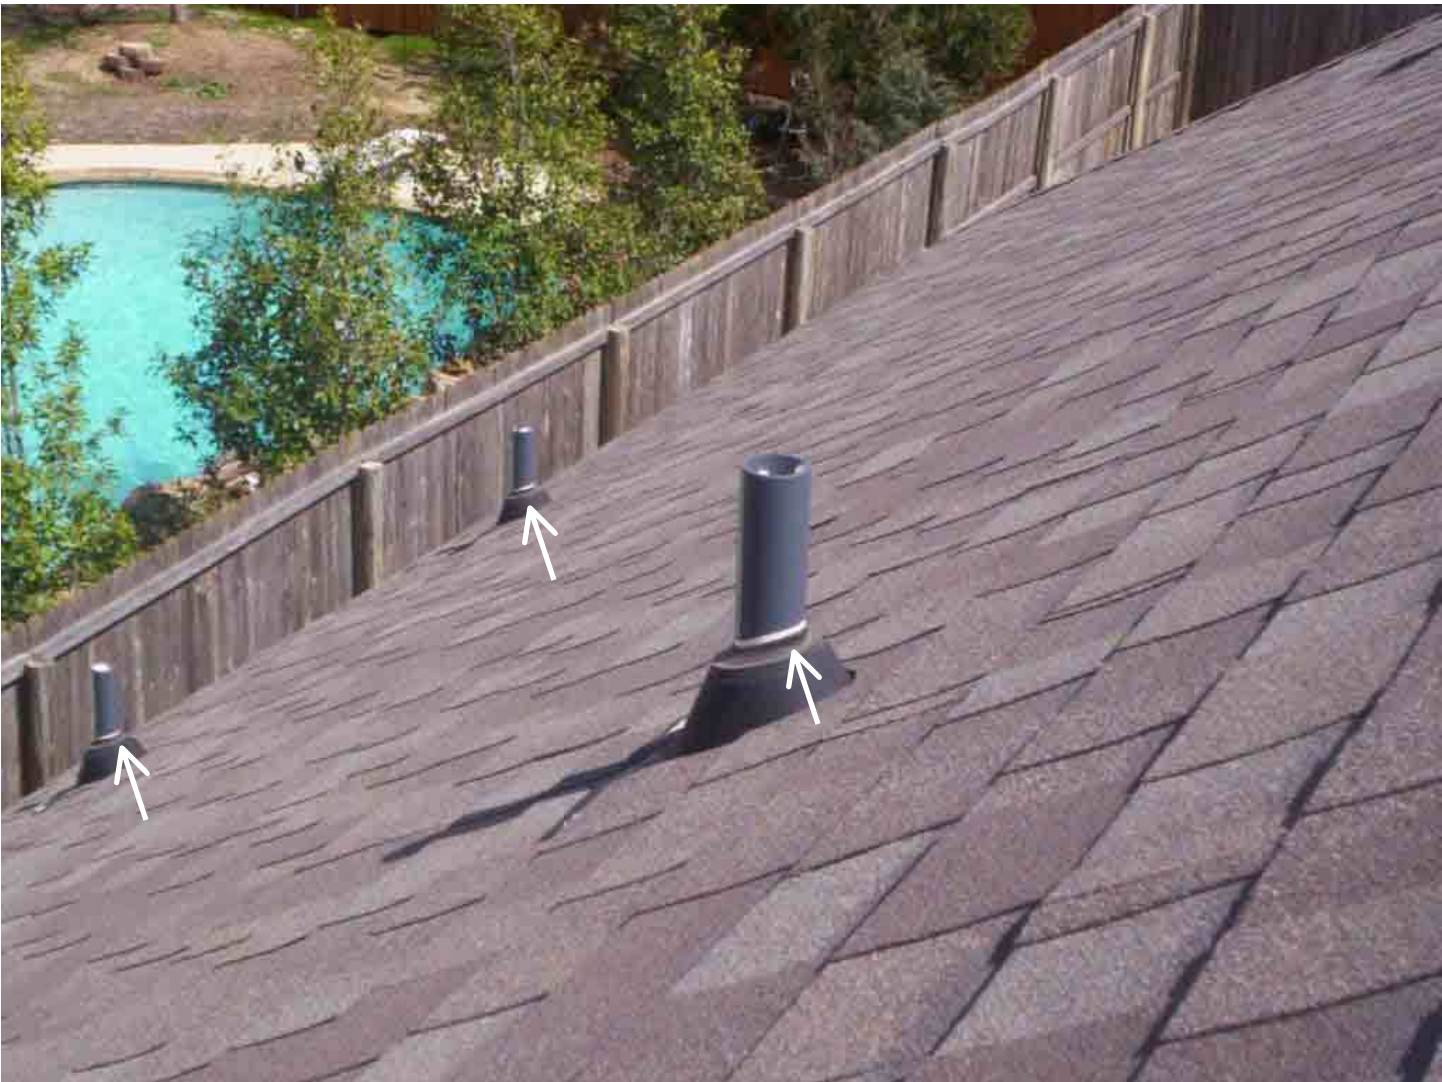
↑ vent separation examples at north
