Select Inspect

Property Consultants, LLC

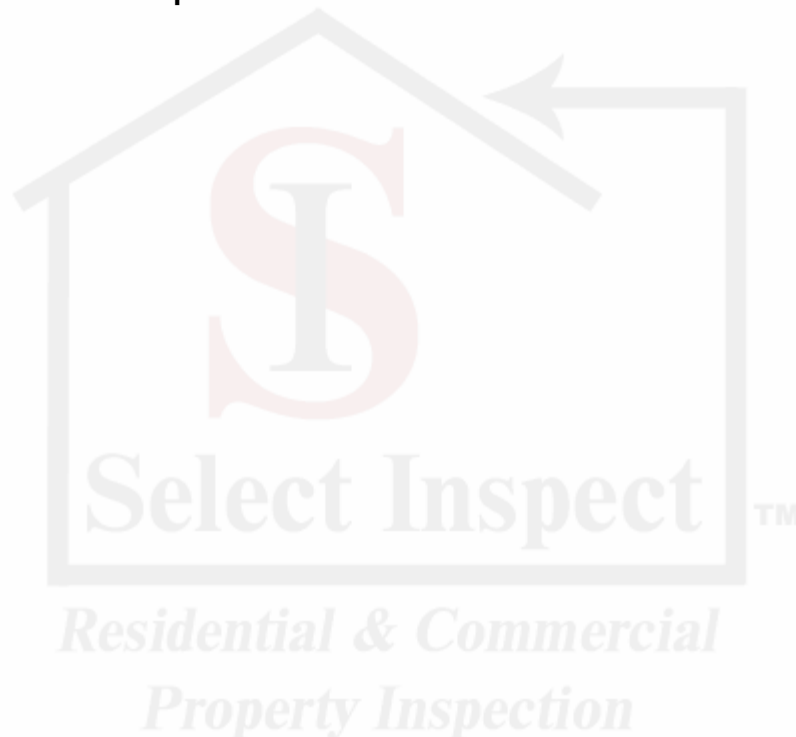
Limitations & Scope of Inspection Statement

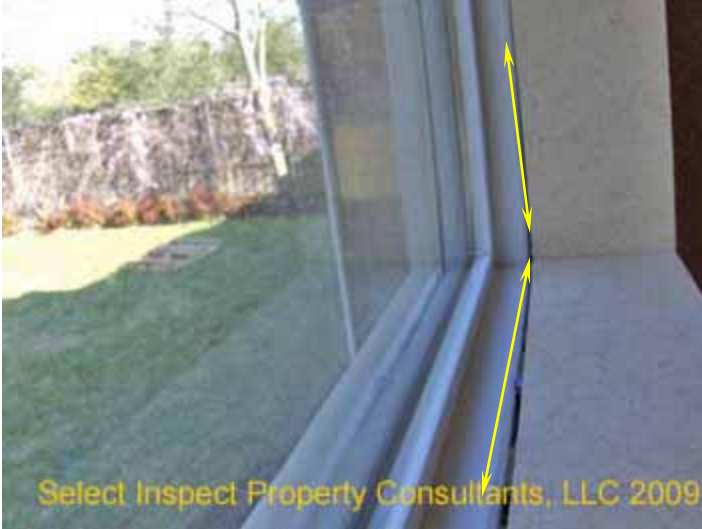
↑ sealant / grout needed at the guest bathroom window

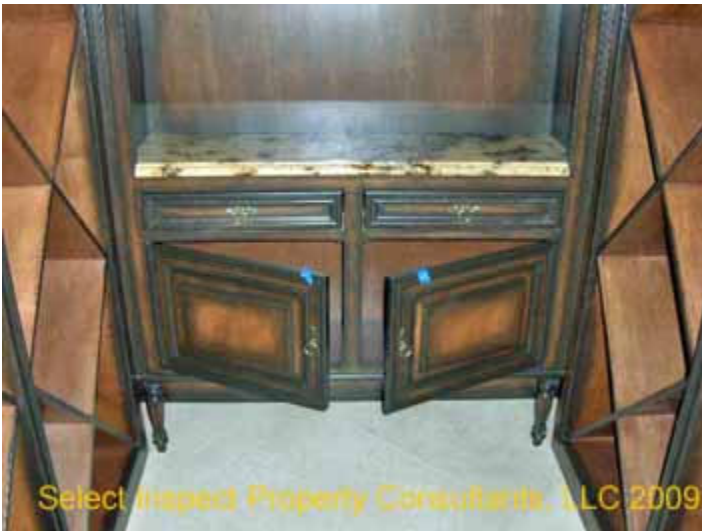
↑ wine grotto cabinets were askew; adjustment of the hinges should correct the condition

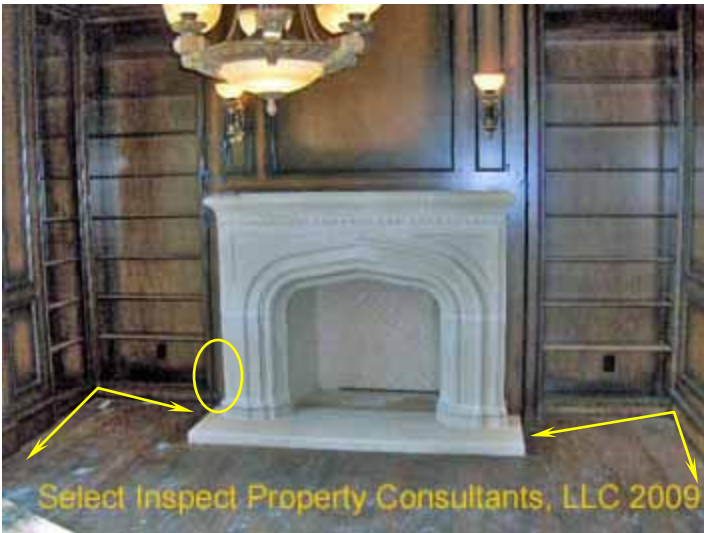
↑ gaps remain at perimeter; peeling veneer at the left

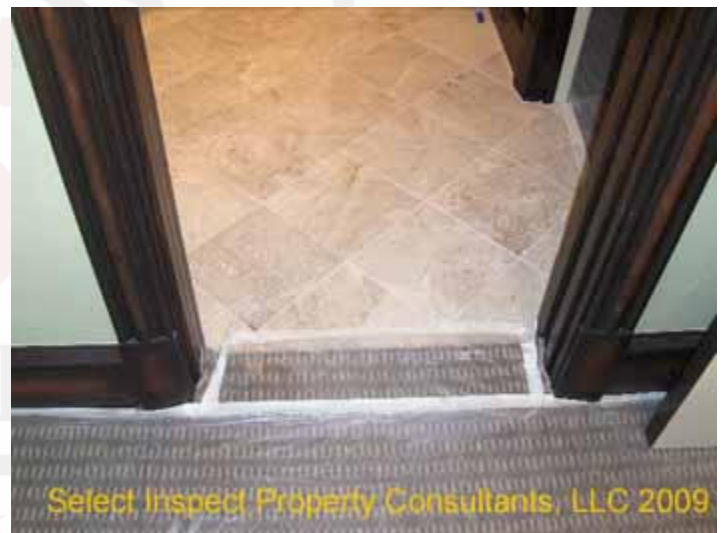
↑ deficient transfer at upstairs southeast bathroom doorway

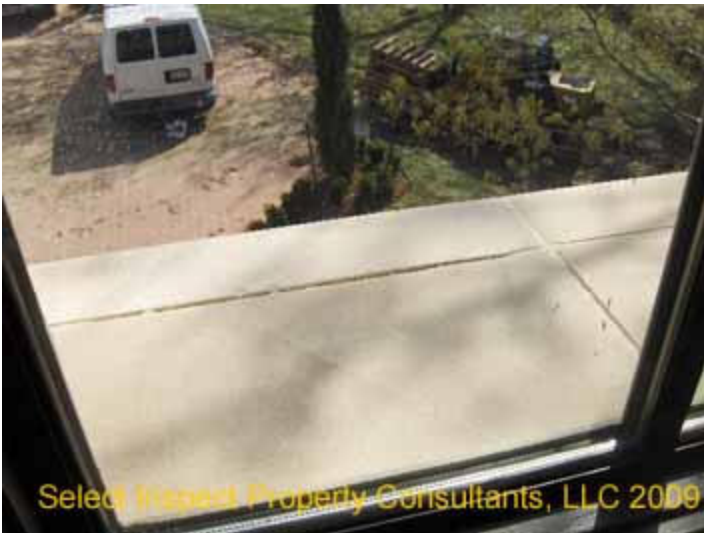
↑ mortar tuck pointing needed

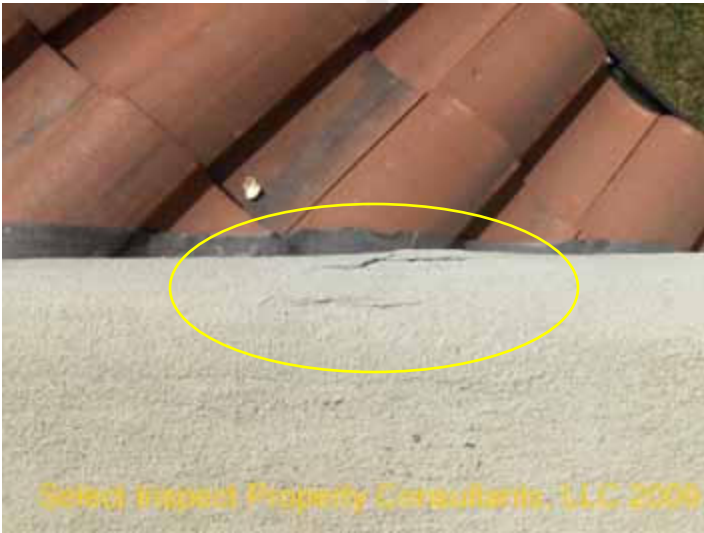
↑ damaged stucco/EIFS at game room window

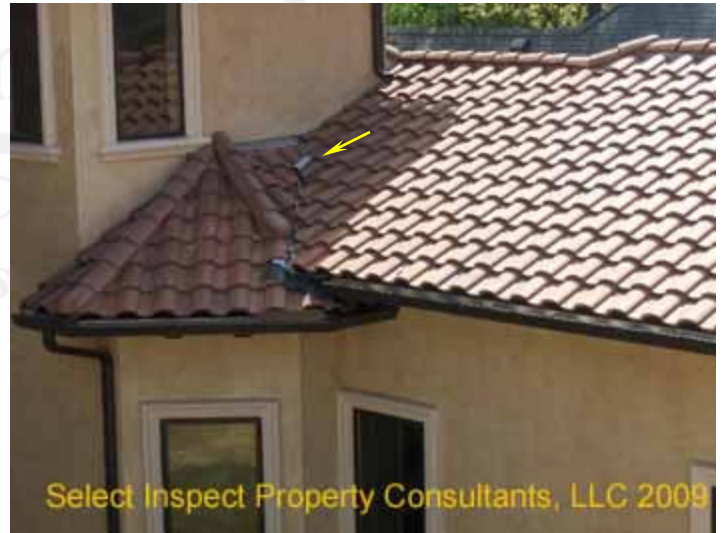
↑ debris at master bedroom roof

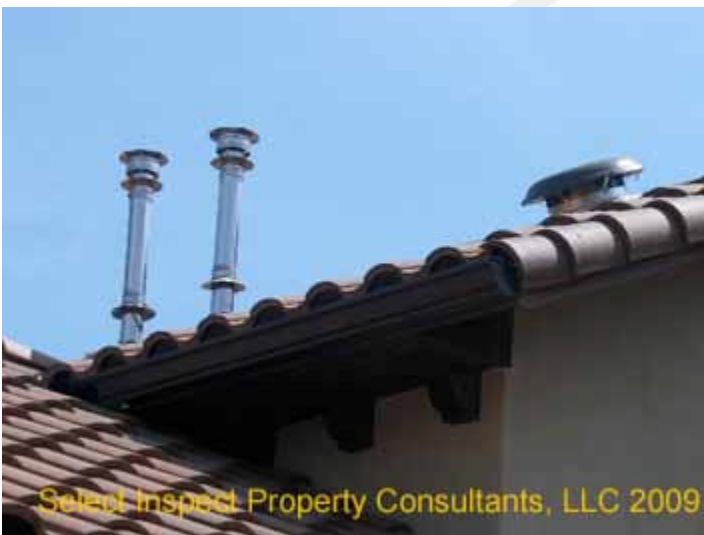
↑ paint exposed roof metal to resist corrosion.

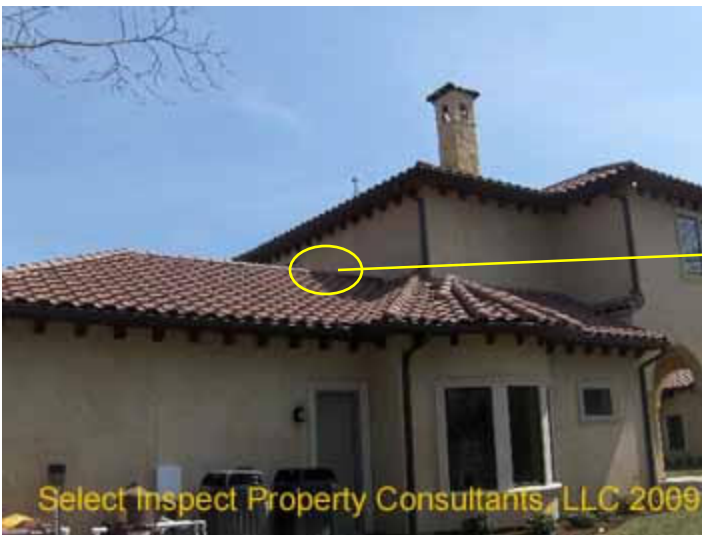
↑ damaged tile & suspected damaged ridge support/vent

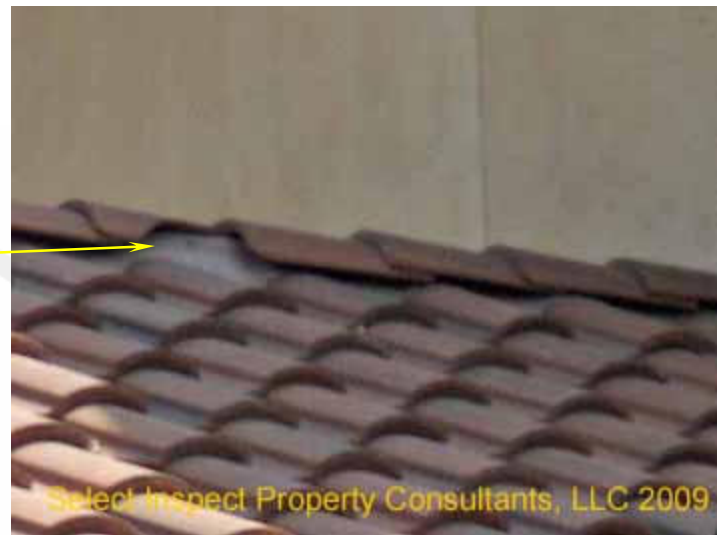
↑ close view of image at left

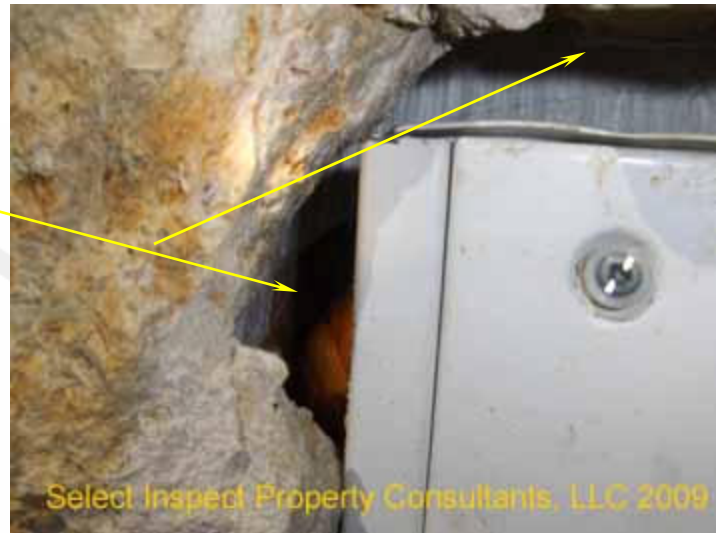
↑ exposed substrate; openings at moisture barrier

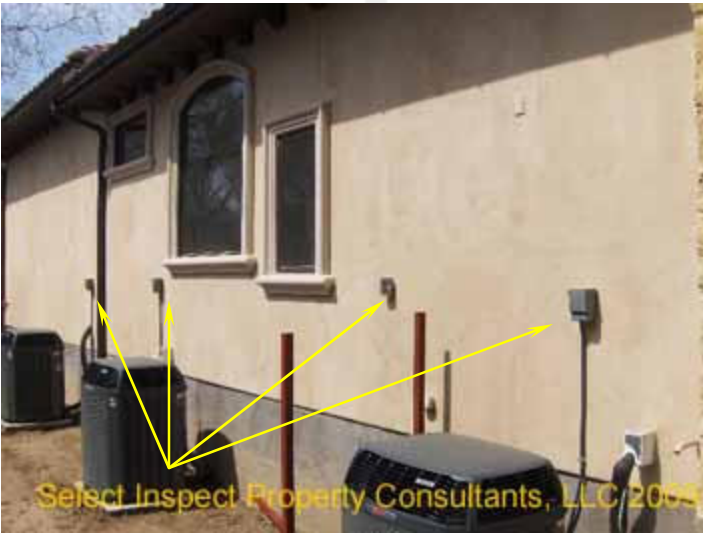
↑ sealant needed at Air-conditioner service disconnects; example at south

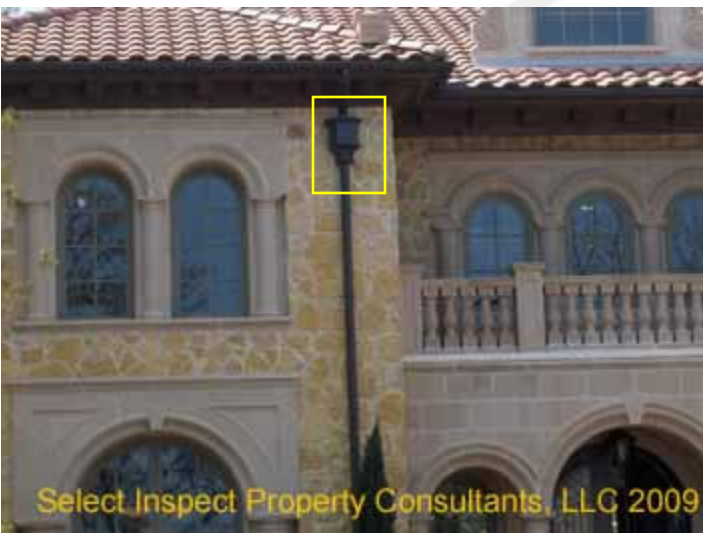
↑ ? askew scupper; just appeared visually offset to me ??

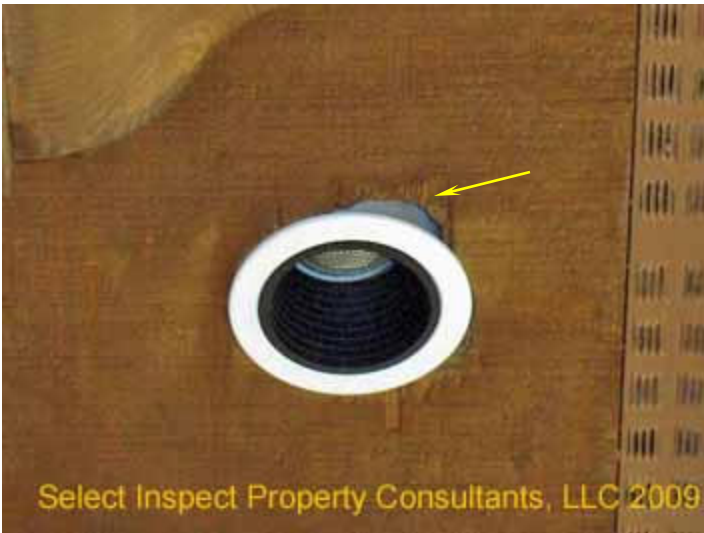
↑ damaged soffit & reveal at southeast eave light

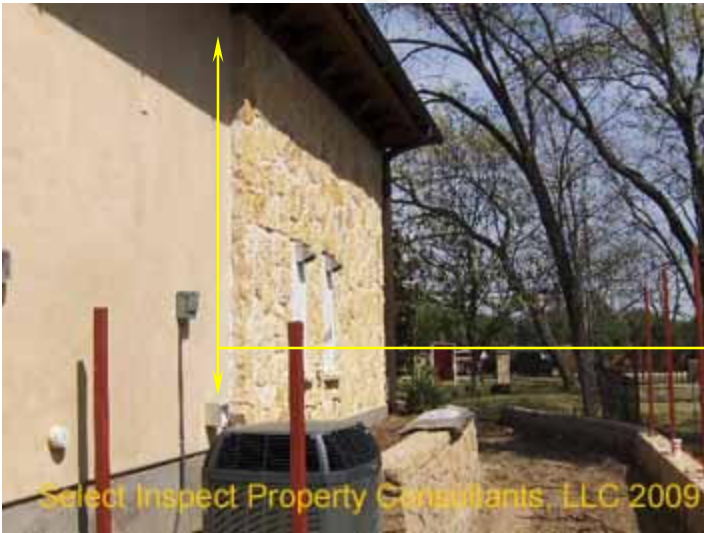
↑ unfinished stucco; exposed house wrap

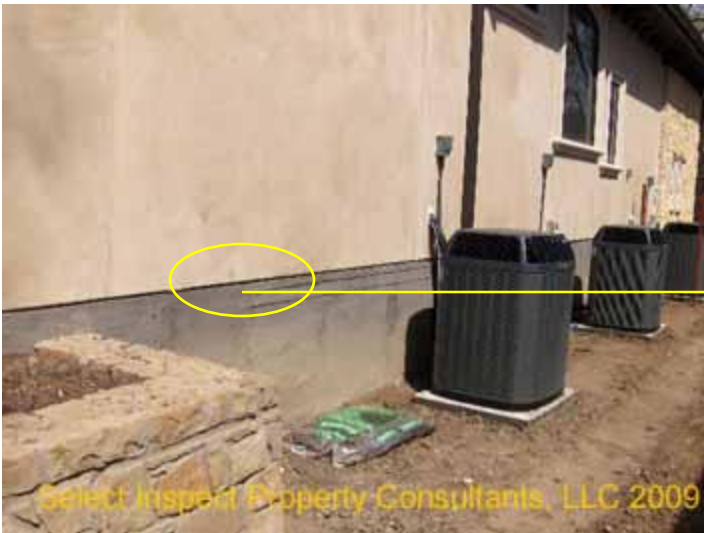
↑ damaged stucco at south

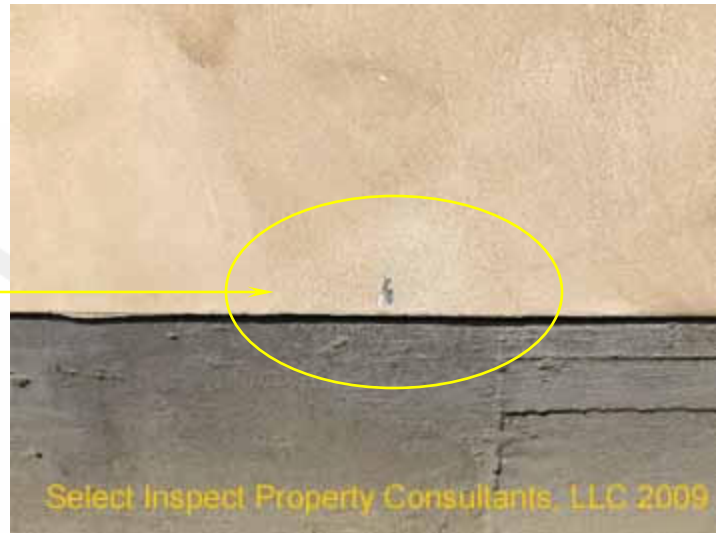
↑ close view of image at left

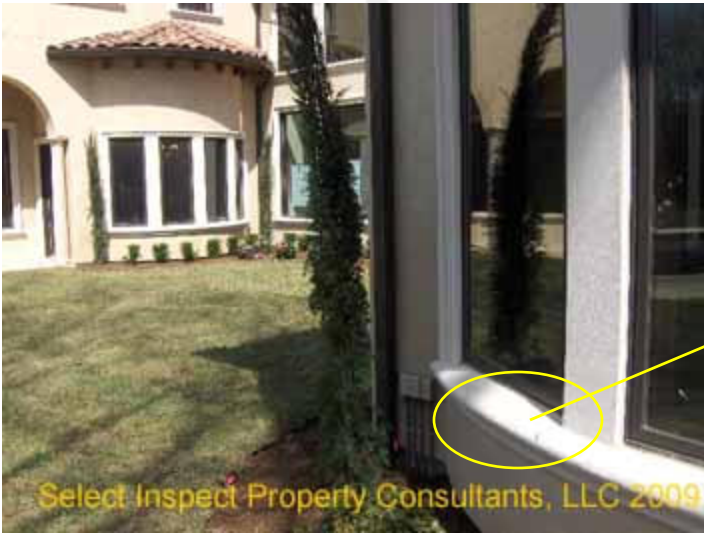
↑ damaged stucco at master bedroom window

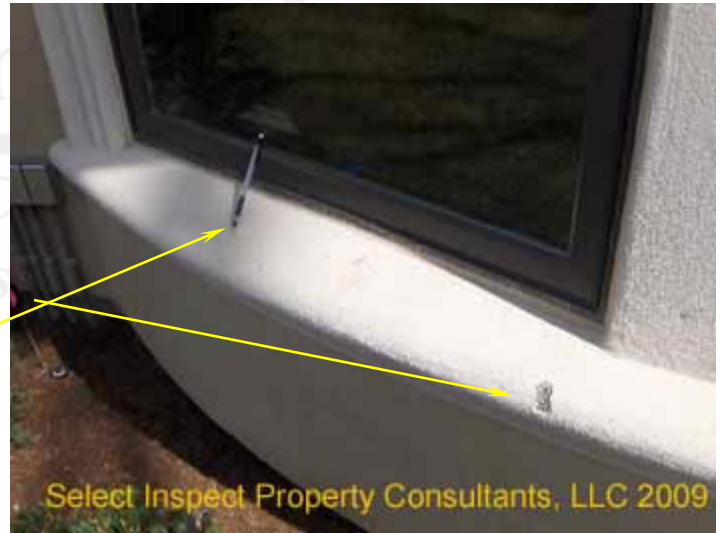
↑ close view of image at left

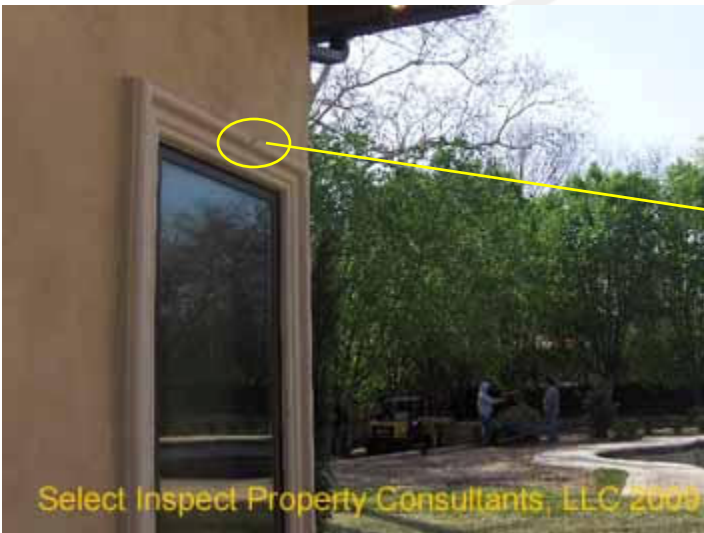
↑ damaged stucco at master bedroom window

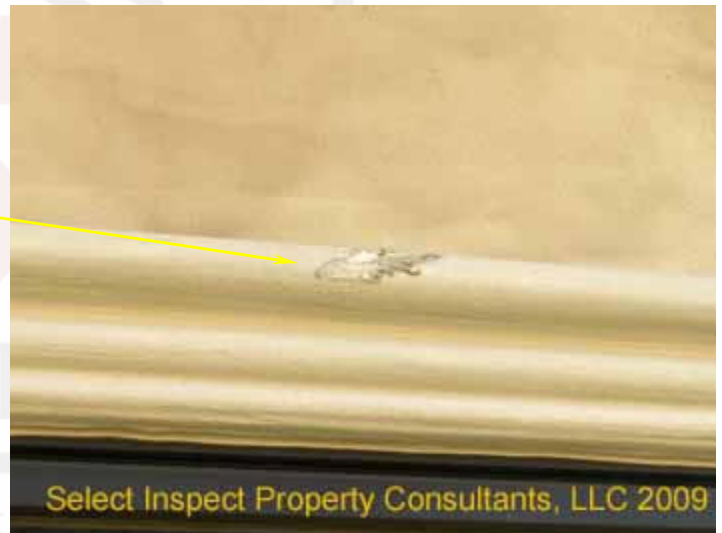
↑ close view of image at left

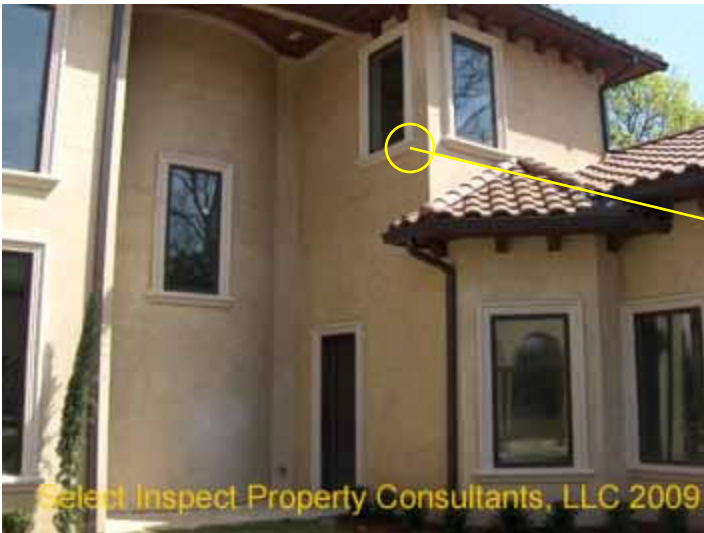
↑ discoloration (moisture or cosmetic ?)

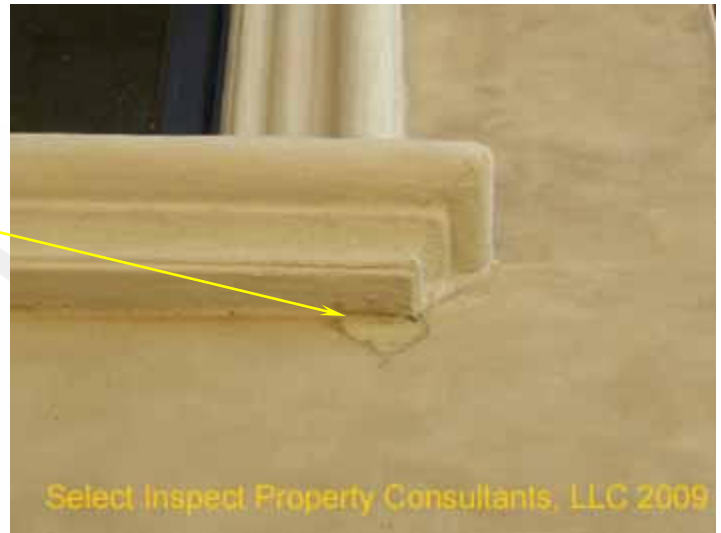
↑ close view of image at left

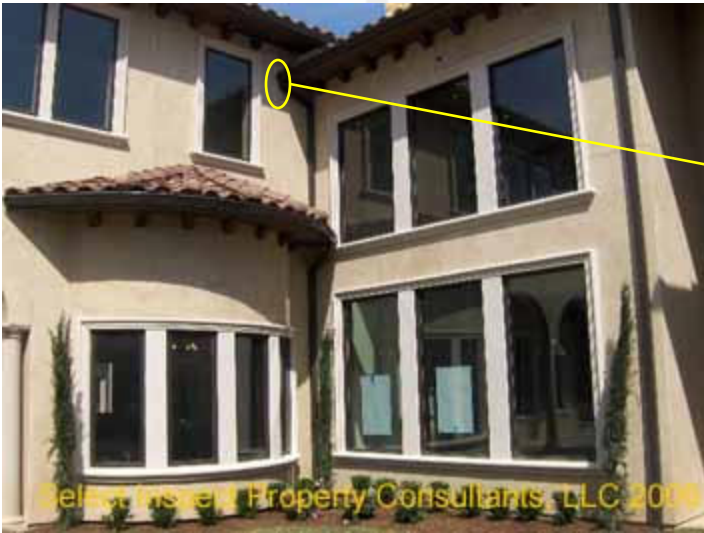
↑ discoloration; undetermined cause

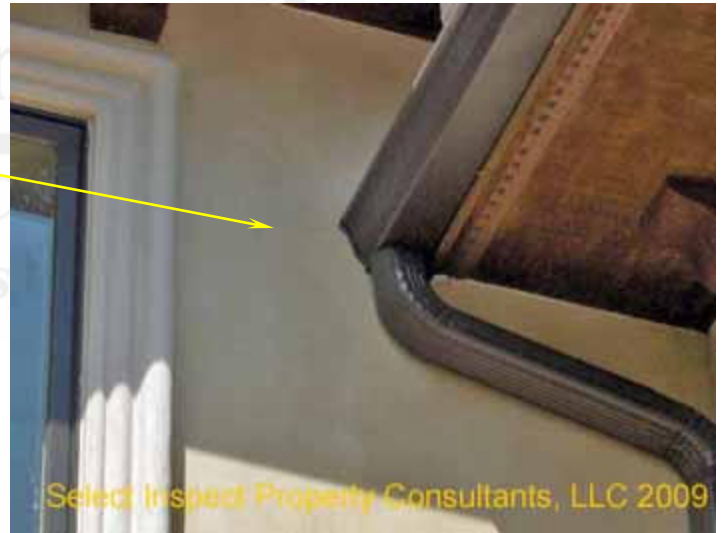
↑ close view of image at left

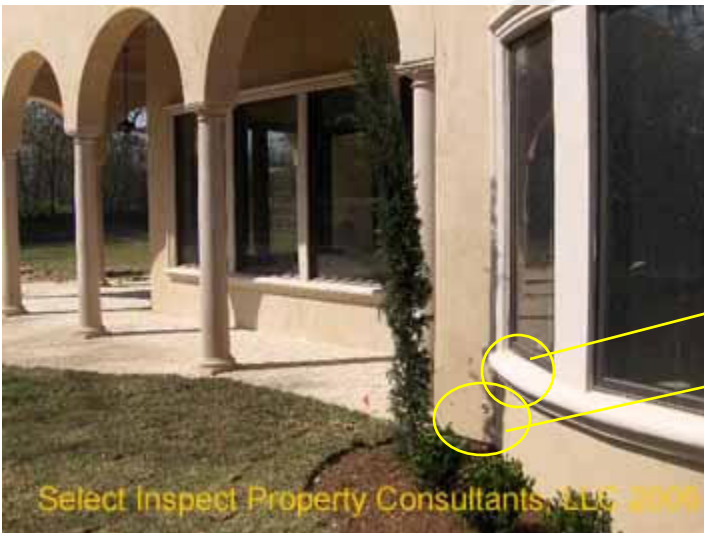
↑ damaged stucco & undetermined open pipe (cleanout?)

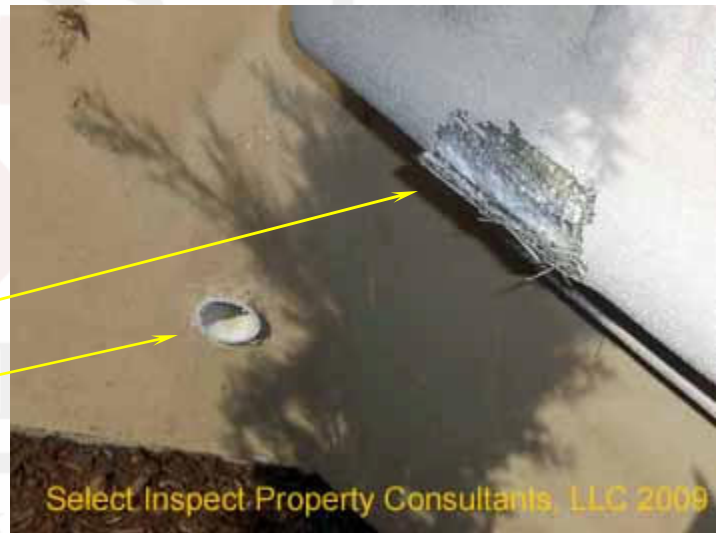
↑ close view of image at left

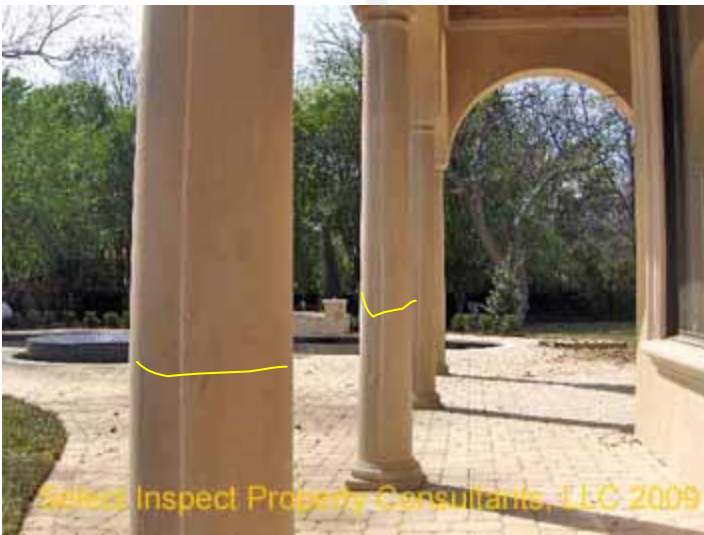
↑ 5 of 8 columns were cracked at the patio

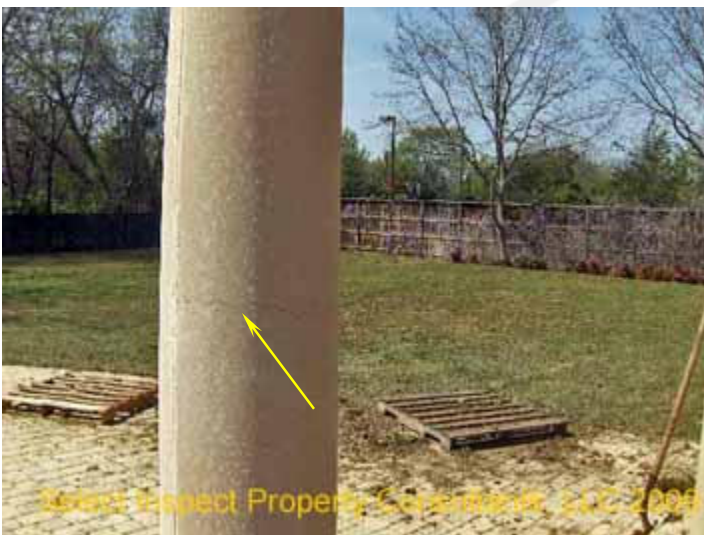
↑ close view example cracked column

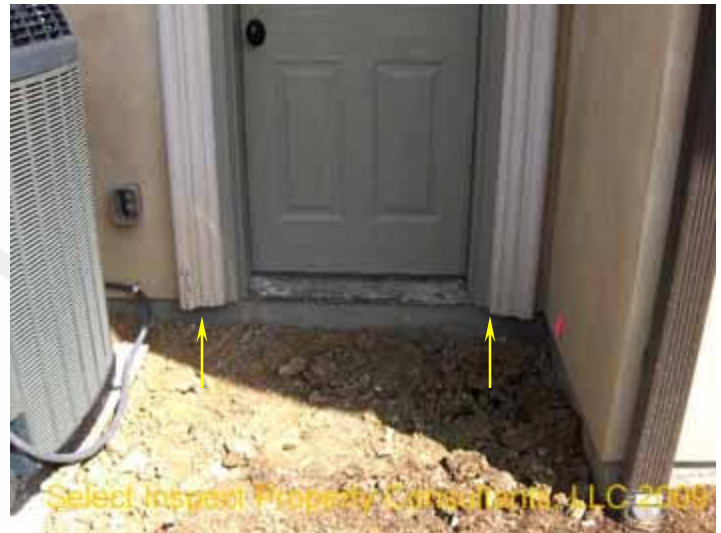
↑ recommend paint/sealant at the exposed underside trim at doorway

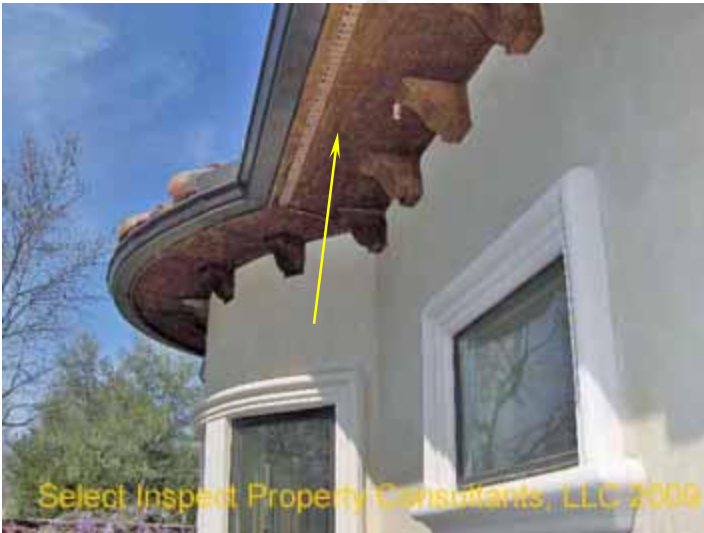
↑ slight discoloration; peeled soffit; very minor

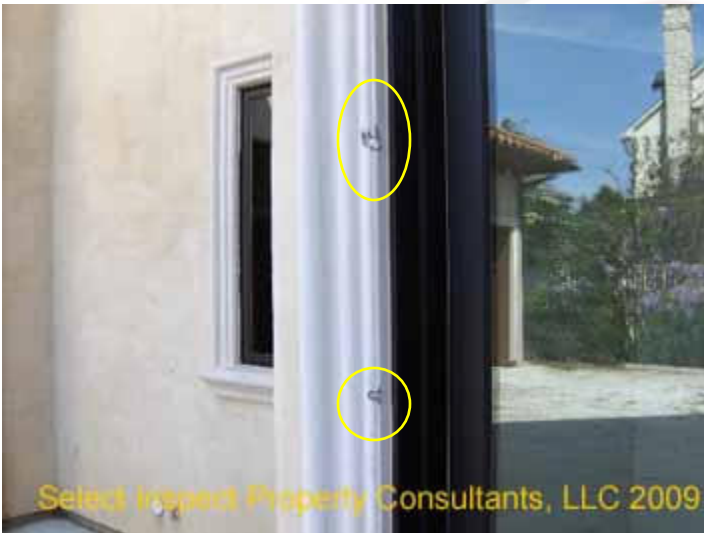
↑ damaged stucco at driveway door

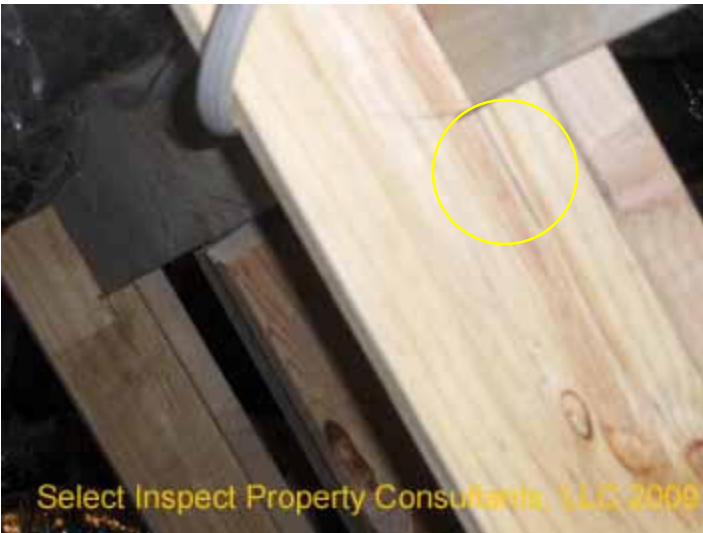
↑ over cut strut; Significant issues were not found or observed concerning this item at the time of inspection

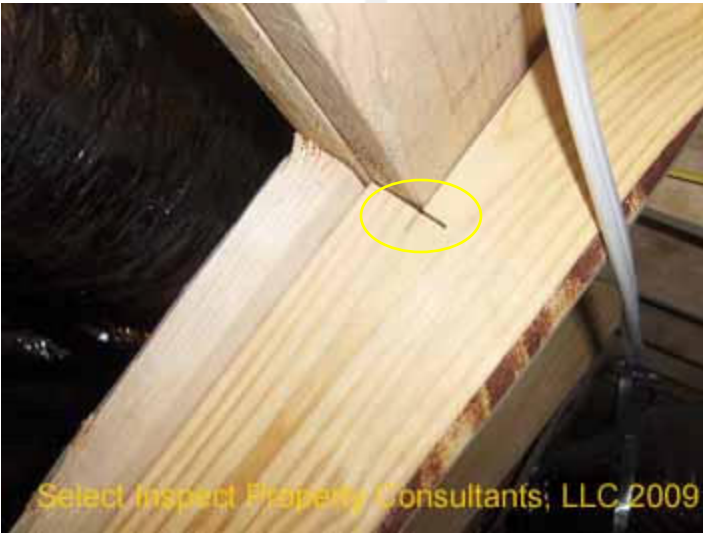
↑ better; tight cut example

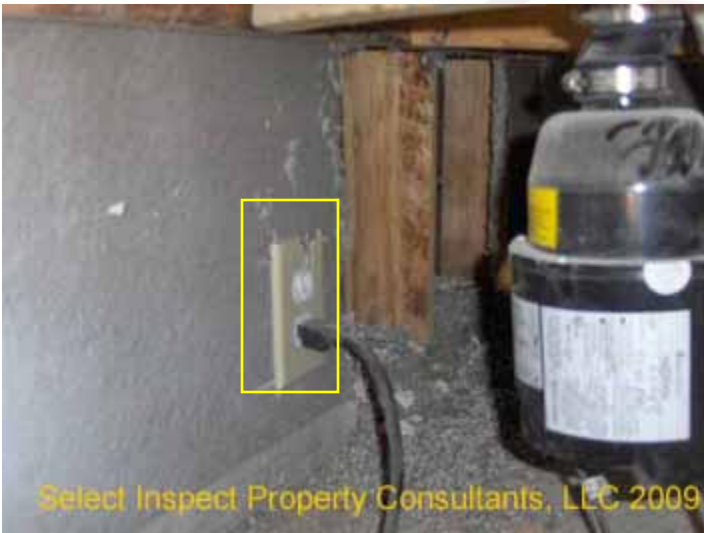
↑ damaged receptacle(s) cover below master bathtub

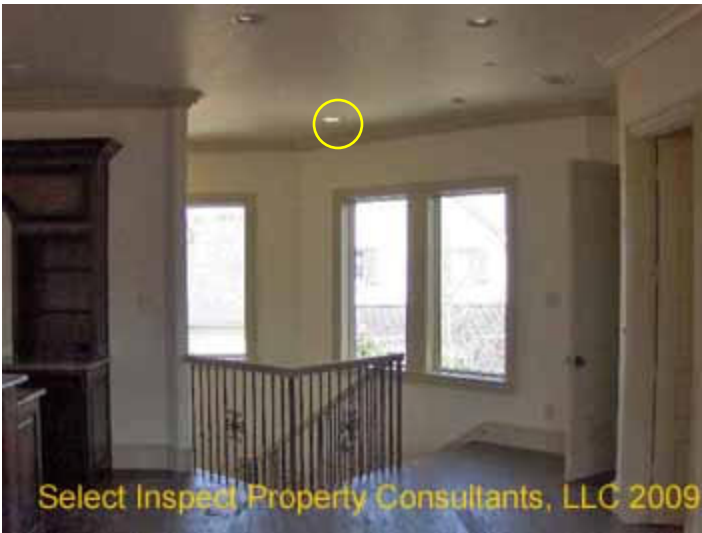
↑ upstairs light switch not discovered for over stair lighting

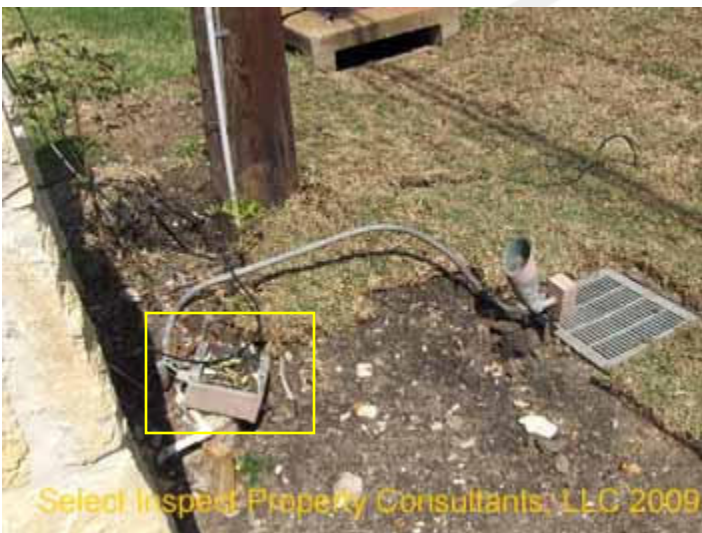
↑ exposed electrical at northeast near the street may be a hazard.

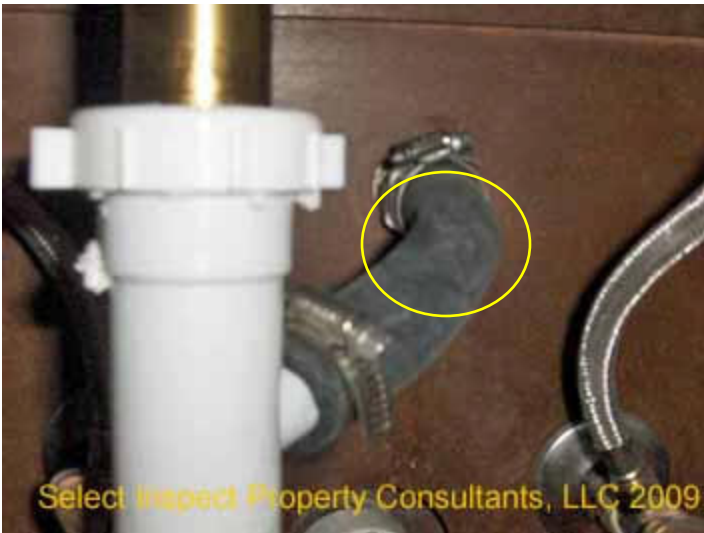
↑ crimped air-conditioner primary condensate line is prone to failure

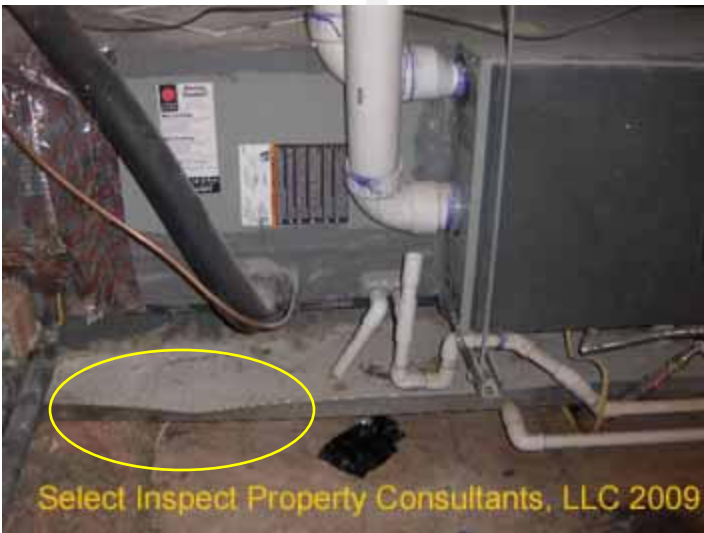
↑ deficient auxiliary pan at master bedroom HVAC

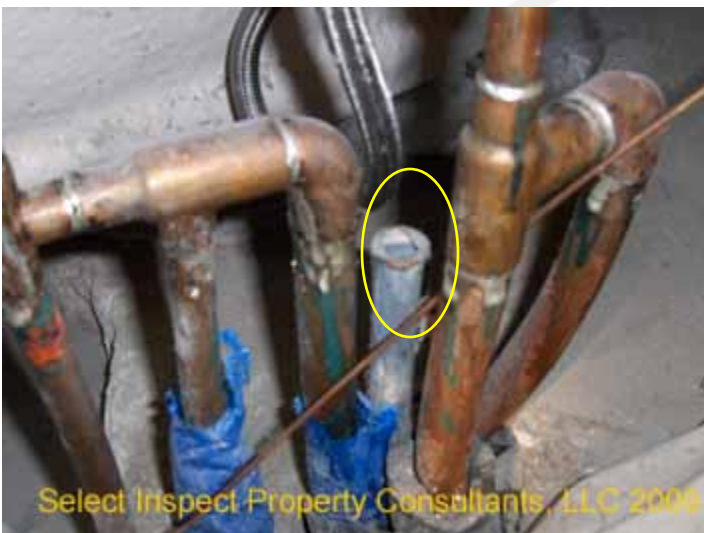
↑ hollow plumbing support stake may be a future entry point for wood destroying insects
