Property Inspection Report

Concerning: 123 street Lucas, Texas
(Address or Other Identification of Inspected Property)

By: Bruce W. Carr; TREC #5281 ASHI Member # 211804 Friday, May 13, 2011
(Name and License Number of Inspector) (Date)

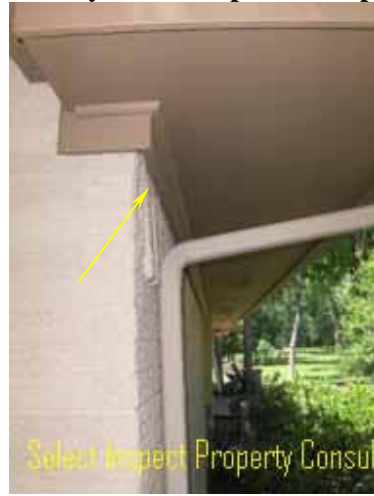
↑ frieze-board separation at the northeast

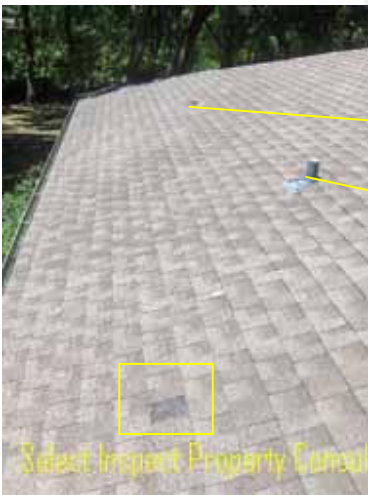
↑ delaminated shingle & plumbing vent(s) was shorter than required

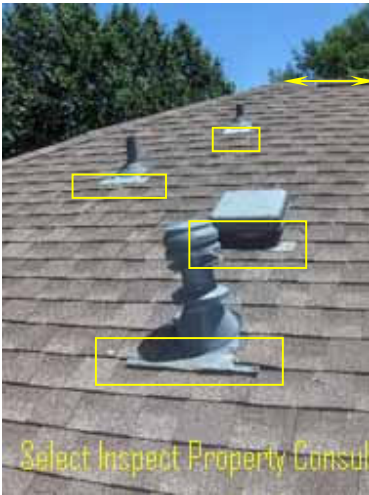
↑ lifted flashing and uncaulked, exposed fasteners locations

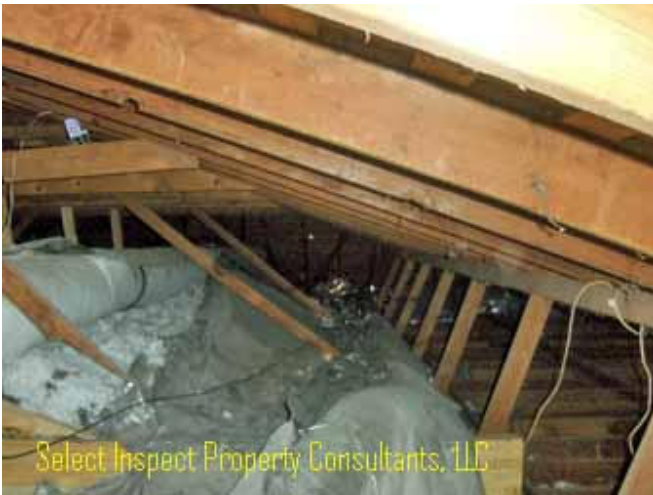
↑ southwest & south attic not readily accessible

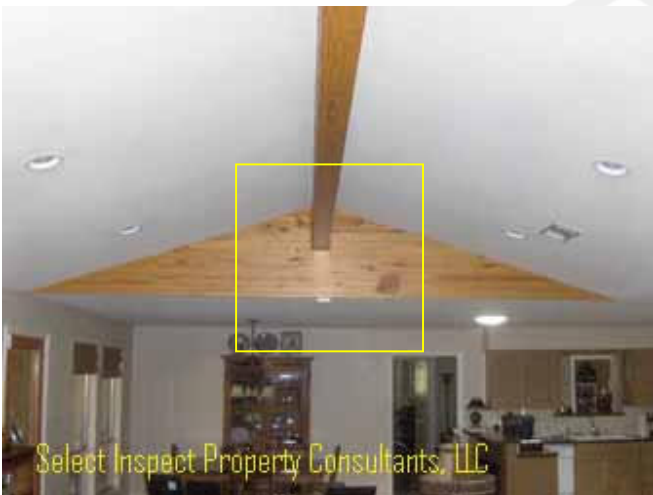
↑ Unusual Thermal anomalies not discovered at family room north- some energy loss at peak
