Property Inspection Report

PROPERTY INSPECTION REPORT

2020 Wing Point

Tuesday, November 09, 2010

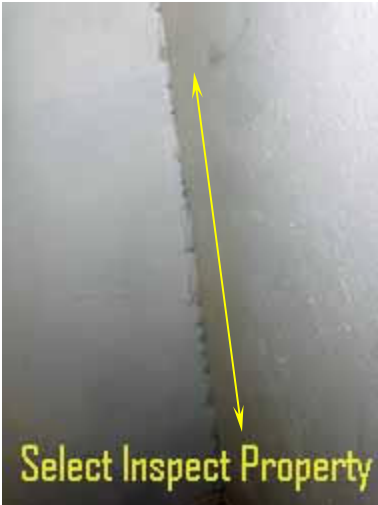
↑ example compression at hall closet

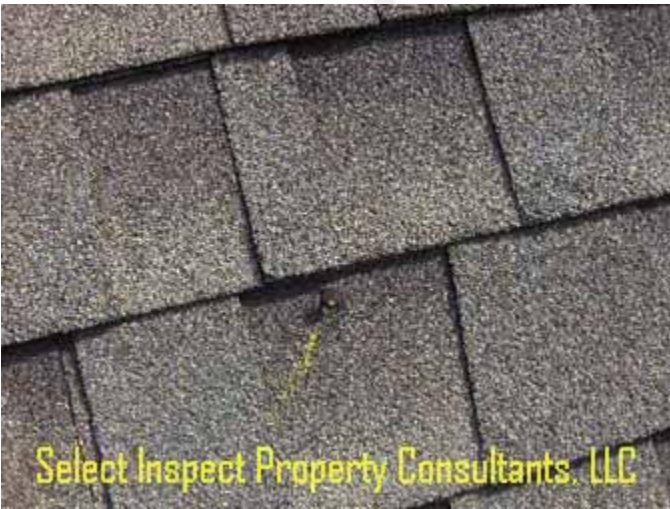
↑ popped roof nail; example

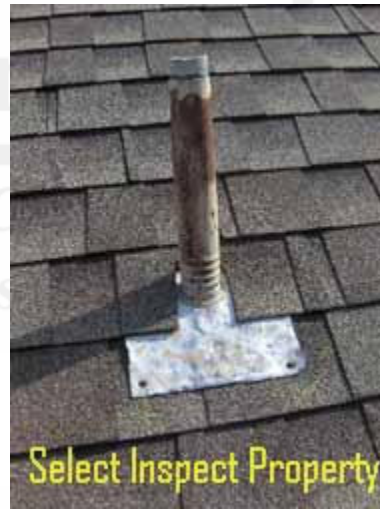
↑ deficient vent lead & uncaulked, exposed fasteners

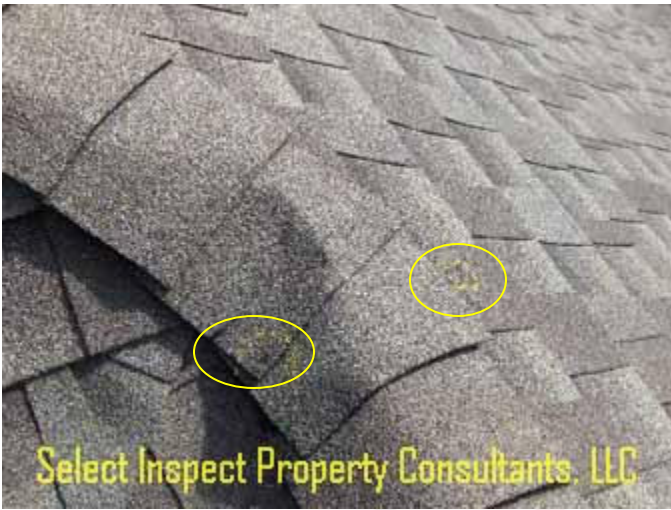
↑ uncaulked, exposed fasteners

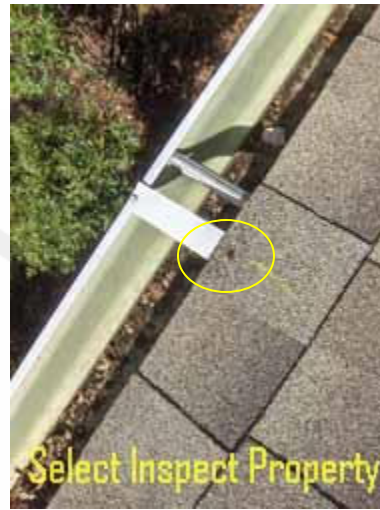
↑ uncaulked, exposed fasteners at multiple gutter locations; example

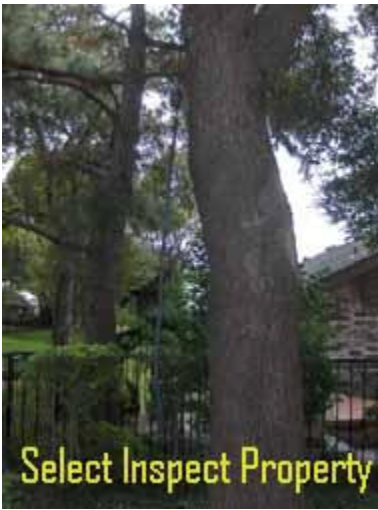
↑ deficient electrical; multiple conditions

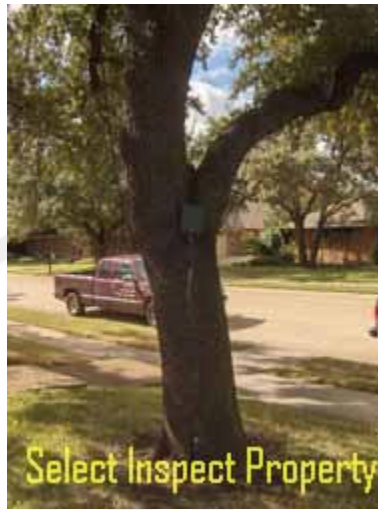
↑ deficient electrical; multiple conditions

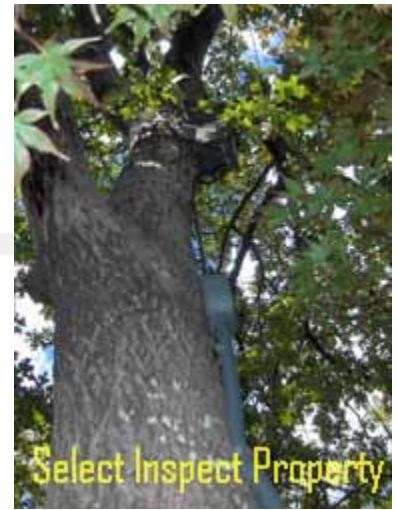
↑ deficient electrical; multiple conditions

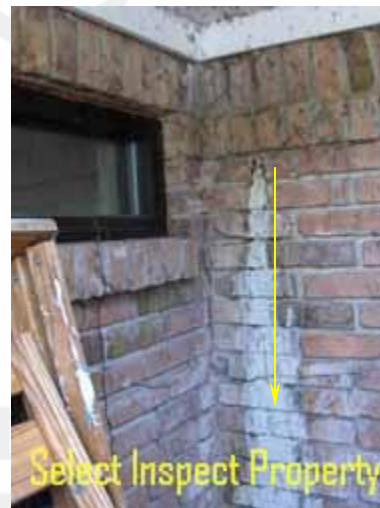
↑ stains from prior auxiliary condensate drainage

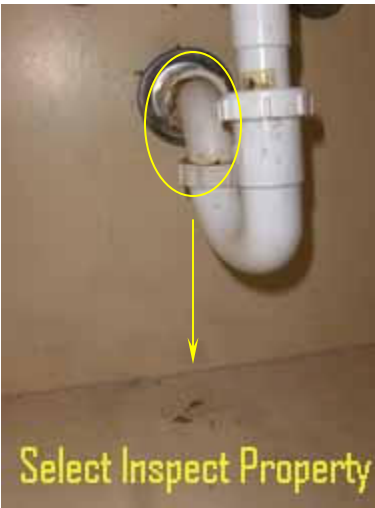
↑ leakage evidence & moisture damage under north bathroom sink

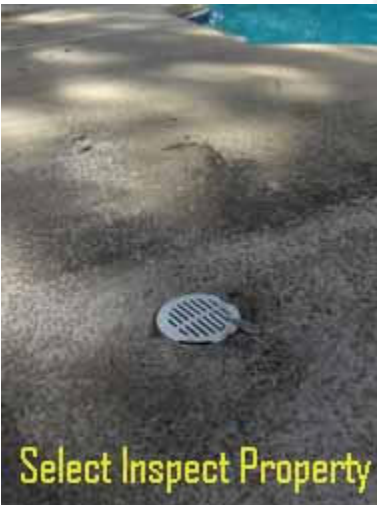
↑ sharp drain edges may be a cut hazard; example
