Property Inspection Report

Concerning: 123 street McKinney, Texas
(Address or Other Identification of Inspected Property)

By: Bruce W. Carr; TREC #5281 ASHI Member # 211804 Saturday, April 02, 2011
(Name and License Number of Inspector) (Date)

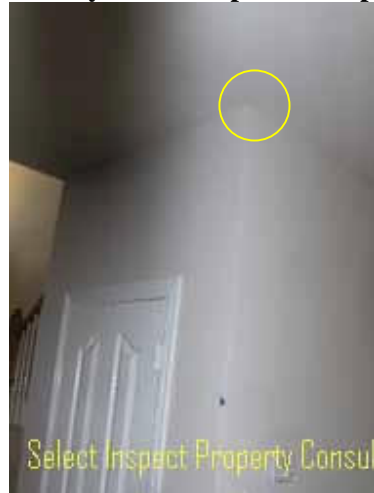
↑ cracks discovered at family room/loft

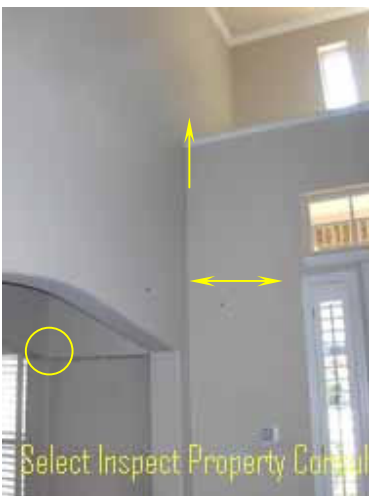
↑ cracks discovered at entry

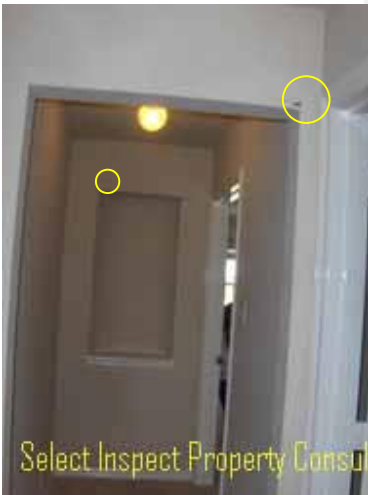
↑ cracks discovered at master hall

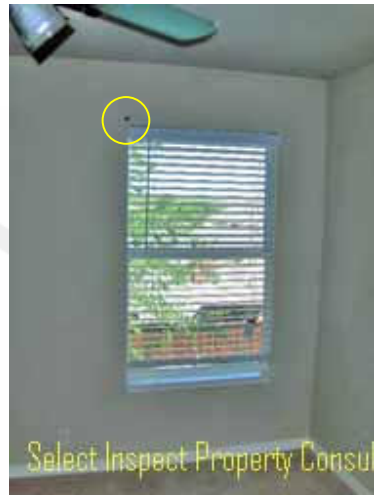
↑ cracks discovered at north bedroom

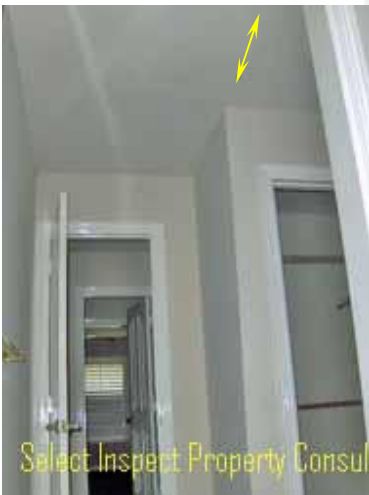
↑ cracks discovered at split bath

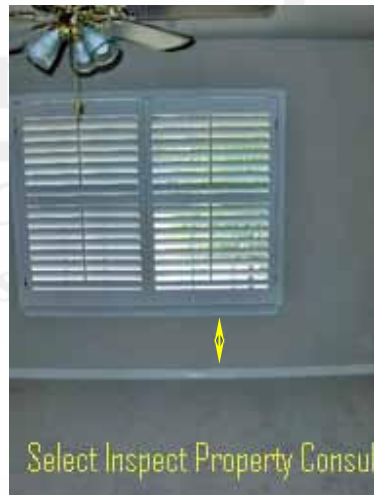
↑ cracks (crack repair evidence) discovered at west bedroom

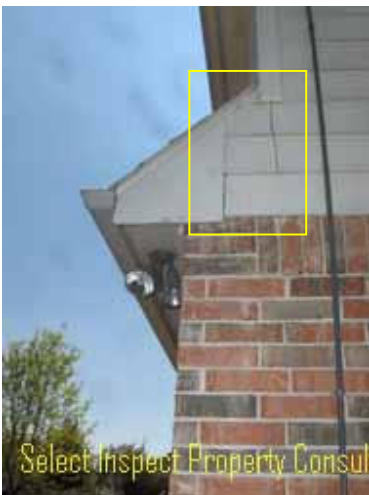
↑ exterior stress; garage east corner

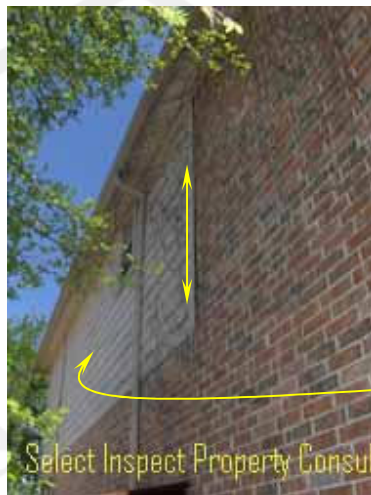
↑ exterior stress & openings; west-northwest

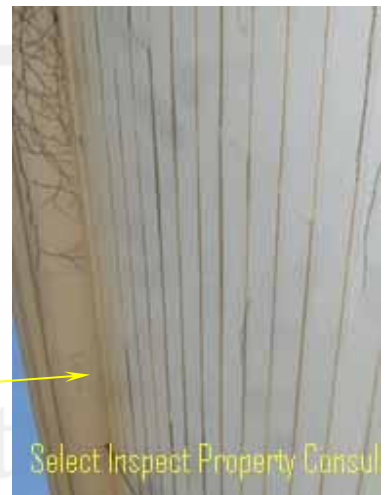
↑ bulging/warped siding- indicates stress; northwest

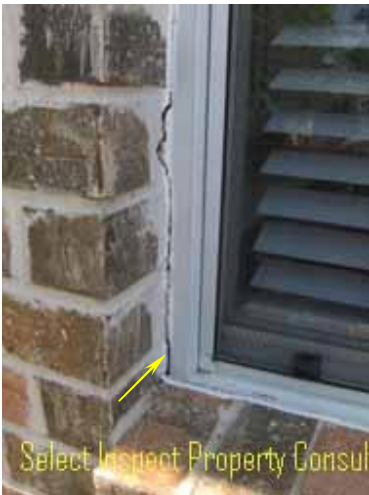
↑ window separation from brick veneer- indicates structural stress; example at breakfast nook

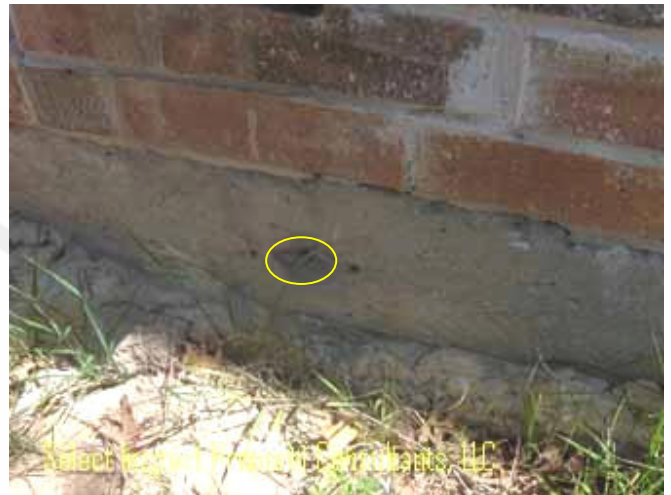
↑ exposed post tension end; example at the northwest

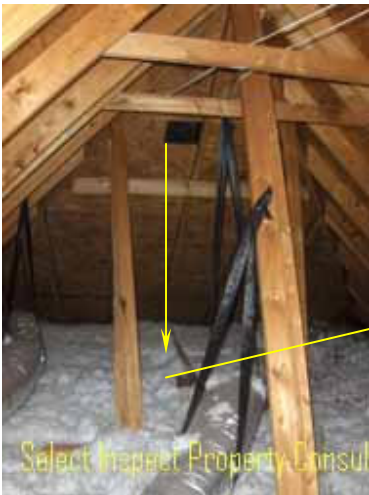
- Moisture intrusion in the attic was indicated by staining & or damage at multiple locations; all discovered were related to roof deficiencies & HVAC deficiency. The roof penetrations should be examined and maintained with other roof repairs & HVAC conditions corrected by a licensed technician.

↑ moisture damage & fungus; attic above master

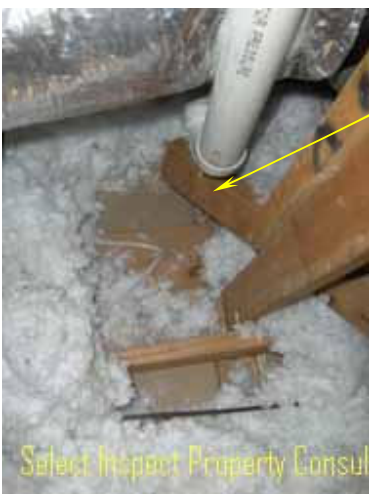
↑ moisture staining at framing & ceiling drywall

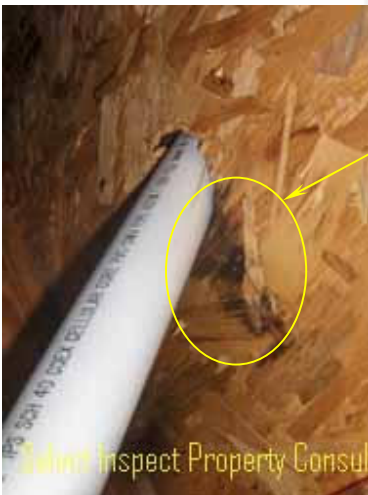
↑ moisture intrusion & decay at roof deck

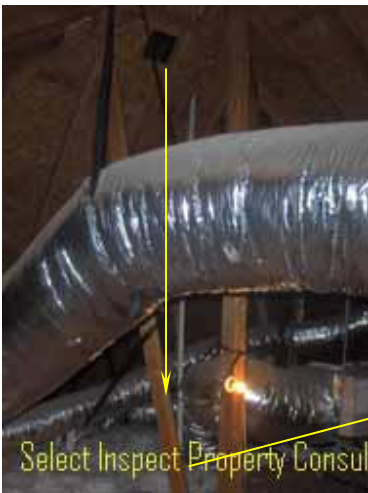
↑ moisture intrusion suspected from roof vent; example

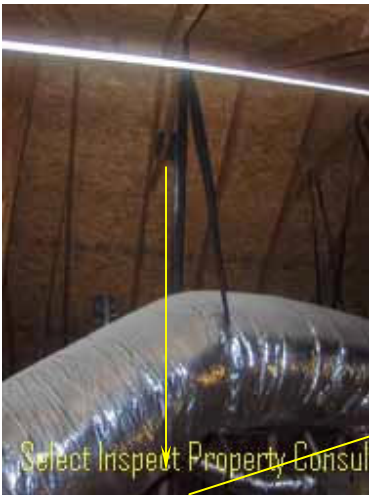
↑ moisture staining below roof vent implies moisture intrusion

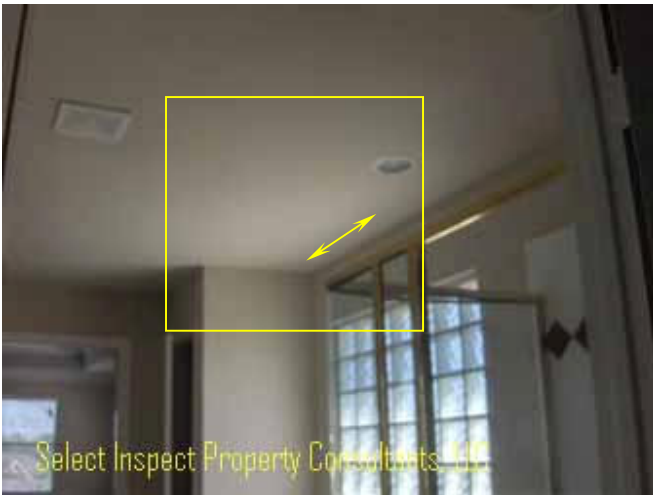
↑ Thermal imaging implies energy loss at the master bathroom

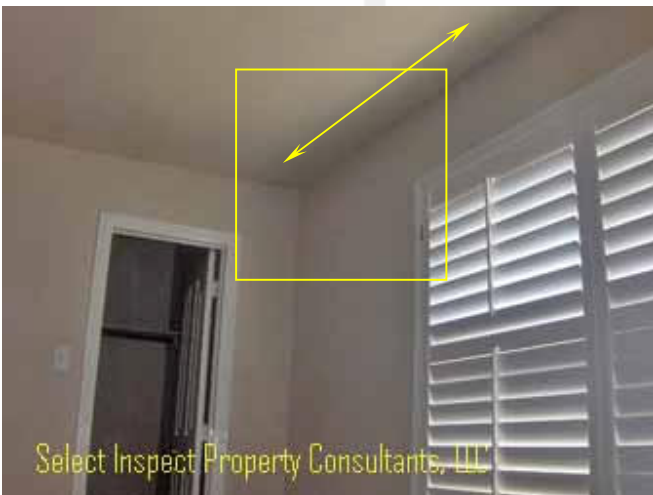
↑ Thermal imaging implies energy loss at south bedroom

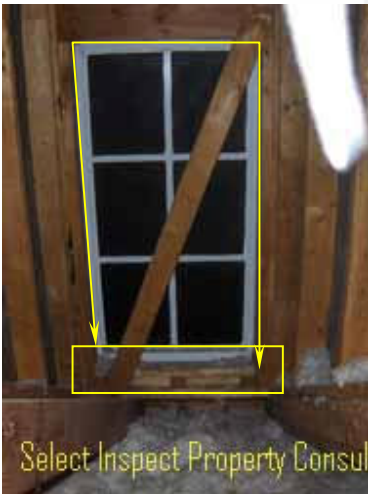
↑ missing master bathroom flashing at attic (dormer) windows; interior windows undetermined due to drywall

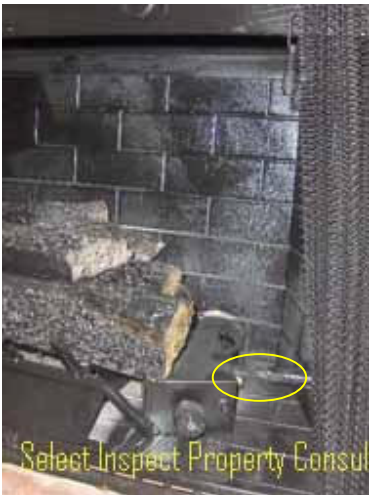
↑ disconnected fireplace logs-gas tested operable; logs not inspected

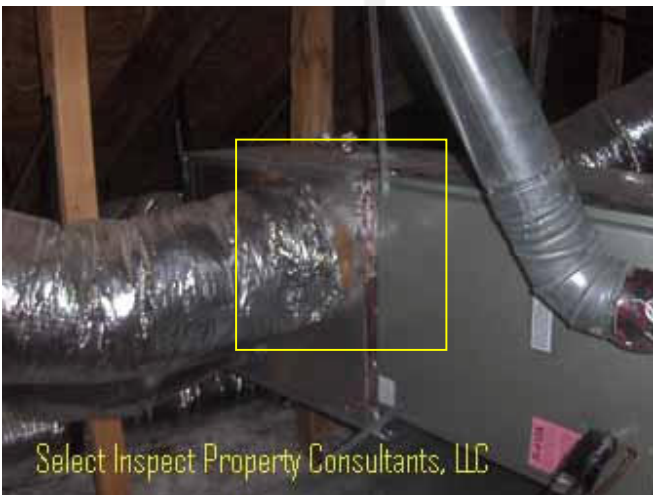
↑ energy loss at HVAC; example poor duct/plenum connections

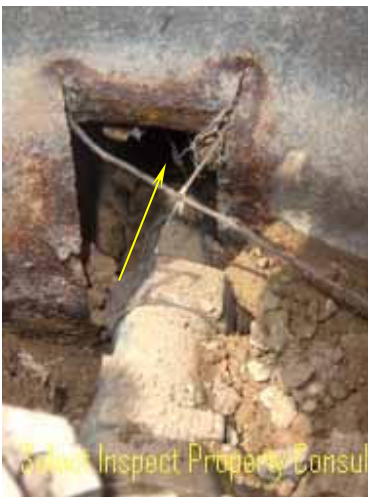
↑ water supply broken/disconnected adjacent the meter

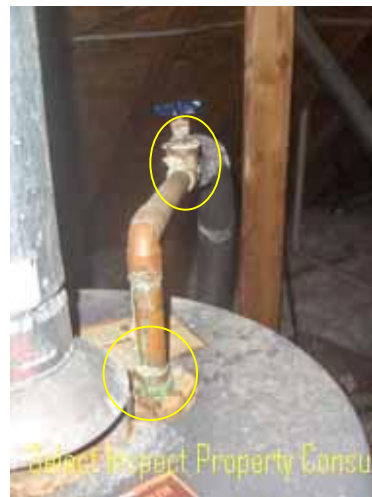
↑ seepage & corrosion at the water heater connections

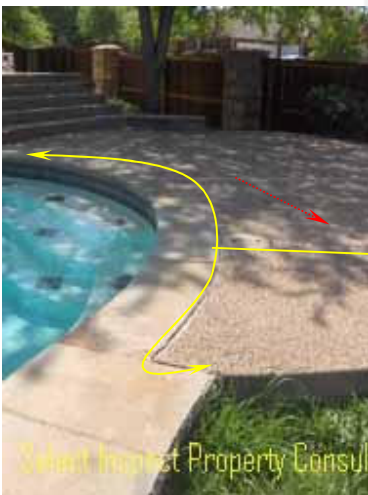
↑ deck has settled downhill

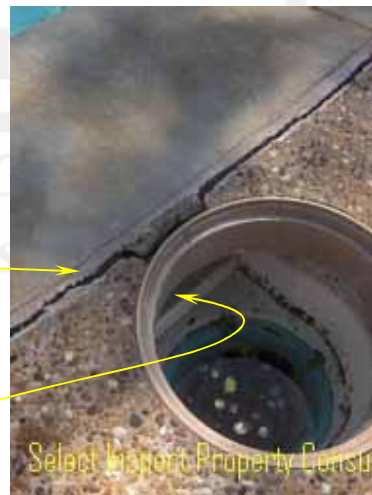
↑ separation of pool coping & deck/skimmer; close view of image at left
