Property Inspection Report

Concerning: 123 street Southlake, Texas
(Address or Other Identification of Inspected Property)

By: Bruce W. Carr; TREC #5281 ASHI Member # 211804 Tuesday, February 22, 2011
(Name and License Number of Inspector) (Date)

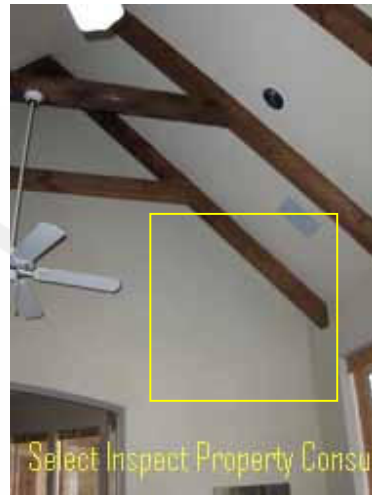
↑ Thermal imaging from square at right

↑ Thermal imaging implies energy loss at family room

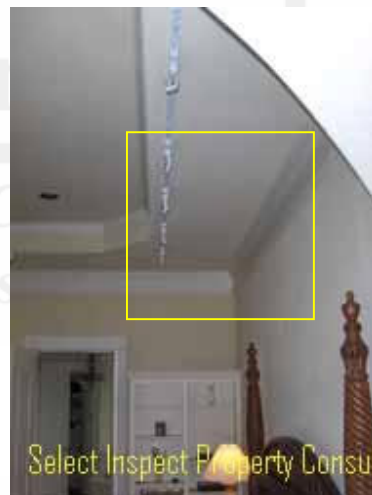
↑ Thermal imaging from square at right

↑ Thermal imaging implies energy loss at master bedroom perimeter & furr down; example at north side of the room
