## Property Inspection Report

**Concerning:** 123 street Flower Mound, Texas  
**(Address or Other Identification of Inspected Property)**

**By:** Bruce W. Carr; TREC #5281 ASHI Member # 211804 Tuesday, May 10, 2011  
(Name and License Number of Inspector) (Date)

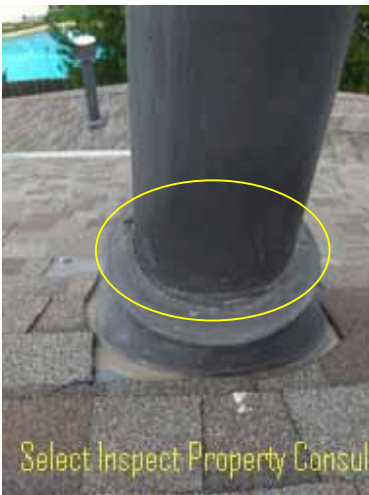
↑ openings at fireplace flue rain shield

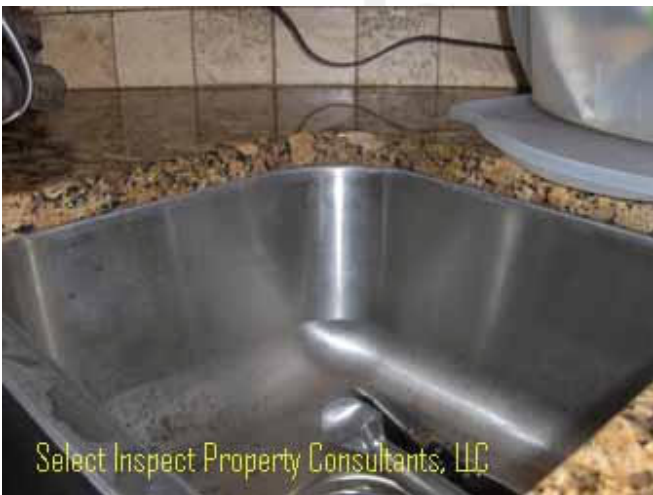
↑ fouling area at kitchen sink is prone to bacterial contamination

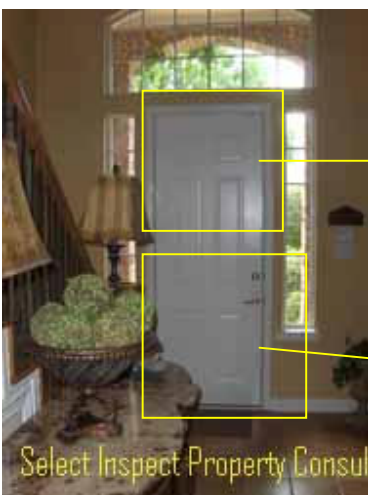
↑ Thermal imaging implies energy loss at front doorway

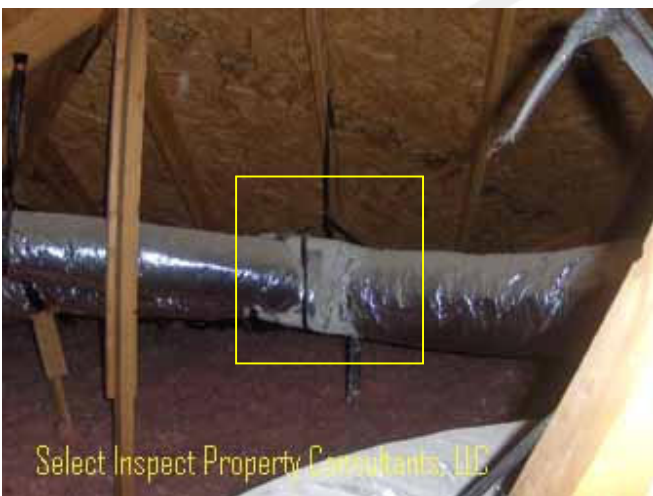
↑ significant energy loss not discovered at air ducting; some manifold joints lose some due to compression at connections
