## Property Inspection Report

### PROPERTY INSPECTION REPORT

123 street

Friday, May 06, 2011

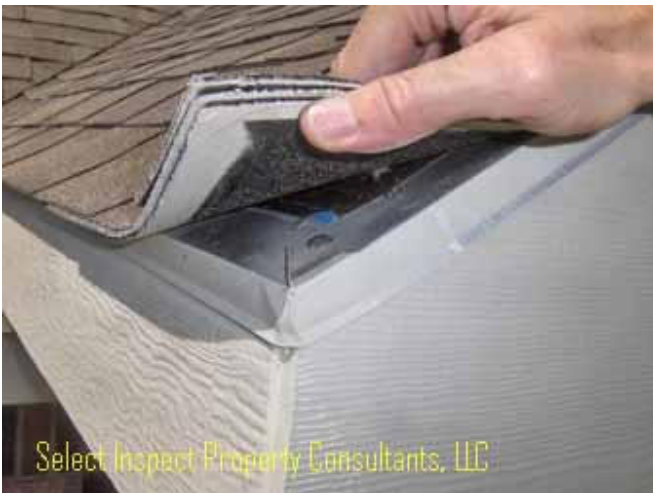
↑ close view of image above; roof underlayment incorrect

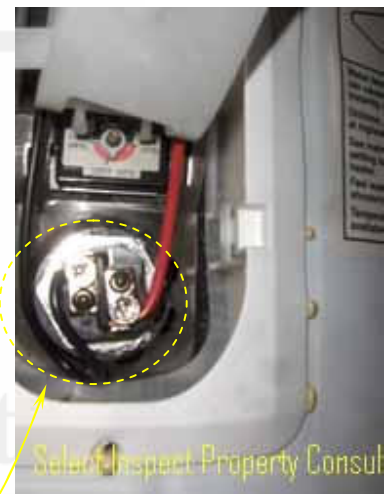
↑ seepage evidence at lower element
