Property Inspection Report

Concerning: 123 street McKinney, Texas
(Address or Other Identification of Inspected Property)

By: Bruce W. Carr; TREC #5281 ASHI Member # 211804 Thursday, April 28, 2011
(Name and License Number of Inspector) (Date)

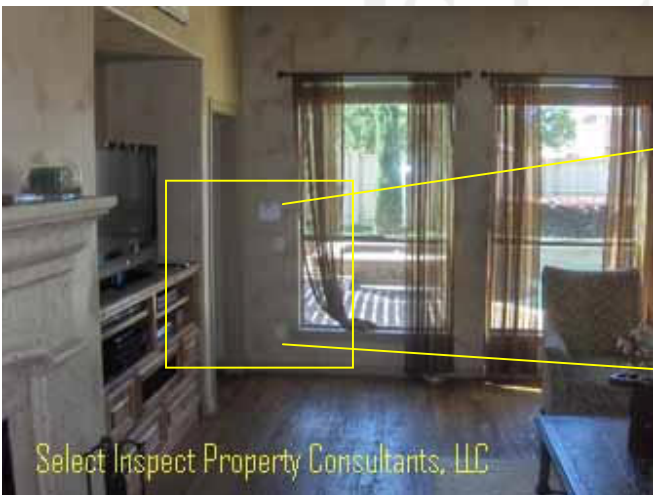
↑ Thermal imaging implies energy loss at pool control & receptacle

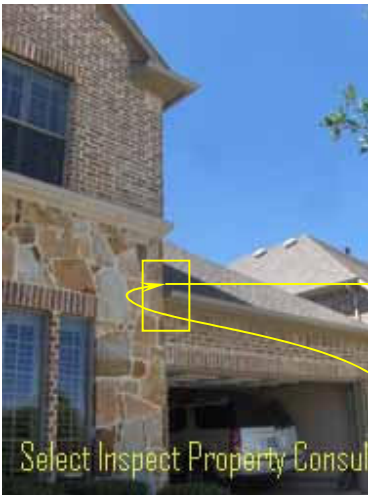
↑ unworkmanlike eave/wall; openings

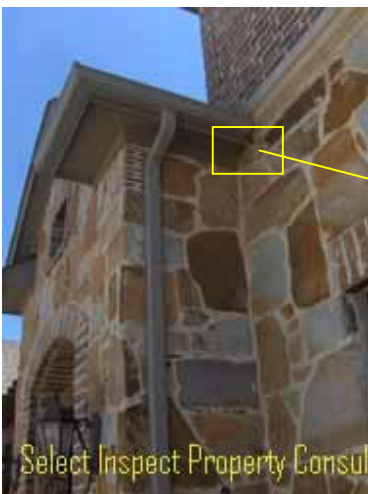
↑ unworkmanlike eave/wall; openings

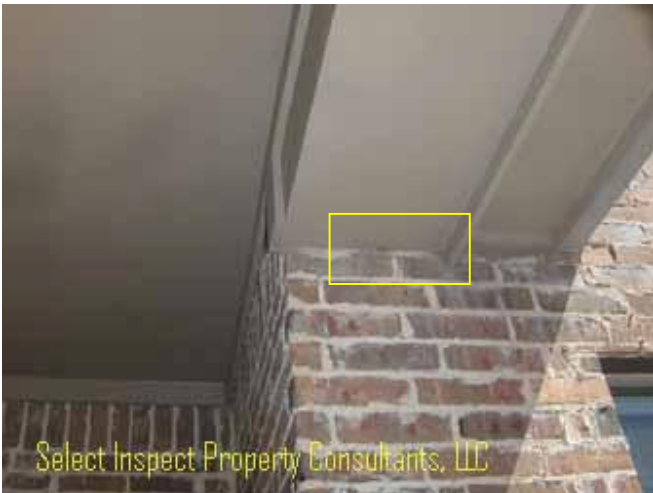
↑ unworkmanlike eave/wall; openings at rear porch; visible framing

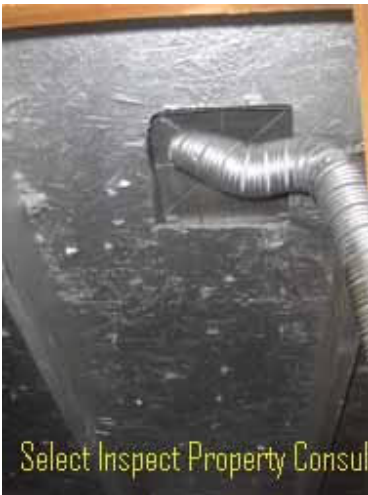
↑ exhaust fan termination at passive vent
