New Home Final Inspection

at: **54321 New Street; Colony, TX 75034**

February 6, 2009

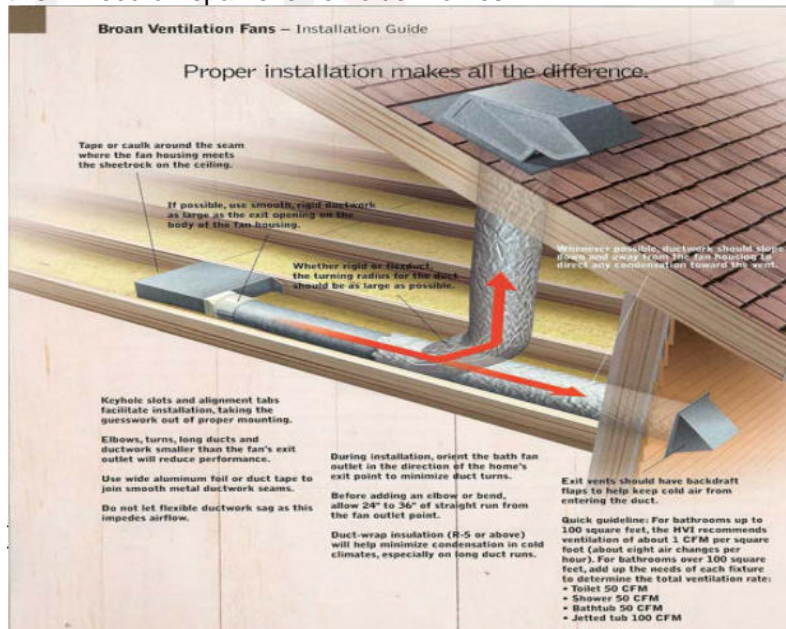
- **dishwasher**: crimp at the drain line adjacent the disposal connection was discovered. The condition may be prone to congestion and leakage.
- **disposal**: operable
- **doorbell**: operable
- **dryer vent**: The dryer vent is routed upward. Measuring the exact length is beyond the scope of this inspection. Upward venting dryer ducts are more prone to clogging than shorter horizontal vents.
- **exhaust fan(s)**: Some or all bathroom /laundry exhaust fans vent to the eaves. Vent termination within the attic, at passive roof vents, or at eave vents does not meet most manufacturer guidelines. Current standards require venting of bathroom and utility room exhaust fully to the exterior. (IRC M1506 & 303.3). Texas Real Estate Commission considers this in need of repair even on older homes.
