New Home Punch-out Inspection

Custom Home Builder

at: **2009 New Street; Flower Mound, TX 75022**

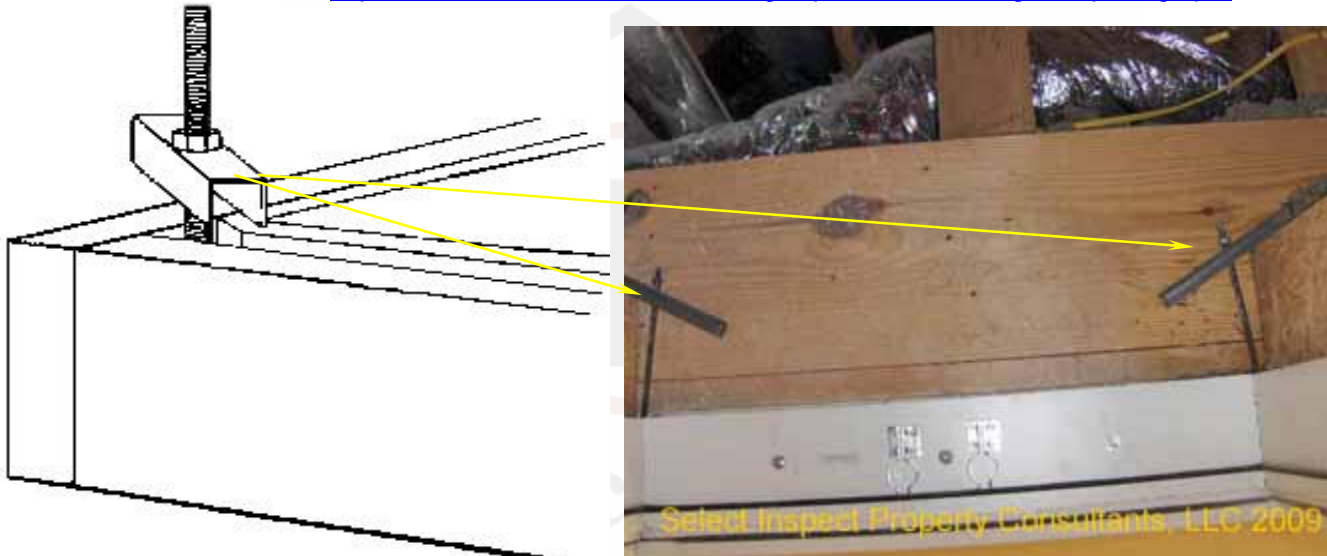
- Scissor ladder at the master closet was not properly secured at the toggle bolts; these bolts were incorrect and not offering full anchorage as intended. This image is from page 5 of the installation manual;
http://www.rainbowatticstair.com/images/pdfs/installation_guide_prestige.pdf

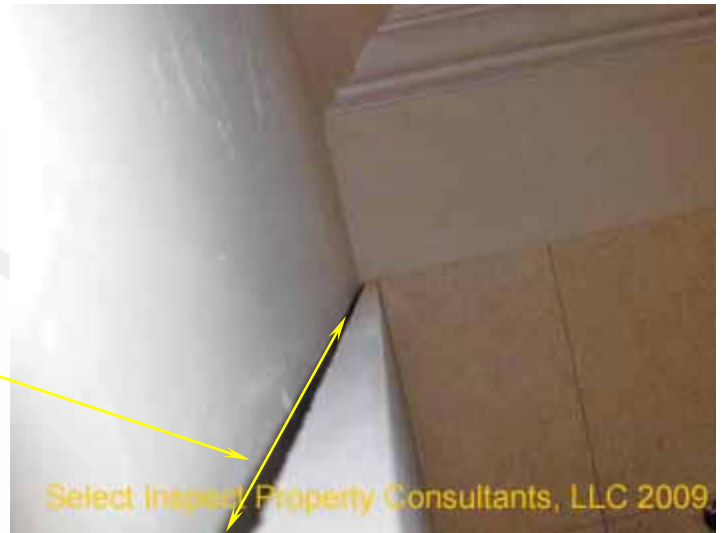
- Recommend sealing the top tile/panel edge at the wall of the shower(s) to reduce potential for moisture intrusion and fungal accumulation at the shower substrate (between the shower and walls)
- Multiple cosmetic items remain needing punch-out.
- Media room trim has separated at painted joints; "hard-board" type remains unfinished below the downstairs ½ bathroom sink; glazing incomplete at various features; etc.
- Reveals at the kitchen bar overhead light mount and family room fireplace gas valve.

↑ Seal the top tile edge at the shower walls- example

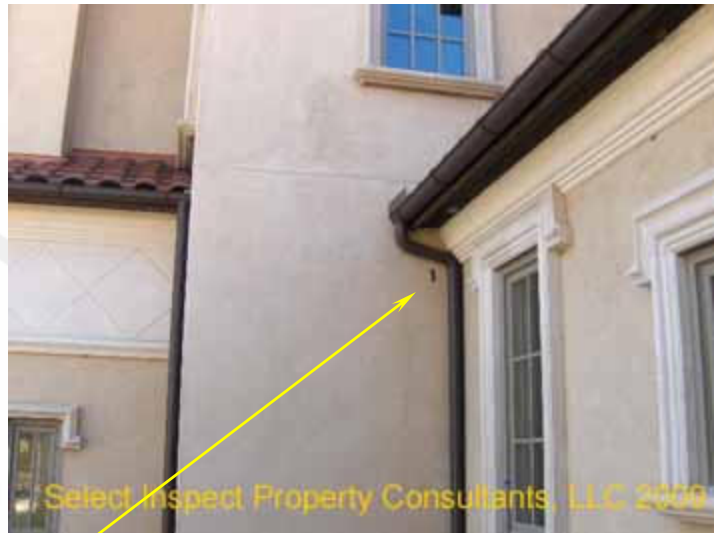
- 2 large openings exist at the north exposure near the northwest corner of the garage, and at the nearby upper east facing wall.
 - Damaged Artificial Stucco / EIFS was noted at the northeast garage doorway trim.

↑ openings at eastern walls near garage

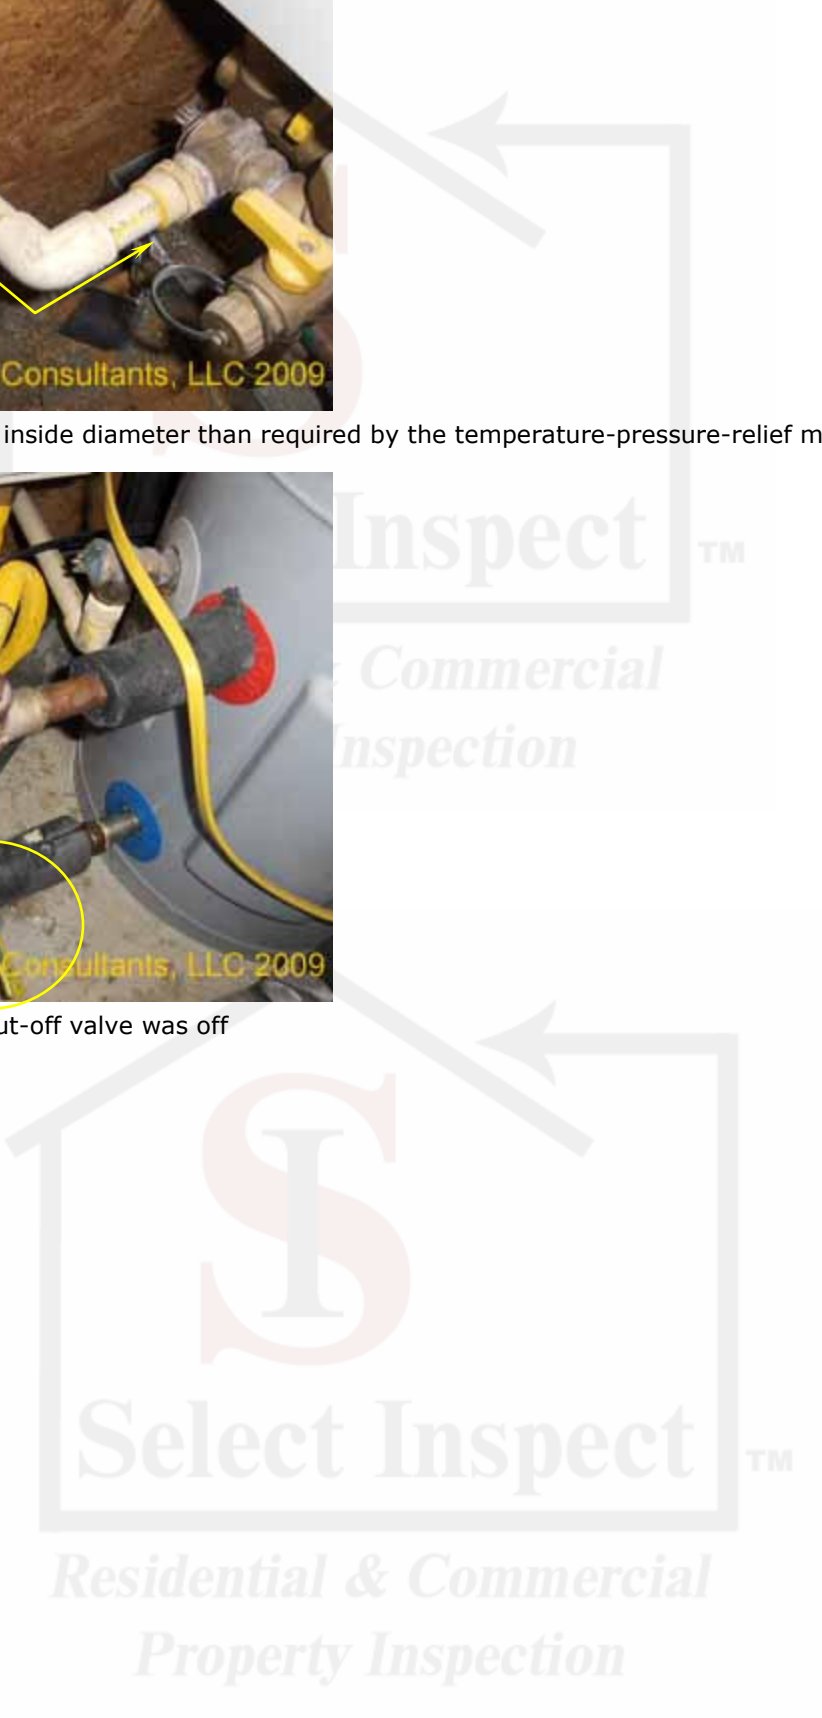
↑ water heat; storage tank shut-off valve was off
