New Home Punch-out Inspection

Custom Home Builder

at: **2009 New Street; Flower Mound, TX 76051**

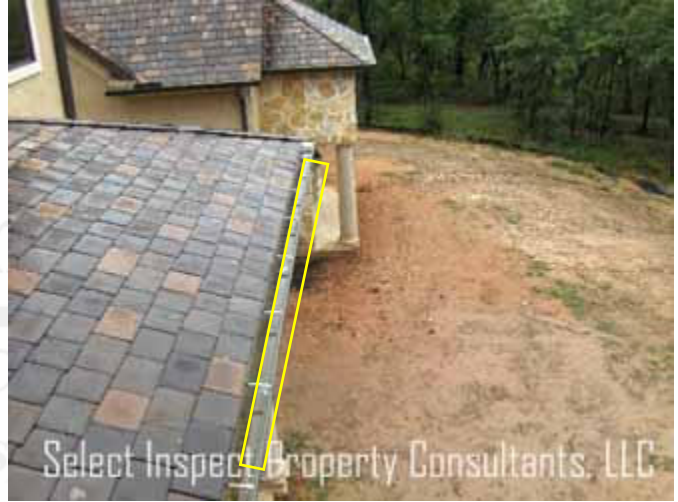
- Deficient slope & pooling water was noted at the porte-cochere & rear porch

↑ negative gutter slope at rear porch

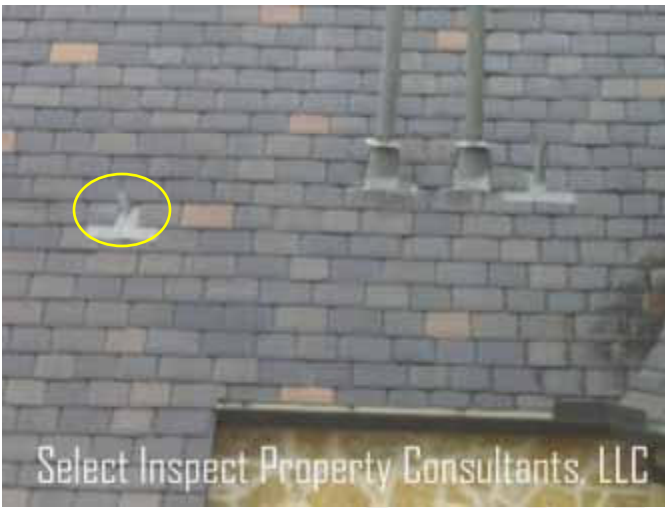
↑ plumbing vent less than 6" above roof; drive side of porte-cochere

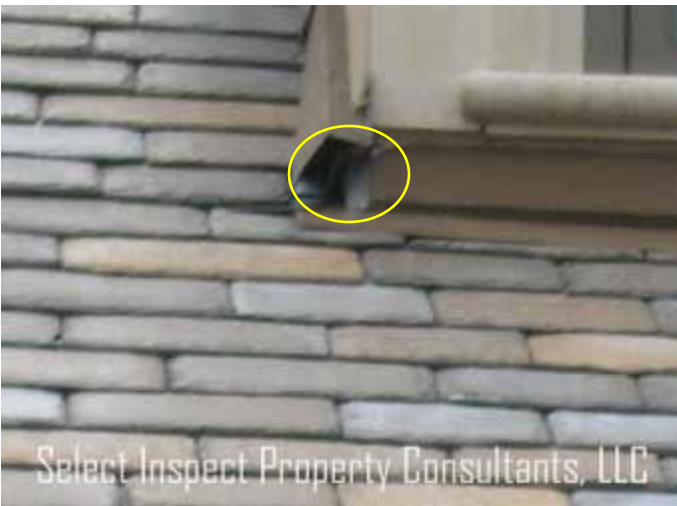
- Flashing was short cut & openings exist at the left dormer & detached garage dormer.
- Various uneven (possibly inadequately secured) slate were noted at the three-car garage & rear exposure(s).

↑ opening at left dormer flashing detail

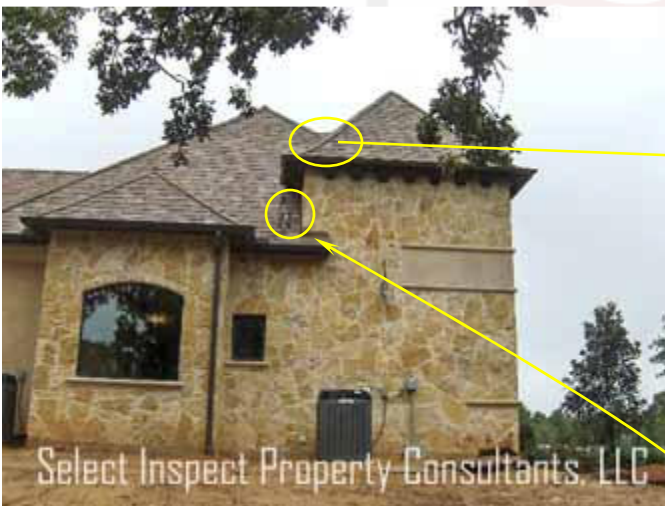
- Plumbing vent flashing was inconsistent with others at the master bathroom; this appeared to have an opening. Obvious deficiencies were not discovered at this location in the south attic.

↑ slipped shingle & questionable plumbing vent flashing at south above master bathroom

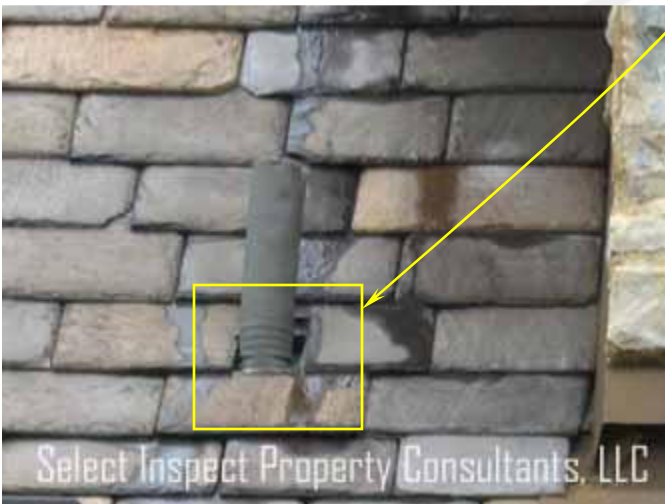
↑ close view of image above; apparent opening & this was inconsistent with other plumbing vents

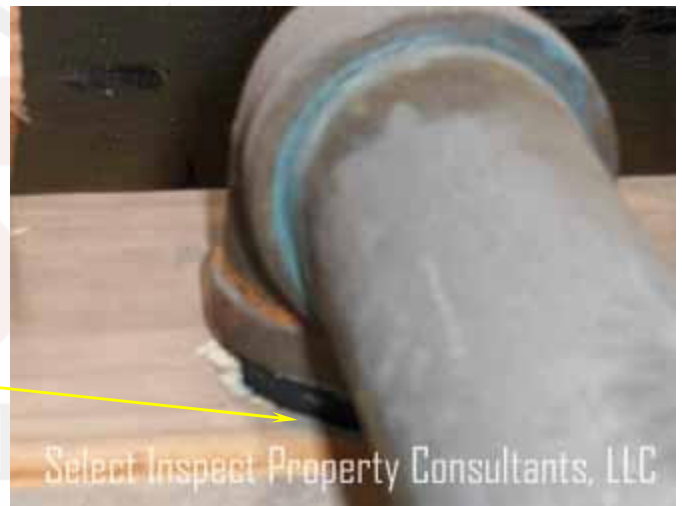
↑ close view of image at left; ideally the opening should be minimum 5/8" from plate edge

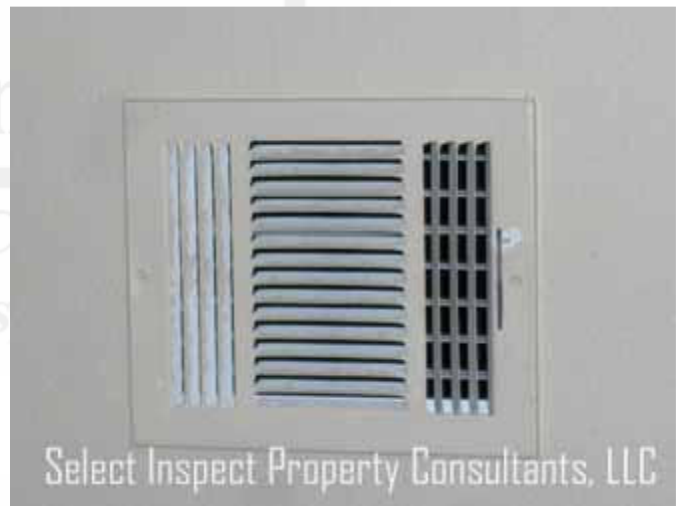
- Family room; opening at central ceiling beam
 - Guest bedroom; unworkmanlike paint at air registers
 - Guest bath; opening at shower grout; openings & missing light at closet; incomplete seal & paint upper front at toilet cabinet.

↑ unworkmanlike paint at guest bedroom air register

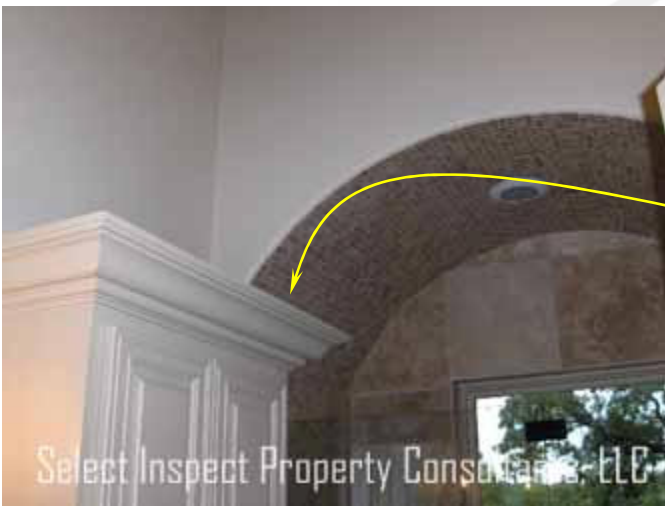
↑ incomplete finish at guest bath tile/cabinet

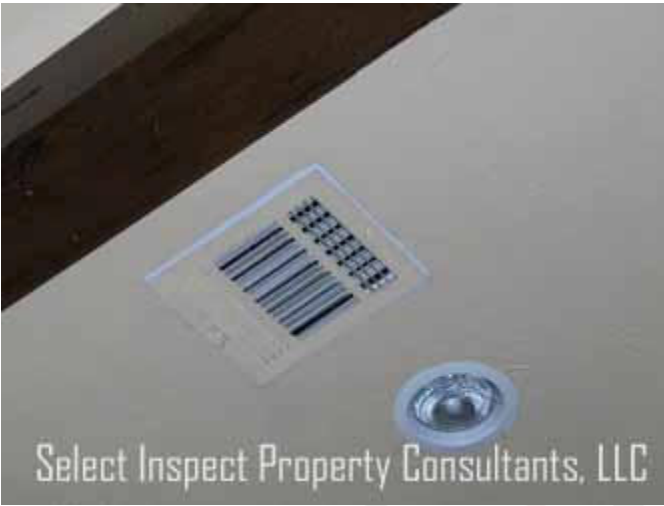
↑ paint needed at office/study air registers; supply & return

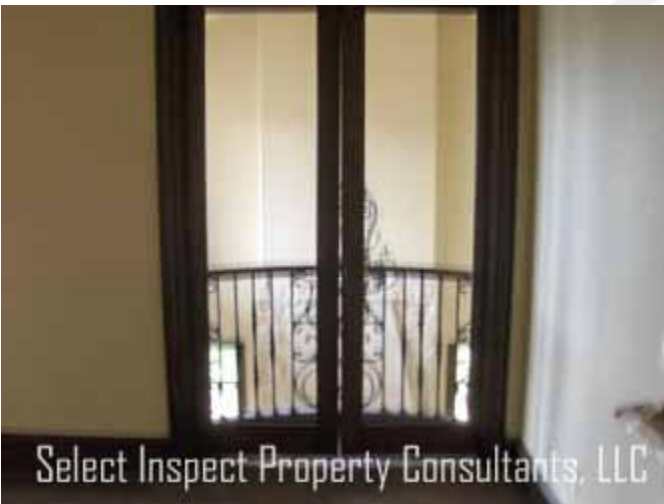
↑ gameroom loft doors were unsquare & not functioning as intended

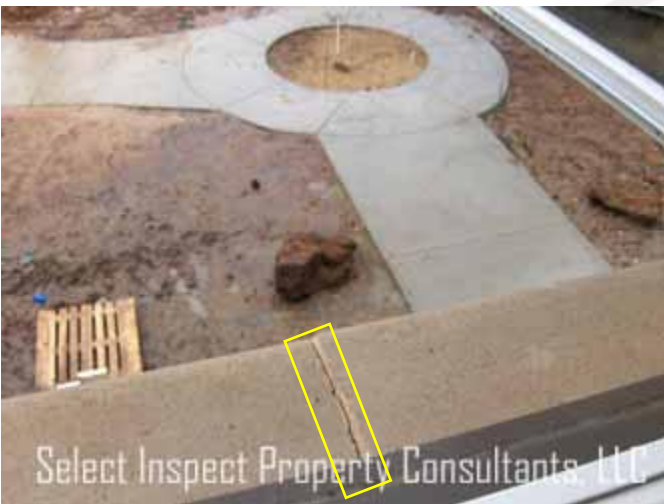
↑ example stone sill mortar needing tuck-pointing

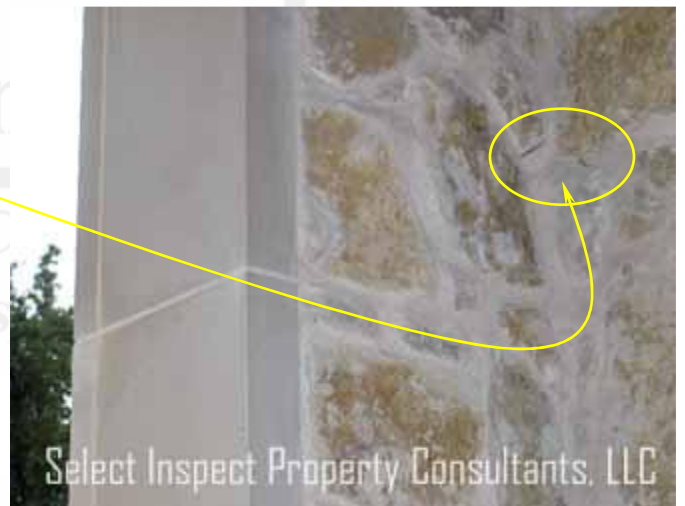
↑ nails at the front porch

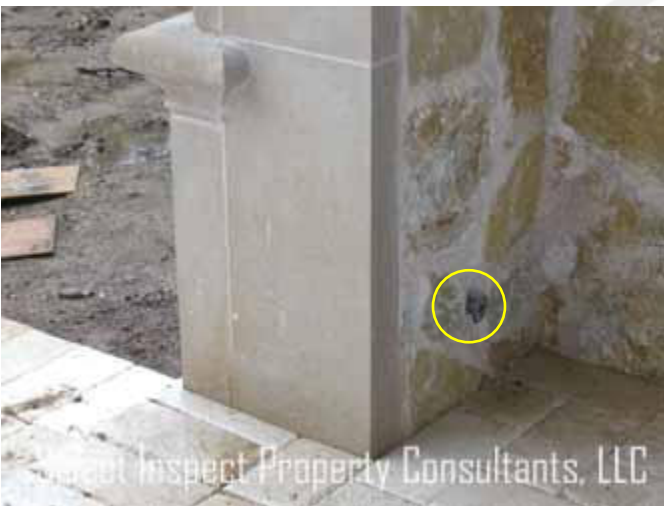
↑ seal needed at front porch gas valve

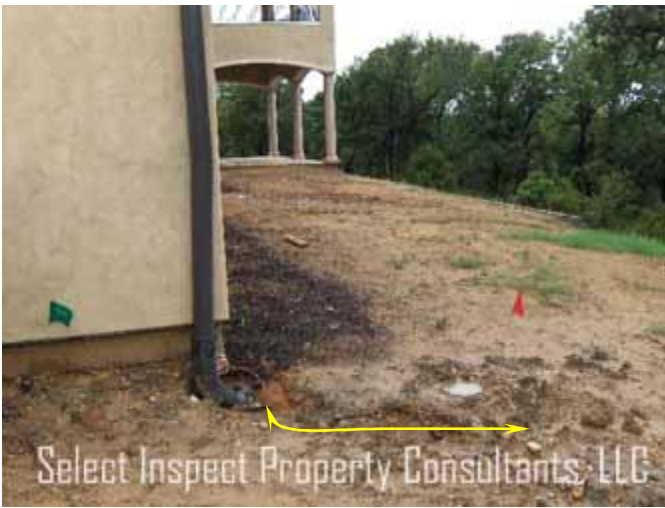
↑ incomplete area drain at north corner of three-car garage

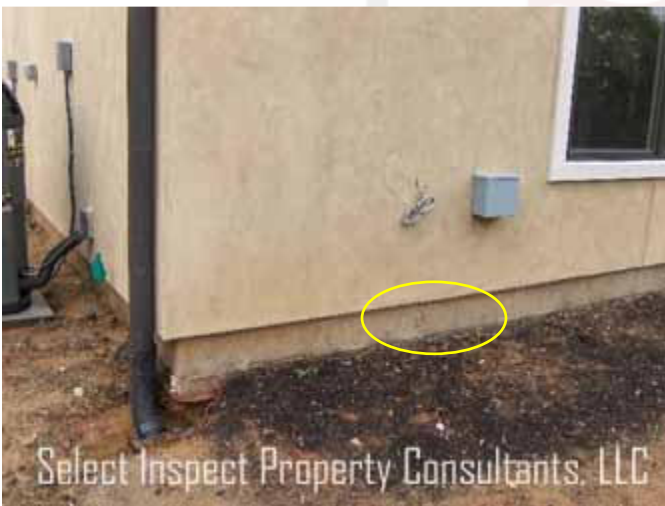
↑ exposed post tension end(s) cap at the north; three-car garage

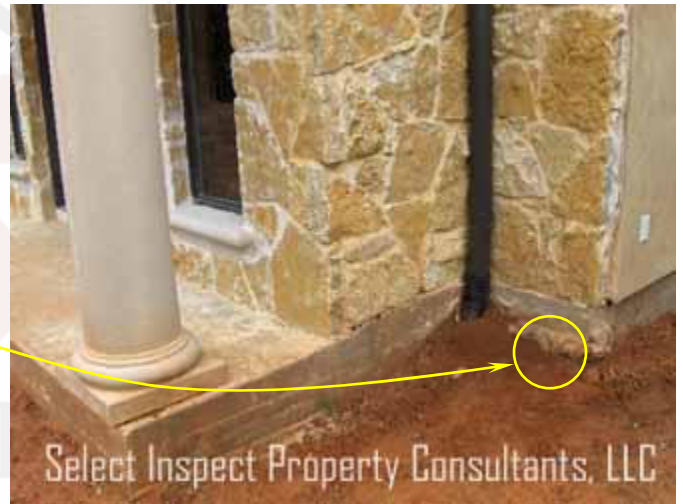
- Form stakes & or boards should be removed from soil adjacent the structure- condition(s) discovered at the east corner of the living room. This is conducive to decay and wood destroying insects; examination for wood destroying insects in related wood is recommended at the time of removal.
- Grading was not consistently directing water away from the structure. Proper drainage provisions should be kept throughout and after the construction process
- Area drain at the north was missing component(s) & not functioning as intended.
- Various area drain tubes were noted protruding the soil & could not be confirmed as deficient or abandoned (trash)

↑ form stake at the master patio should be removed

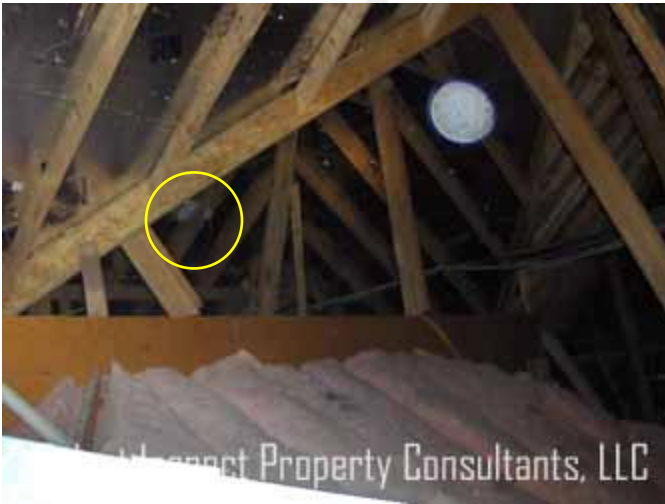
↑ some attic fans & all fan thermostat(s) were not readily accessible

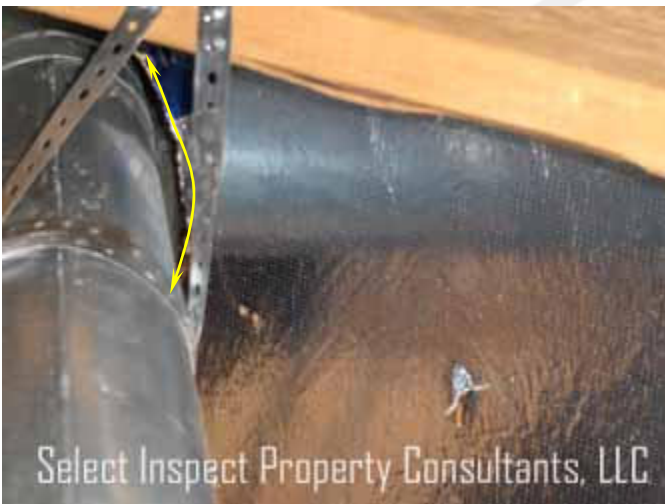
↑ #3 flue did not meet clearance requirements to combustibles; upper central attic

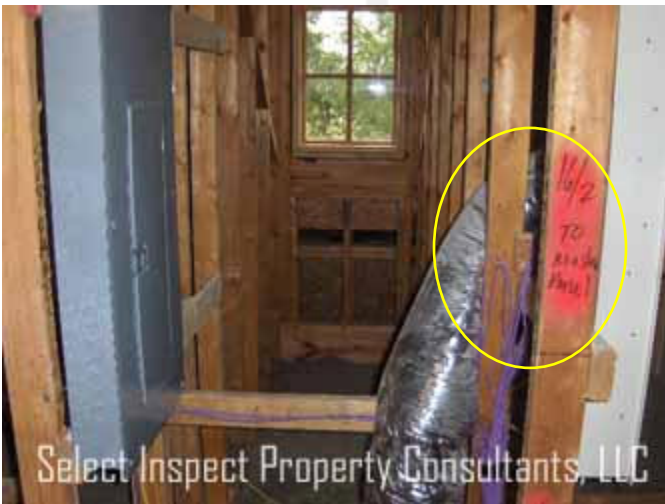
↑ crimped air ducting; example; south walk-in attic

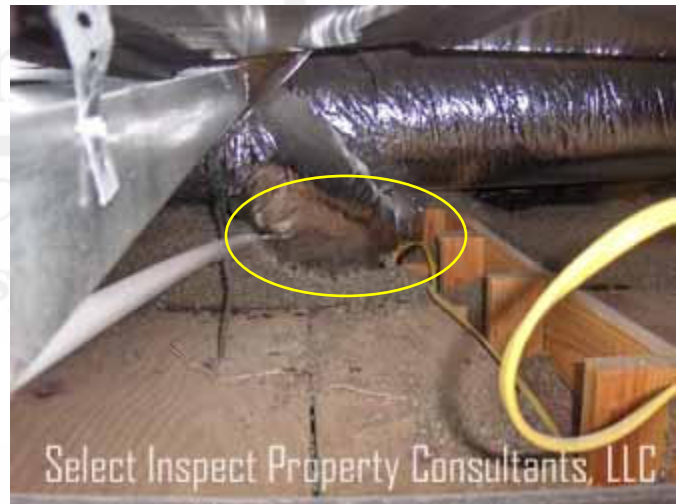
↑ crimped air ducting; example HVAC #2; north attic

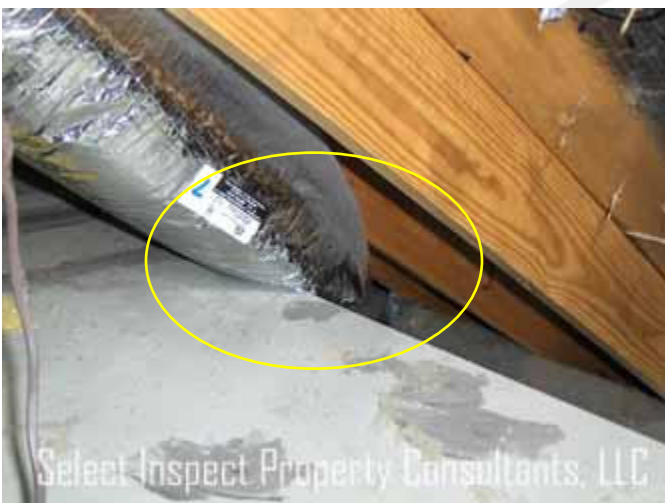
↑ crimped air ducting; example HVAC #2; north attic

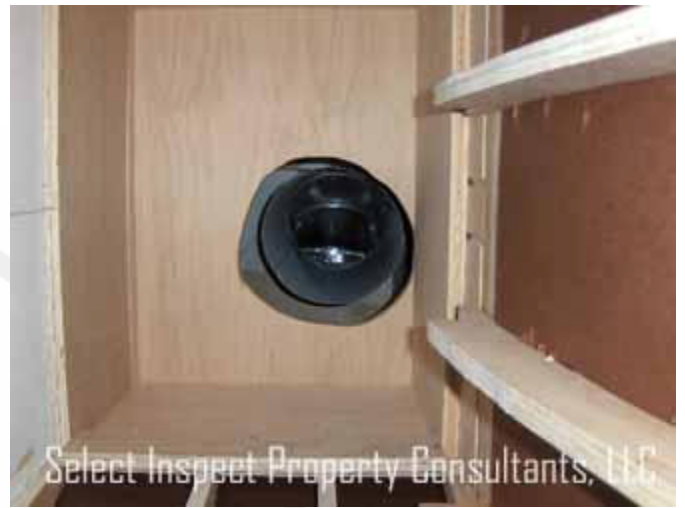
- Multiple cosmetic details requiring touch-up were marked with easy-release blue tape; some of these areas include:
 - Kitchen; incomplete vent hood; may be difficult to access for proper completion & connection of vent duct assembly; medallion tile upper right of vent is missing

↑ may be difficult connecting kitchen vent to not readily accessible vent duct
