Select Inspect
Property Consultants, LLC

Inspection for Builder Warranty

at: **123 street; McKinney, TX 75071**

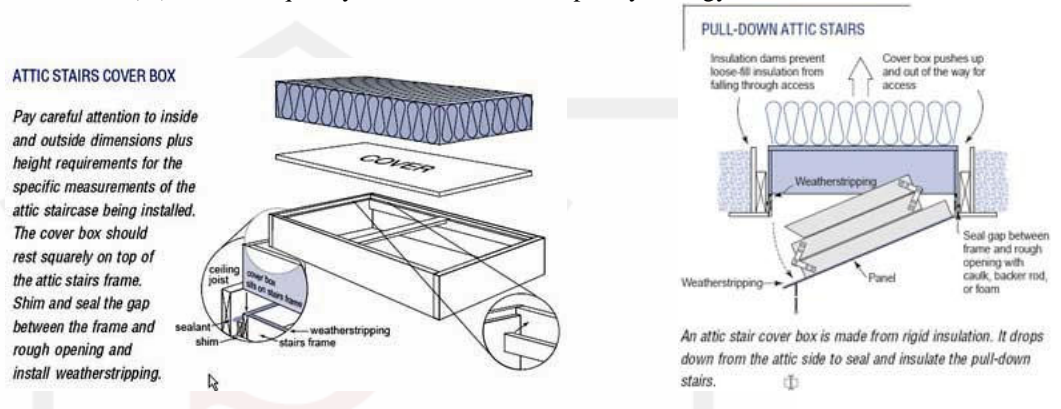
**SCUTTLE HOLE COVER**

- ✦ Ladder hardware (nuts, screws, etc) is loosely secured or missing at stair components. The unit is unsteady and repair would be prudent to reduce risk of failure and injury.
- ✦ Attic access(es) was inadequately insulated & or seals poorly. Energy loss exists
