Select Inspect

New Home Punch-out Inspection

at: **12345 YourStreet; Frisco, TX 75035**

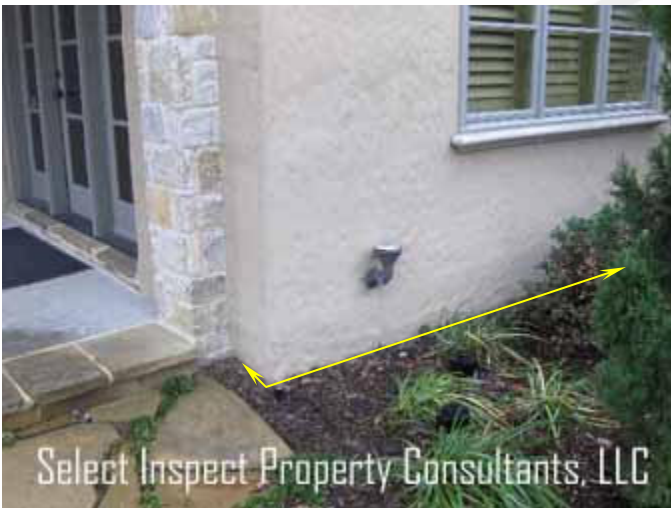
↑ high soil at stucco; obstructed stucco weep screed/drainage; library

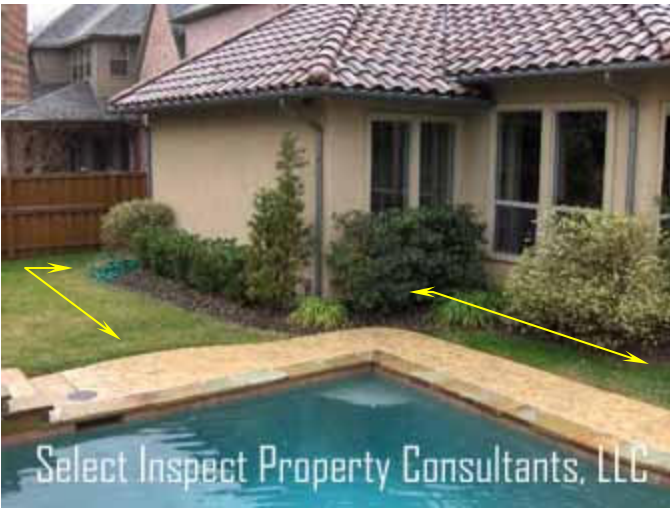
- Deficient drainage & pooling water noted at the east & south adjacent the home & at the front walk near the street.
- Area drain ports were not at the lowest portion of the grade at the east, adjacent the family room, powder bath, & master bedroom. This did not allow ground water to efficiently flow to the drain and be removed from the site. Recommend a drainage specialist offer repair options. Sub grade drains may be necessary at the east & south.

↑ poor drainage at the southeast

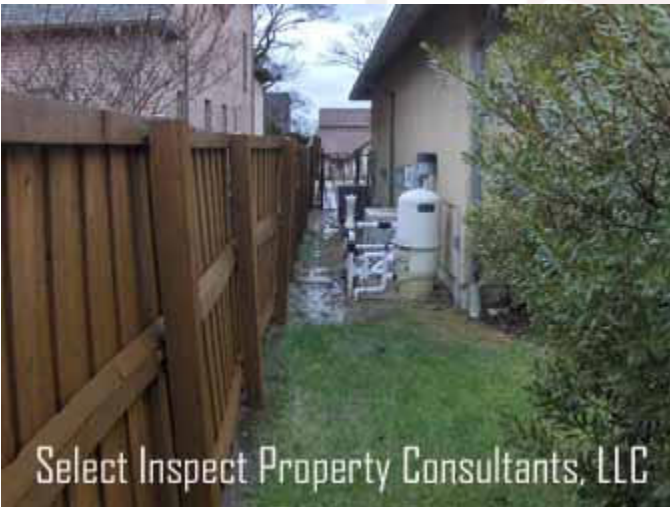
↑ poor drainage at the south

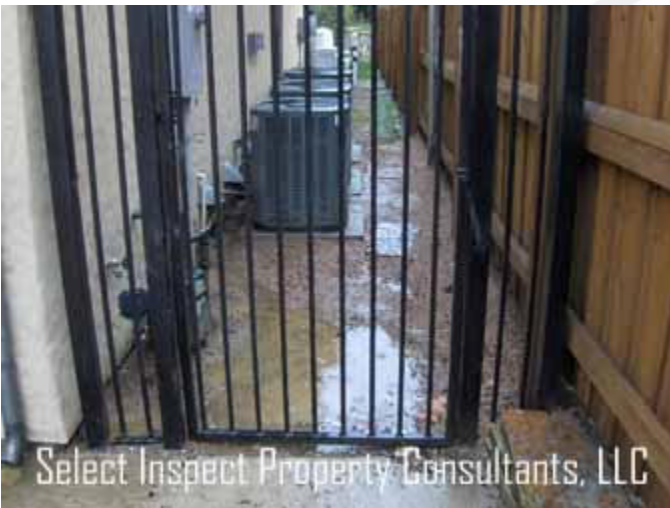
↑ poor drainage at the south; driveway is higher than grade; pooling water

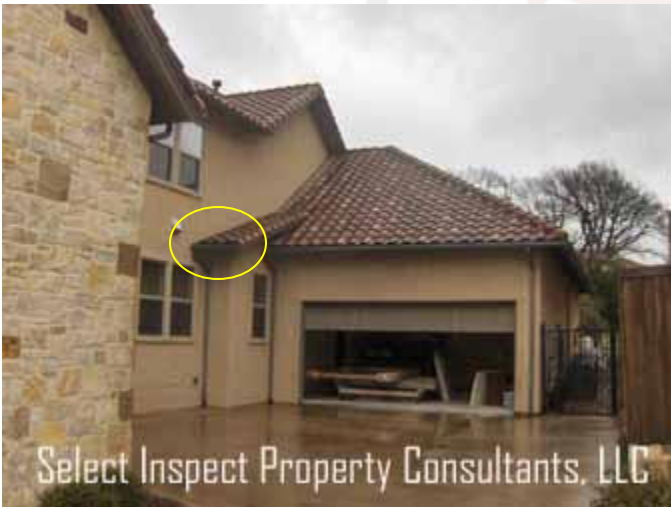
- Gutter slope was deficient at the small section left of the two-car garage. (related image(s) at the end of this document) Adjustment to slope to the gutter down-spout is necessary.

↑ amiss gutter slope; not draining

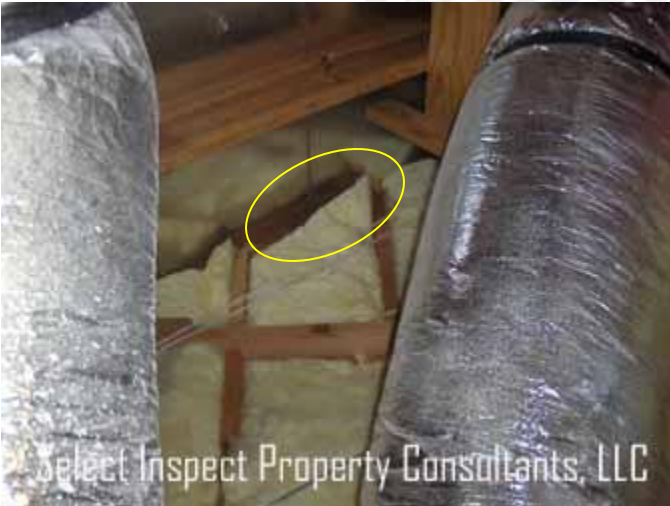
↑ amiss insulation at gameroom northwest corner

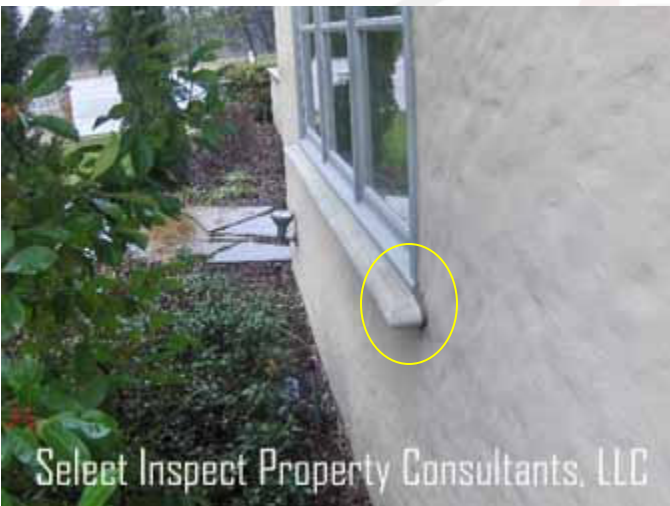
↑ sealant needed; example

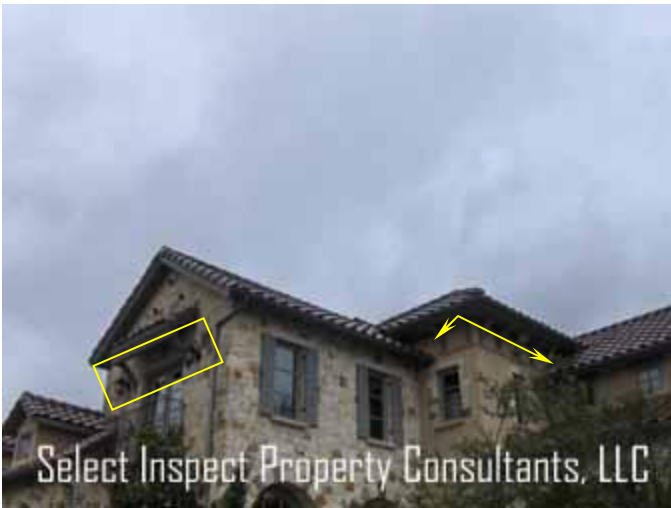
↑ sealant needed at beam penetrations

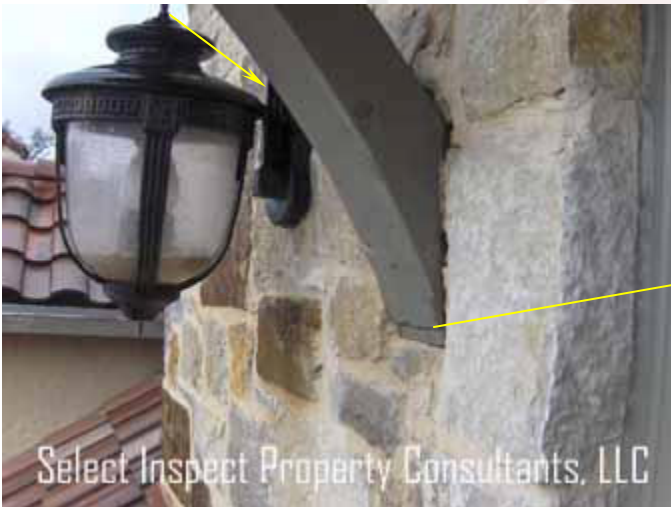
↑ sealant needed; example at lights & beam

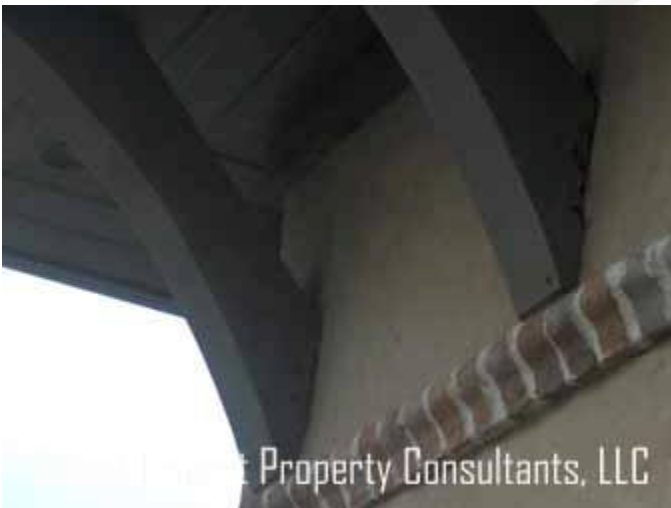
↑ sealant needed; close view of image above

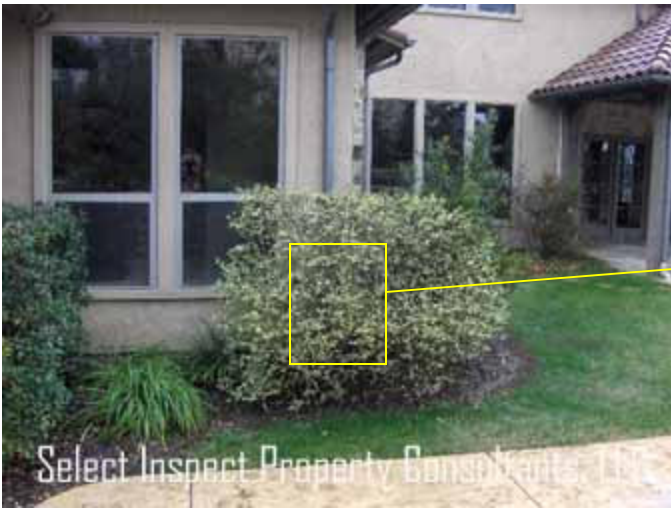
↑ sealant needed at equipment penetrations

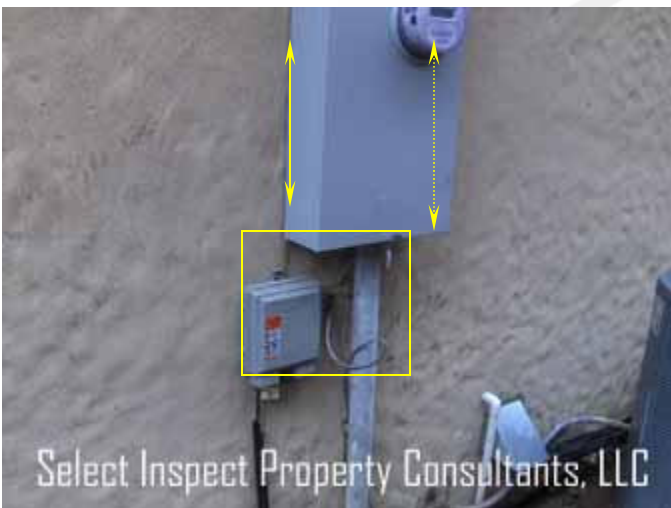
↑ sealant needed at equipment boxes/penetrations

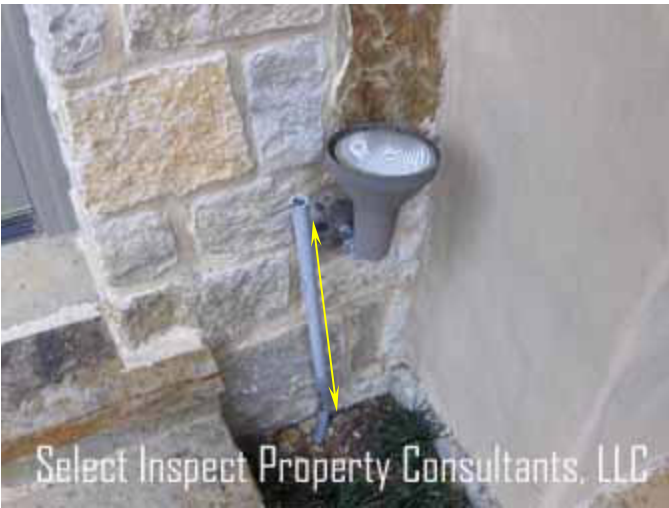
↑ undetermined conduit & wiring at front porch

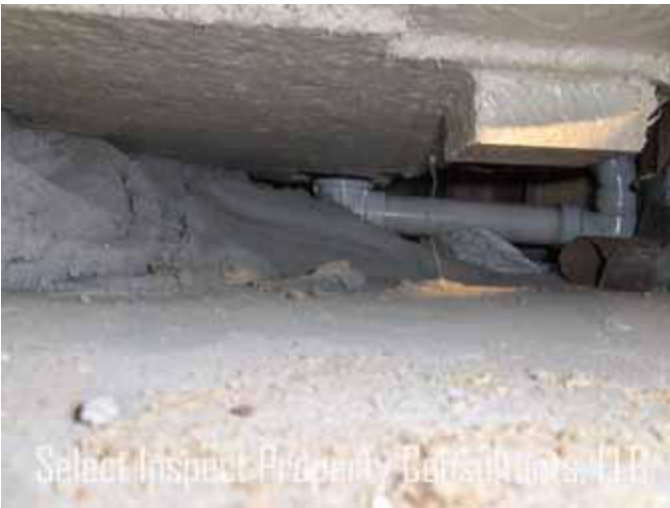
↑ incomplete mortar bed support below master bathtub

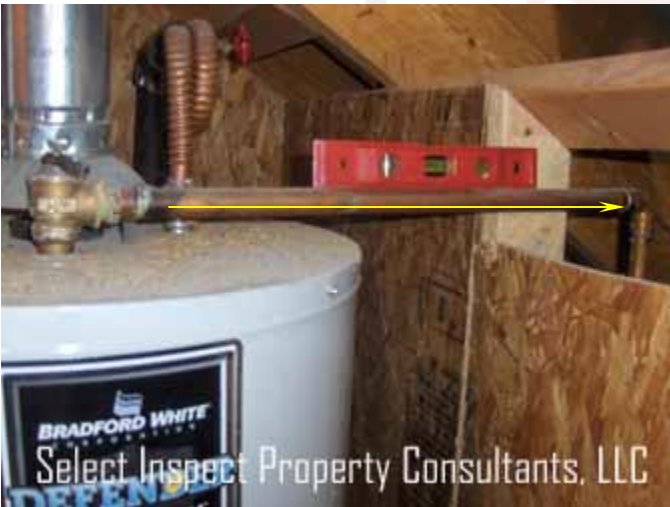
↑ two-car garage water heater; uphill (slightly) temperature/pressure relief
