Select Inspect

New Construction Phase Inspection

at: **123 New Street; McKinney, TX 75071**

Thursday, October 21, 2010

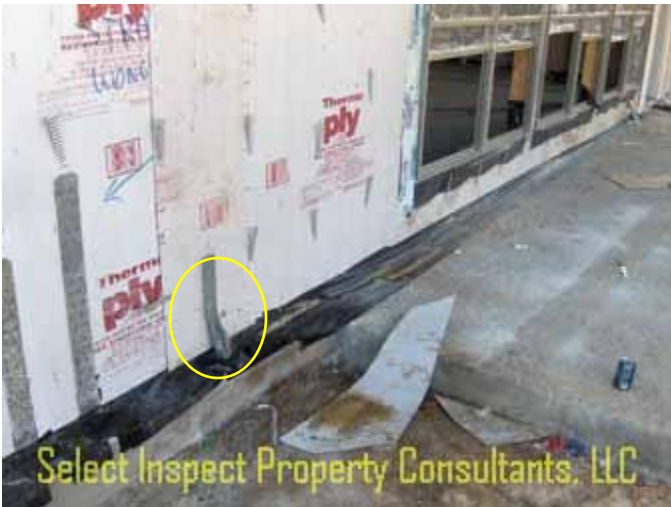
- Anchor bolt nut was missing at the single garage southeast corner.
- Unworkmanlike/bent holdown anchor at the exterior fireplace. Refer to the architect &/or manufacturer for approved correction
- Exposed post tension end(s) cap at the northwest corner should be sealed in an approved method.
- Regularly monitor the property and its components and arrange for repair if / when needed. Repairs should be made by qualified specialists whenever possible.
- Refer to your "Guide to Your Home Inspection" at the web link emailed with your report, for information regarding foundation maintenance and monitoring.

↑ unworkmanlike hold-down strap modification; west

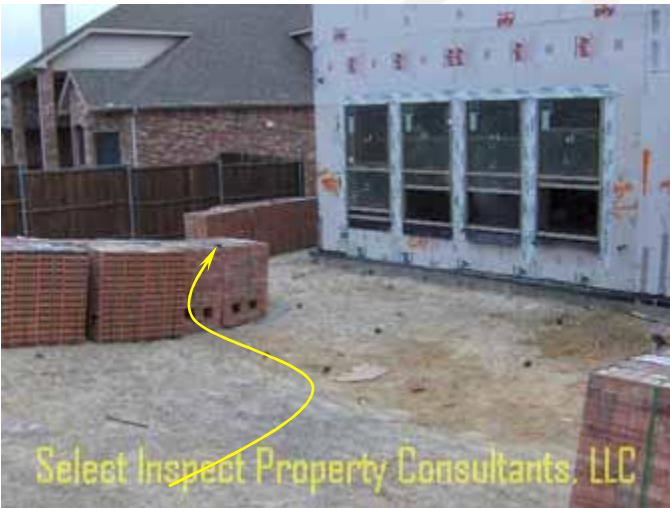
↑ swale at northwest appeared adequate

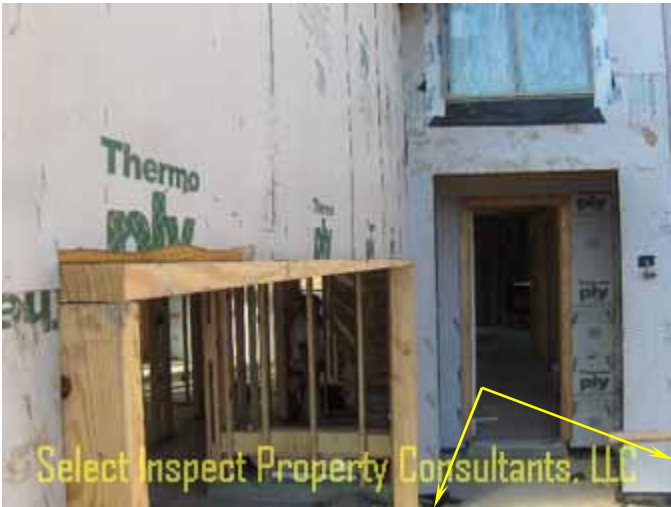
↑ forms remain at two-car garage & living room

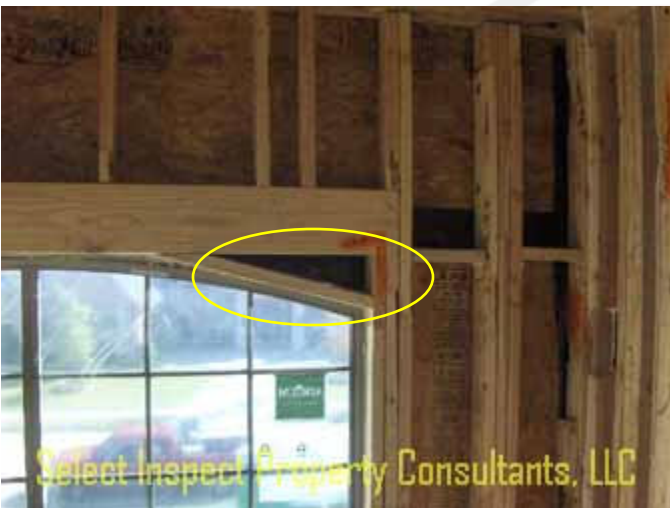
- Damaged (torn, cut, etc) insulation panels, wall joints, fenestrations & other openings and or penetrations of the exterior wall should be sealed with appropriate spray foam prior to brick work and finishing. Condiitons discovered at north, eave under chimney, kitchen wall, over two-car garage, family room, bedrooms, water heater component(s) penetrations at the north, two-car garage adjacent the window. (see one or more related photos)

↑ sealant needed; example; east

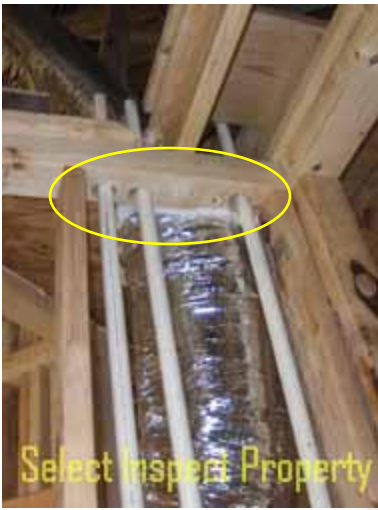
↑ sealant needed; example; northeast closet/chase

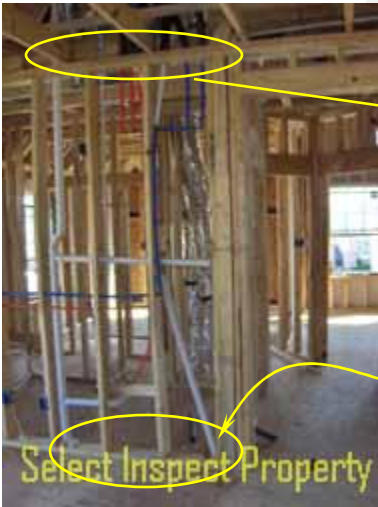
↑ sealant needed; example; north bathroom

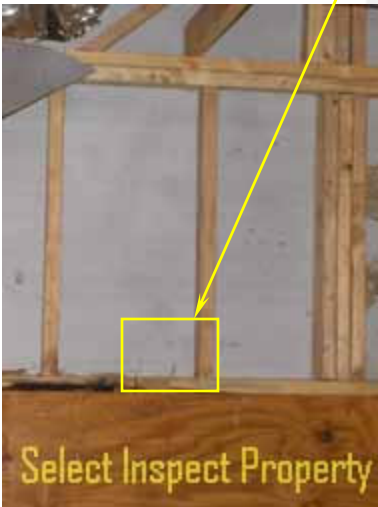
↑ close view of image above

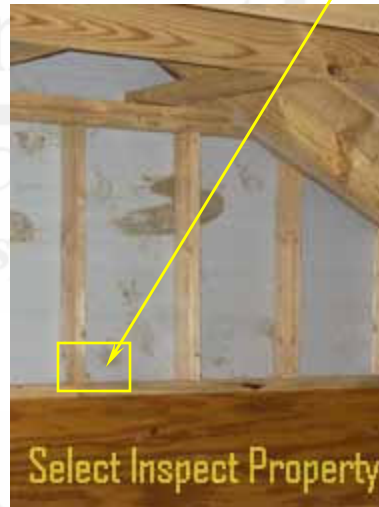
↑ close view of image above

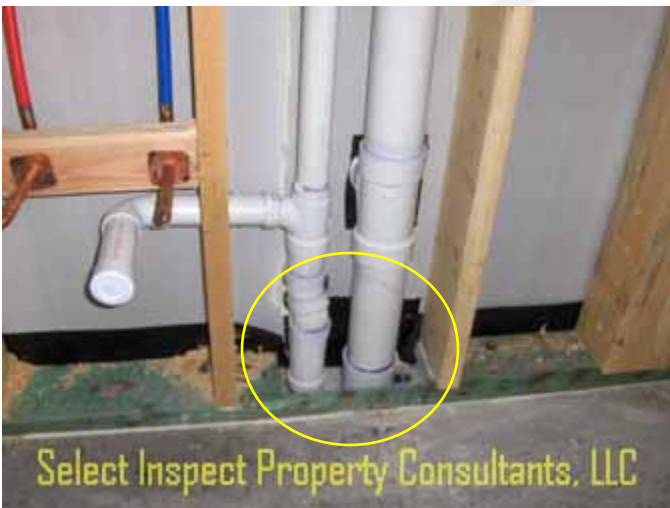
↑ sealant needed; example; at master bathroom

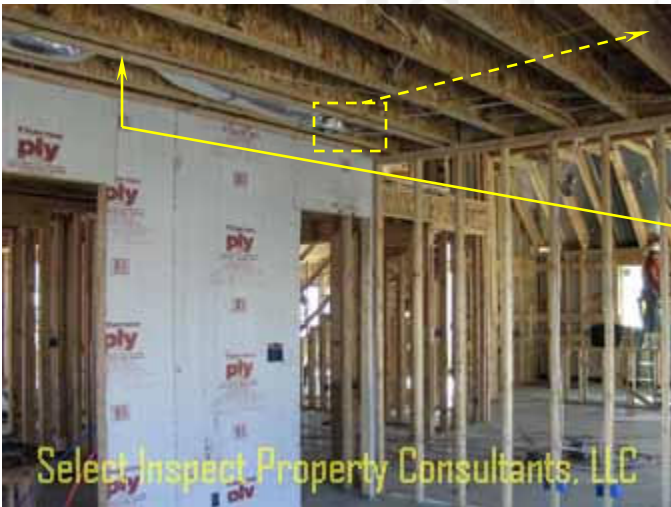
↑ crimped air ducting & less than ideal air register location; master bedroom
