Select Inspect
Property Consultants, LLC

Inspection of New Property

at: **123 street; McKinney, TX 75071**

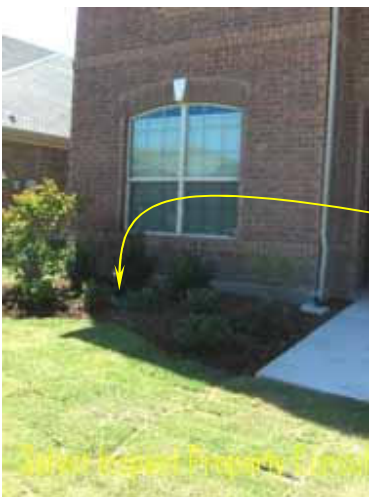
↑ water shut-off-valve location
