Select Inspect
Property Consultants, LLC

Inspection of New Property

at: 123 street; Parker, TX 75002

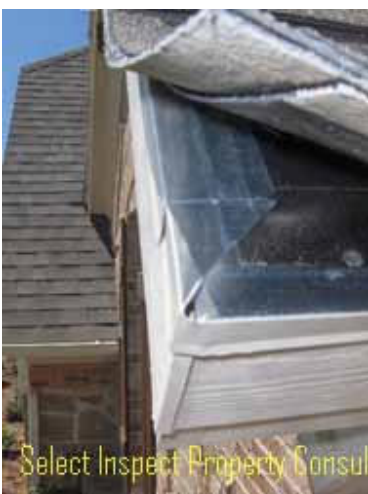
↑ unworkmanlike drip edge flashing & roof underlayment

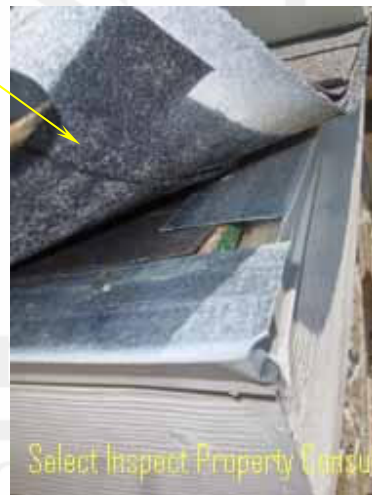
↑ close view of image above; example of multiple similar conditions discovered

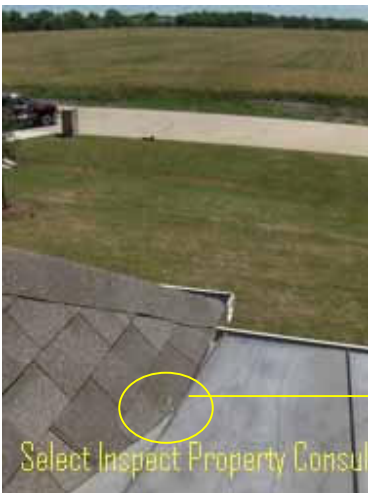
↑ overdriven nail & uncaulked, exposed fasteners, split shingle

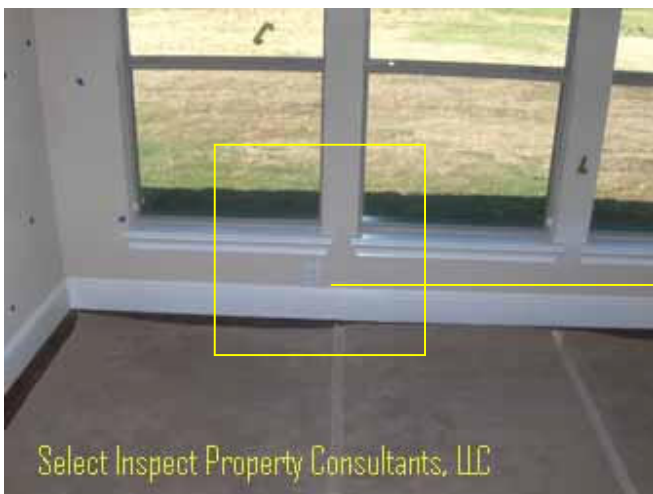
↑ Unusual Thermal anomalies not discovered at receptacle & switches adjacent exterior walls; seems well insulated

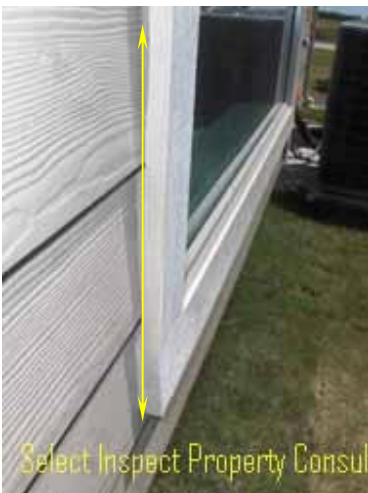
↑ close view of image above

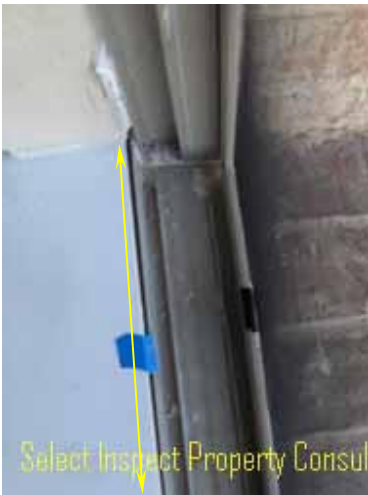
↑ 2 master bedroom window discovered as unsealed at the sills

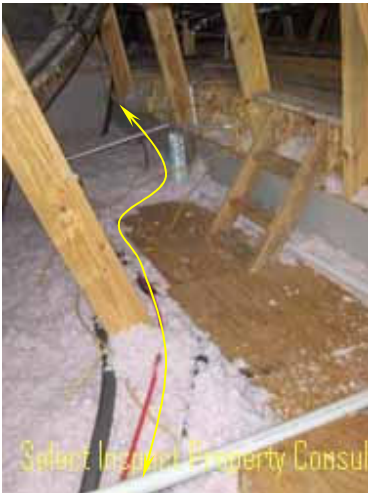
↑ non-insulated plumbing pipe (red implies hot water) near the attic access
