Property Inspection Report

Concerning: 123 street Lucas, Texas
(Address or Other Identification of Inspected Property)

By: Bruce W. Carr; TREC #5281 ASHI Member # 211804 Friday, May 13, 2011
(Name and License Number of Inspector) (Date)

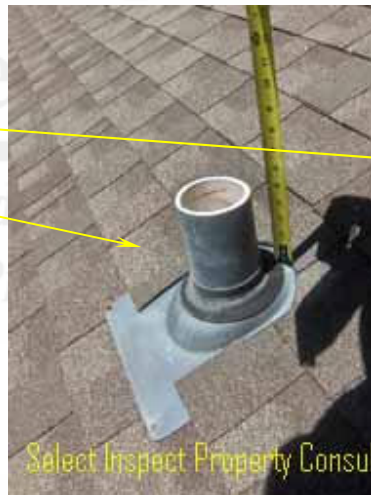
↑ short vent; example

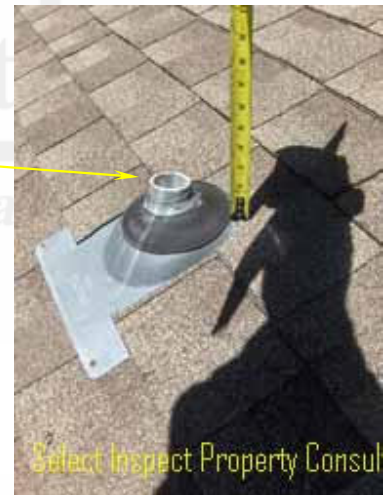
↑ short vent example

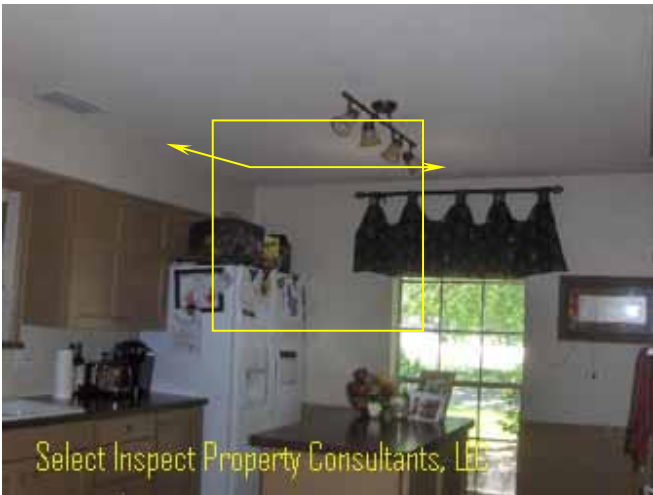
↑ Thermal imaging implies energy loss at kitchen
