Property Inspection Report

PROPERTY INSPECTION REPORT

2020 Wing Point

Tuesday, November 09, 2010

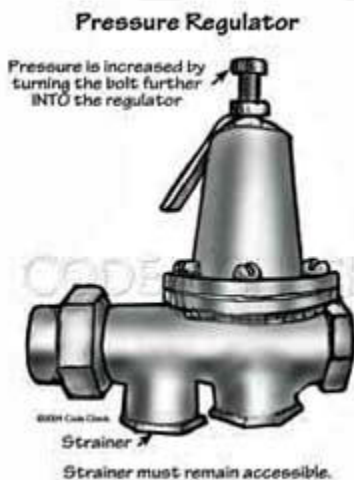
- Water pressure was approximately 84 psi; higher than the recommended 40-80 psi. A pressure reducing valve was not discovered. When a pressure reducing valve is installed, your plumber should install an expansion tank at the water heater. Related information can be found at http://www.watts.com/pro/divisions/watersafety_flowcontrol/learnabout/learnabout_wprv.asp

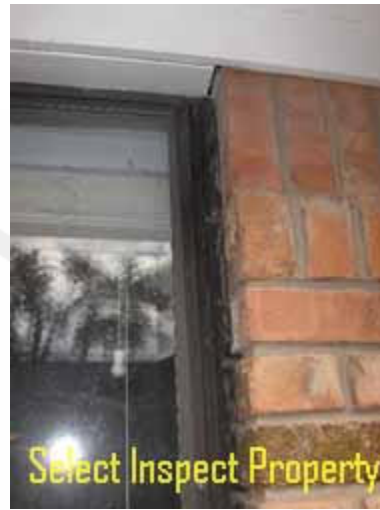
↑ window separation; south example

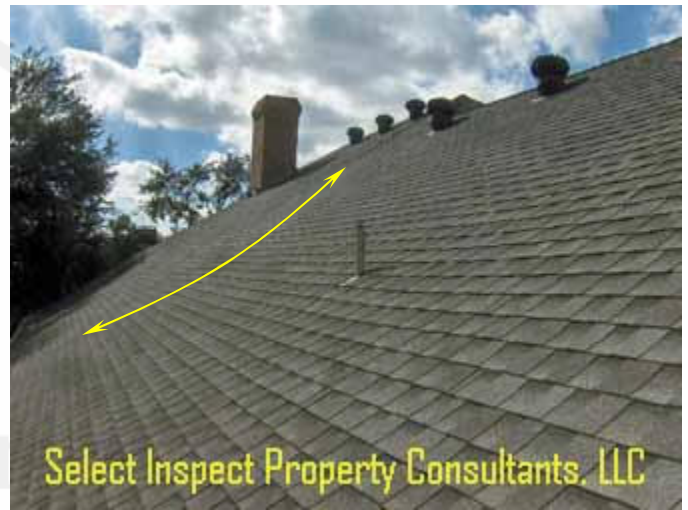
↑ deflection seen at rear roof structure

↑ alternate view same as image at left

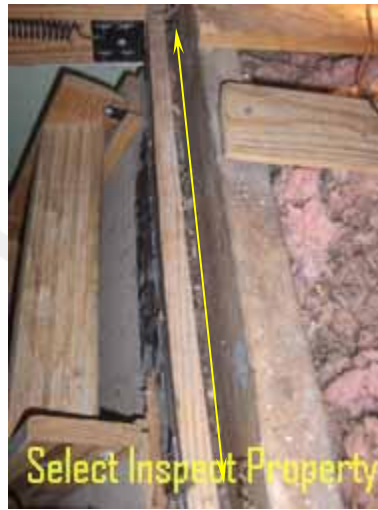
↑ missing shims at attic stair

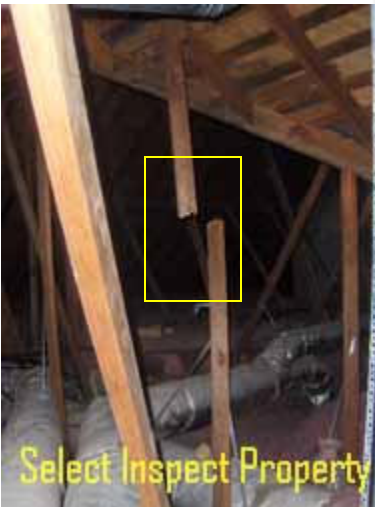
↑ failed framing

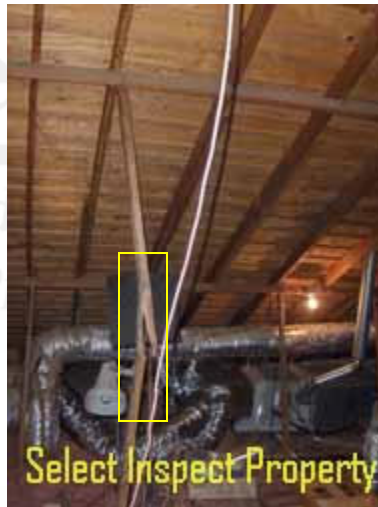
↑ failed framing

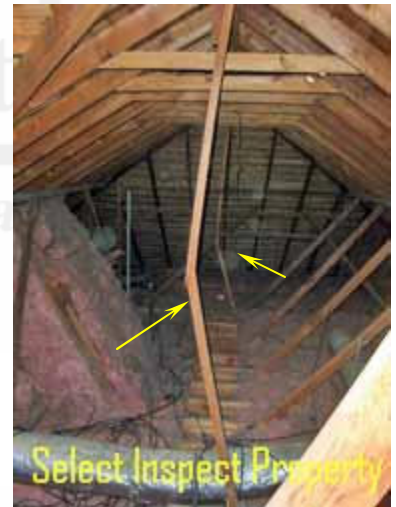
↑ failed framing

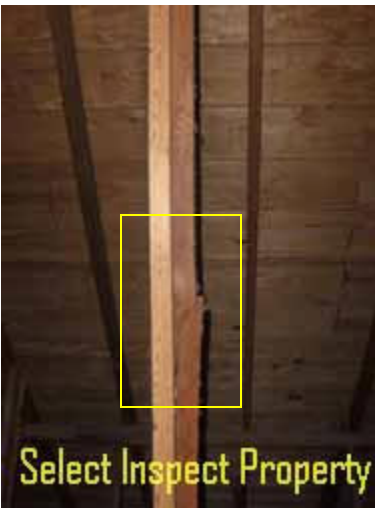
↑ failed framing

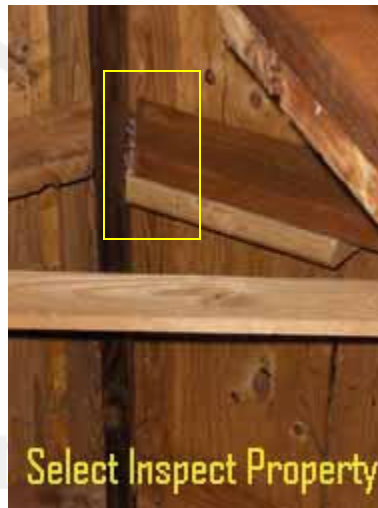
↑ rafter separation & added bracing; example at ridge

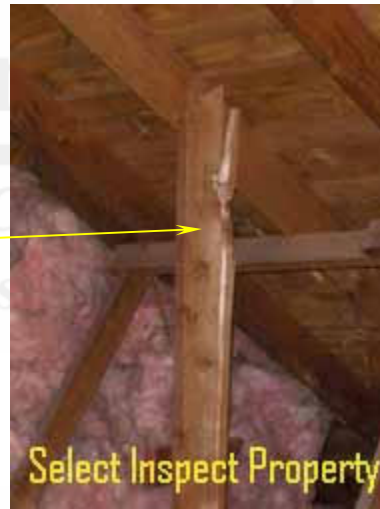
↑ failed framing adjacent front skylight

↑ close view of image at left

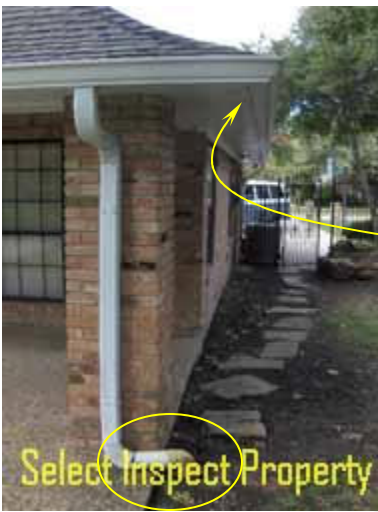
↑ deficient area drain connection & rot

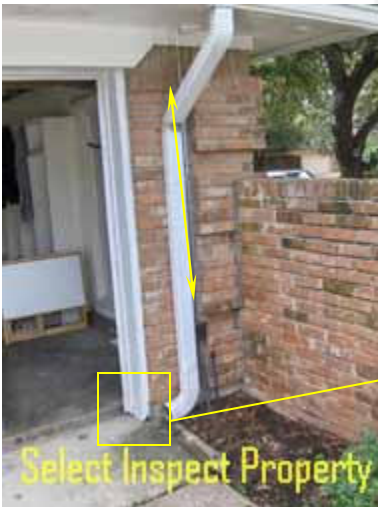
↑ inadequately secured electrical conduit & rot

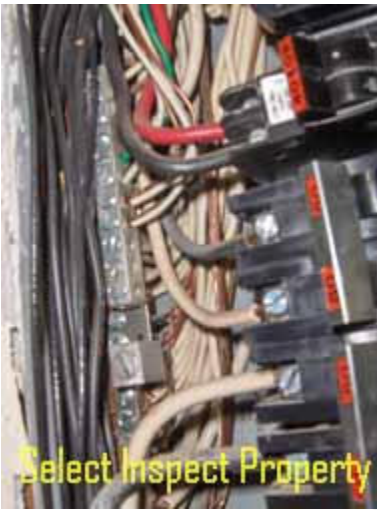
↑ conductors shall be terminated individually in lugs / breakers

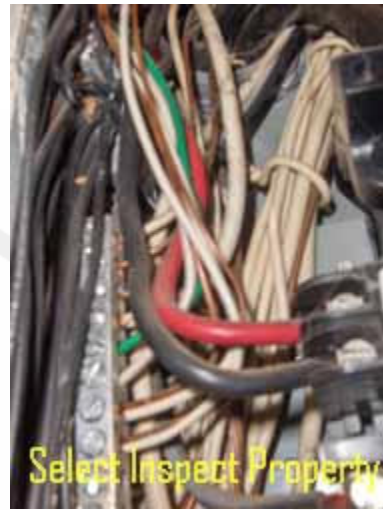
↑ same as left; main panel

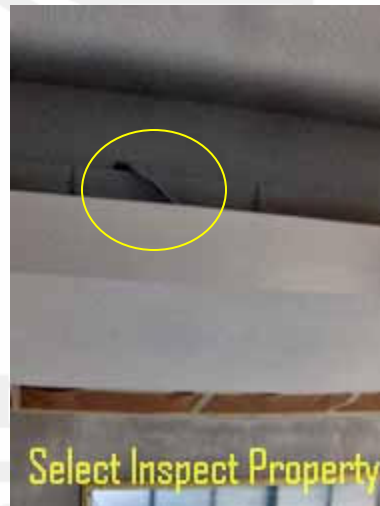
↑ wires shall not be routed between rafters & decking; example at north attic

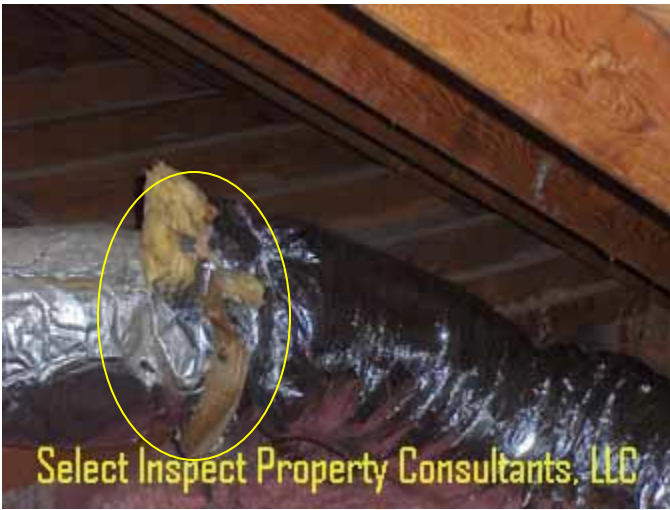
↑ deficient vapor barrier & insulation at ducting connection; example; inadequate support also noted in various locations

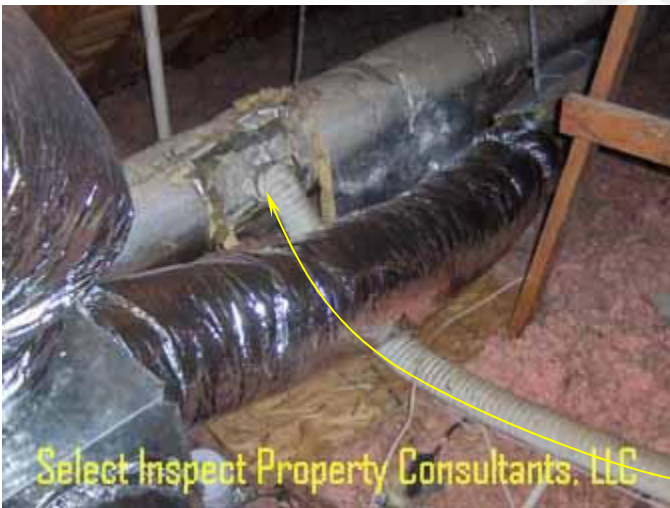
↑ crimped air ducting; example at north unit

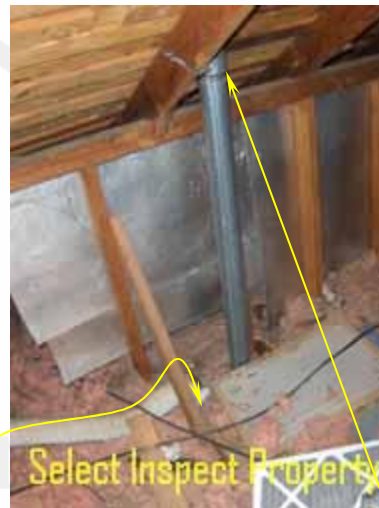
↑ unusual flex duct routed from supply to water heater closet
