Property Inspection Report

Concerning: 123 street McKinney, Texas
(Address or Other Identification of Inspected Property)

By: Bruce W. Carr; TREC #5281 ASHI Member # 211804 Saturday, April 02, 2011
(Name and License Number of Inspector) (Date)

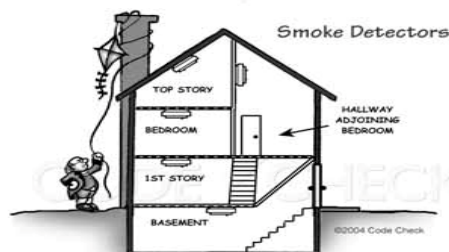
- Detectors at the downstairs were inoperable.
- Detectors were not installed in proximity to north bedroom, south bedroom, & west bedroom at the adjacent hallways- closest was at the stairway/gameroom.
- Smoke detection devices appear or are suspected to be ten years or older; updating is recommended.
- Current minimum recommendation is to have functional smoke detection devices located:
 - In each bedroom / sleeping room,
 - Outside each sleeping area (bedroom hallways) in the immediate vicinity of the sleeping rooms, and
 - On each additional story of the dwelling, including basements but excluding crawl spaces and uninhabitable attics (in dwellings with split levels and without an intervening door between the levels, a smoke alarm installed on the upper level and the adjacent lower level shall suffice provided that the lower level is less than one full story below the upper level).

- It is recommended to test detectors monthly, change batteries annually, and to replace each detector at least once every ten years.
- Modern requirements dictate that smoke detector(s) should be hardwired to the electrical system with battery backup; this can be expensive on homes that do not have wiring in place for this purpose (generally older homes). Alarm(s) were not disassembled to determine if they were/were not hard wired. Consult an electrician if concerned.

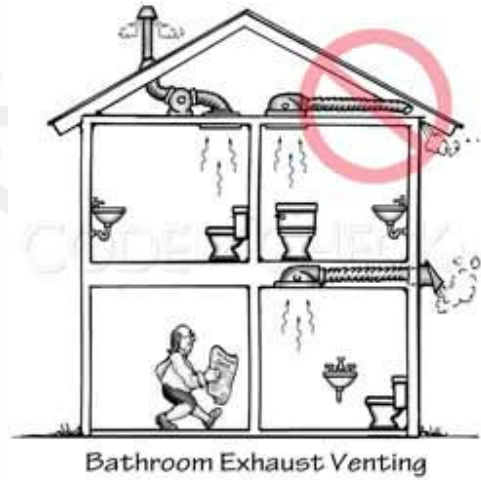
- Master bathroom exhaust fan(s) was inoperable with the switch at the wall.
- Some / all bathroom /laundry exhaust fans appear to vent to the eaves/attic. Vent termination within the attic, at passive roof vents, or at eave vents does not meet most manufacturer guidelines. Current standards require venting of bathroom and utility room exhaust fully to the exterior. (IRC M1507). Texas Real Estate Commission considers this deficient, even on older homes. Related technical information can be found at: <http://www.toolbase.org/PDF/DesignGuides/spotventilation1.pdf>

- ✦ Fans & or fan covers at bathrooms were dirty. This may cause overheating of the motor and electrical components. Cleaning is recommended.

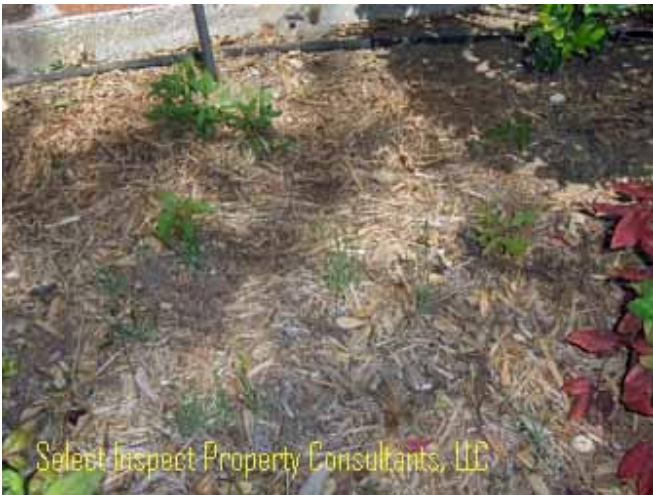
↑ poison oak suspected? At west-southwest

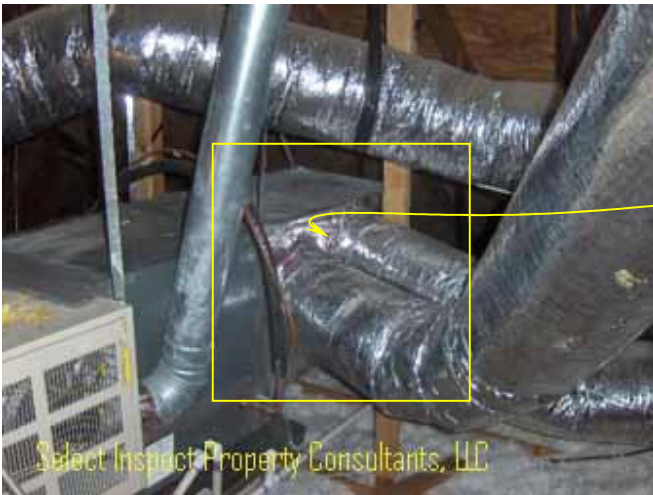
↑ energy loss at HVAC; example poor duct/plenum connections

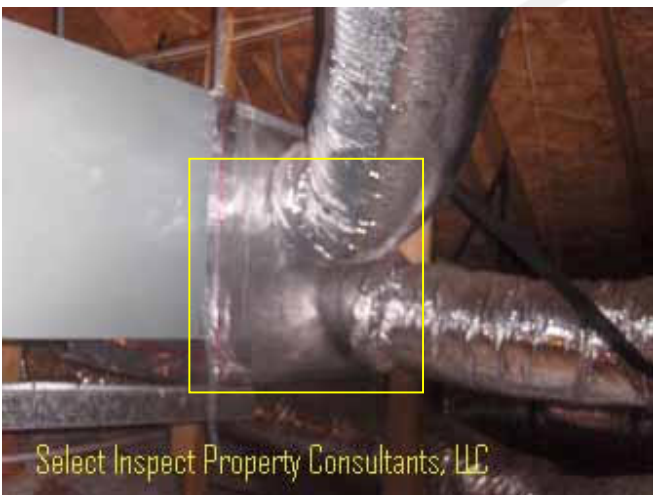
↑ energy loss at HVAC; example poor duct/plenum connections

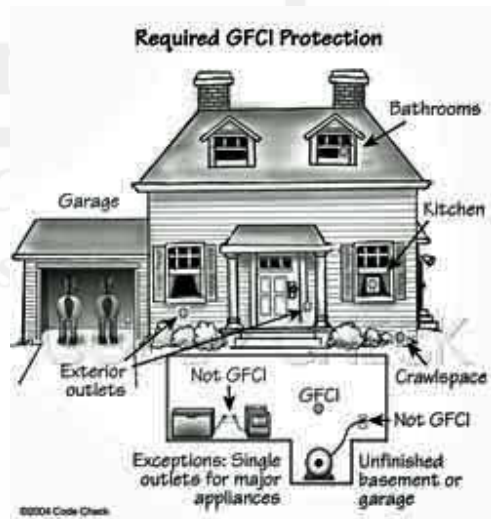
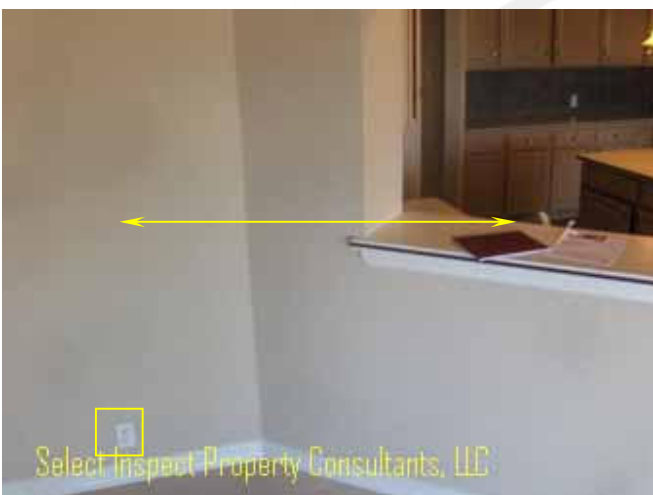
↑ GFCI required for receptacles within 6 feet of sinks; family room
