Property Inspection Report

Concerning: 123 street Southlake, Texas
(Address or Other Identification of Inspected Property)

By: Bruce W. Carr; TREC #5281 ASHI Member # 211804 Tuesday, February 22, 2011
(Name and License Number of Inspector) (Date)

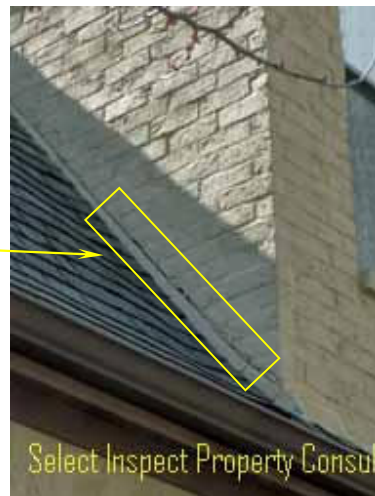
↑ flashing gap implies suspect deflection at roofline or wall stress

↑ close view of image at left

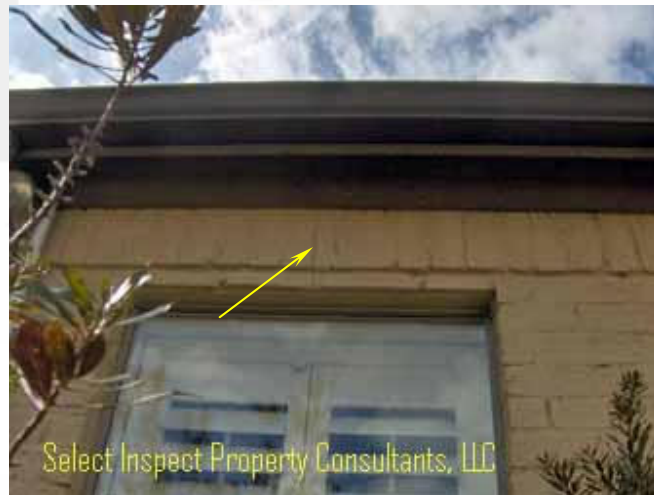
↑ stress cracks at the guest bedroom east

↑ close view of image above left window

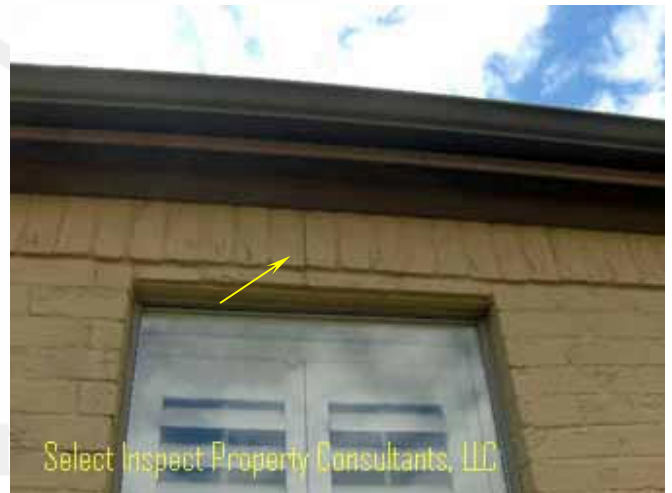
↑ close view of image above right window

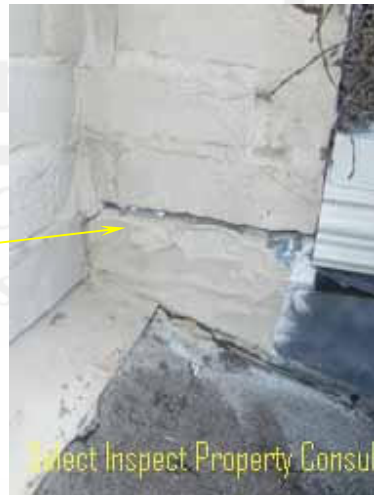
↑ deficiency flashing & openings; front porch right

↑ close view of image at left

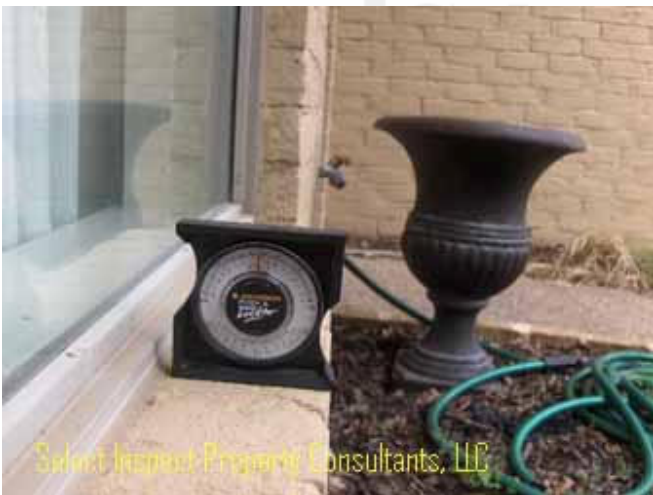
↑ brick ledge(s) had inadequate slope; example 1° rather than minimum 15°

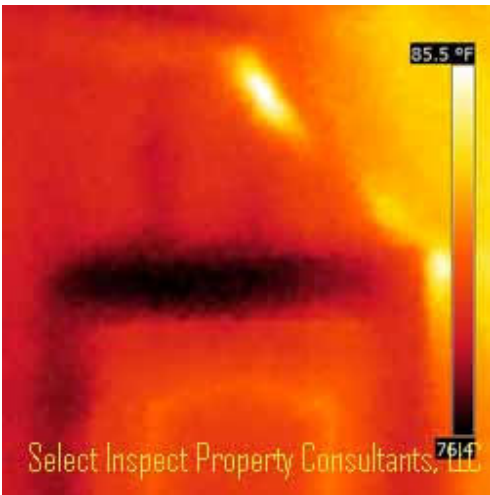
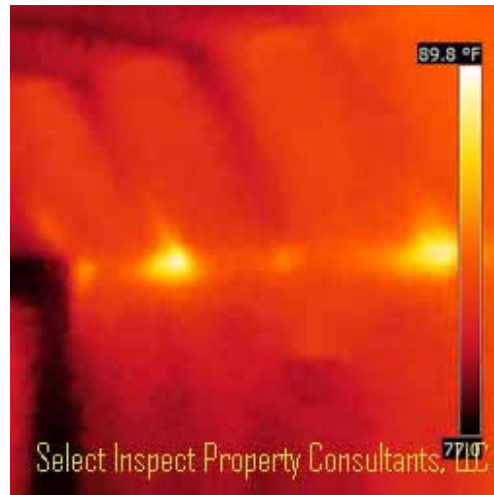
↑ Thermal imaging from image below-left

↑ Thermal imaging from image below-right

↑ Thermal imaging implies energy loss at media room attic doors & ceiling / wall locations

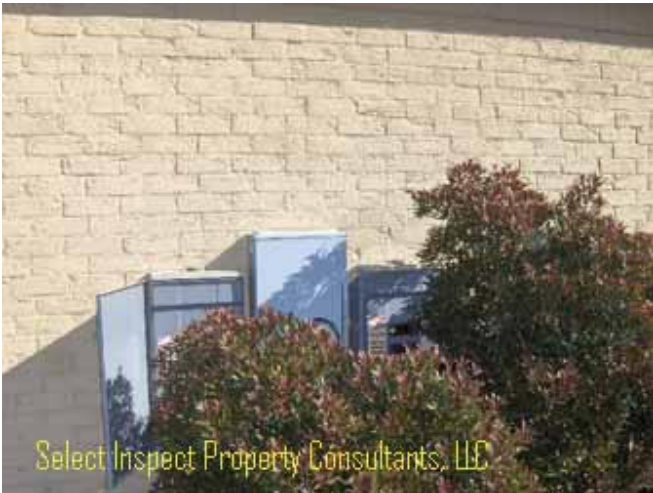
↑ Electrical service equipment requires minimum 36" clearance for access

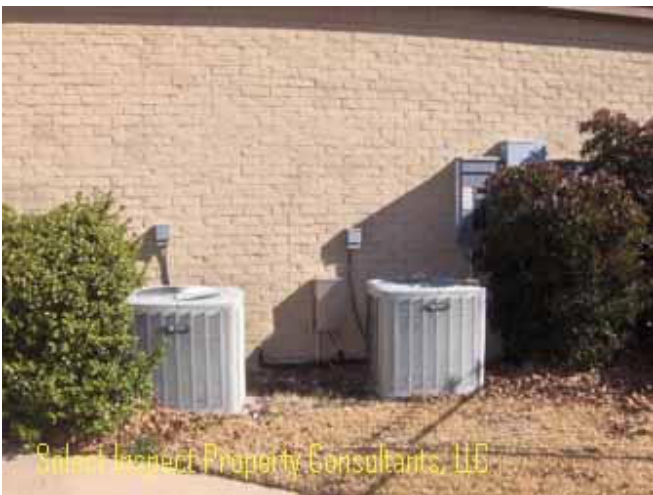
↑ incorrect location of air conditioning condenser(s) service disconnect; inadequate clearance of electrical panel for service personnel & Condensers were too low to grade- should be minimum 4" above soil

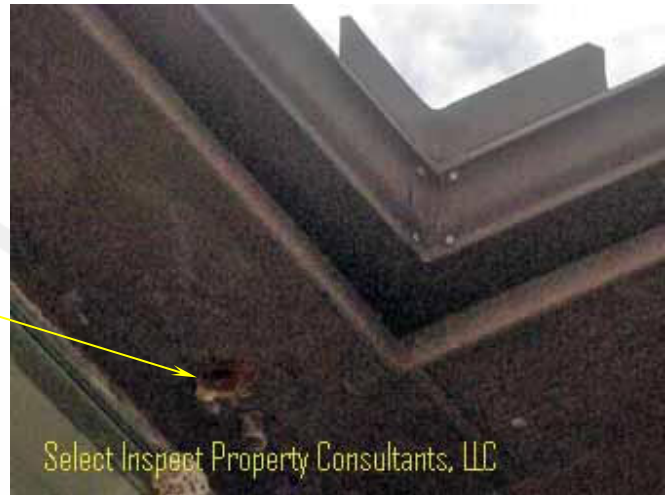
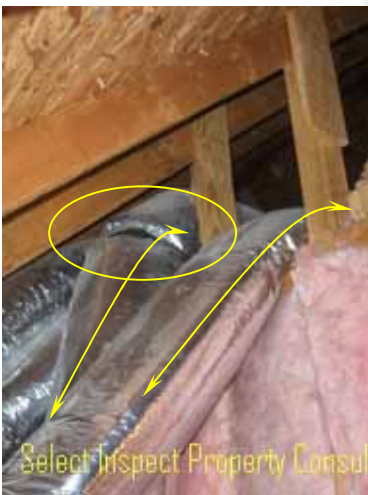
↑ auxiliary condensate drain appeared to have retracted into the eave; potential moisture damage condition

↑ close view of image at left

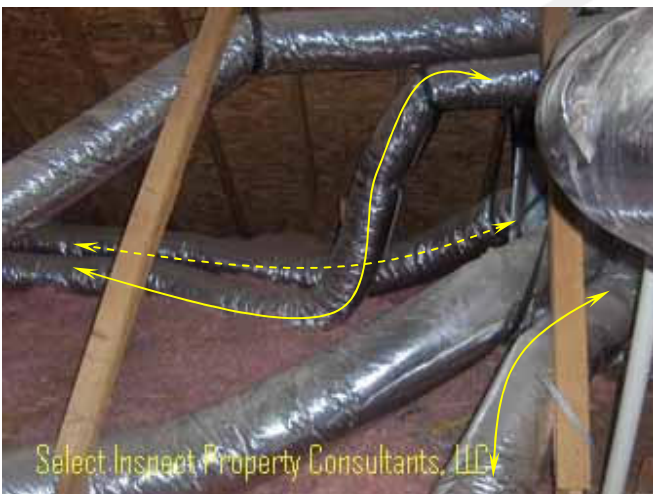
↑ inadequate support of air ducting; example location of multiple deficiencies discovered in all attic areas

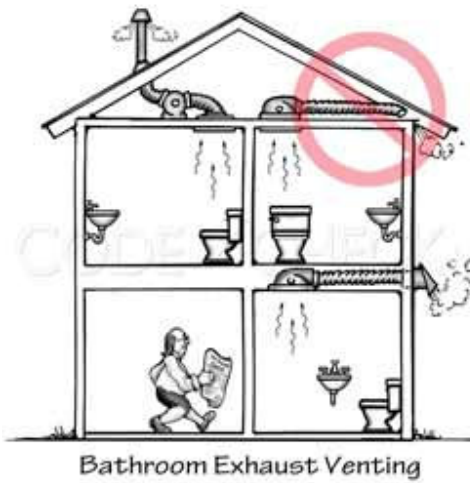
Exhaust fan(s) improperly terminate in the attic, rather than exterior
