## Property Inspection Report

**Concerning:** 123 street Flower Mound, Texas  
**(Address or Other Identification of Inspected Property)**

**By:** Bruce W. Carr; TREC #5281 ASHI Member # 211804 Tuesday, May 10, 2011  
(Name and License Number of Inspector) (Date)

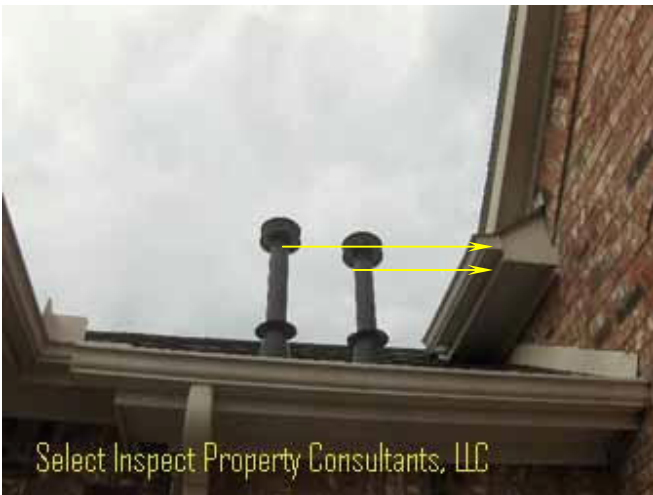
↑ water heater flues too short/close to wall

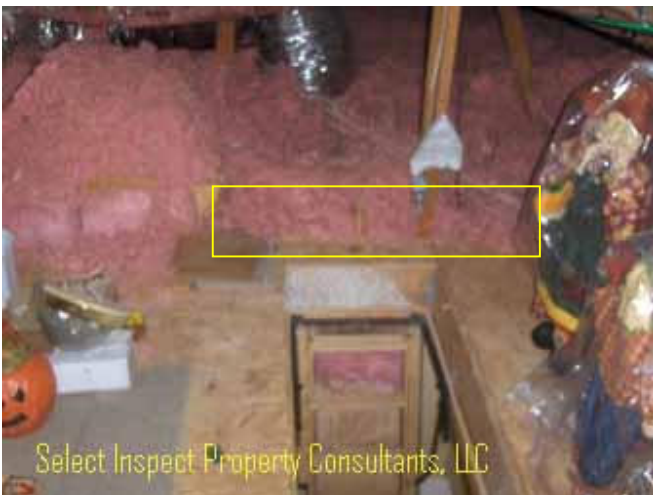
↑ there should be a minimum 24" pathway to the HVAC from the top of the access, with no gaps or obstructions

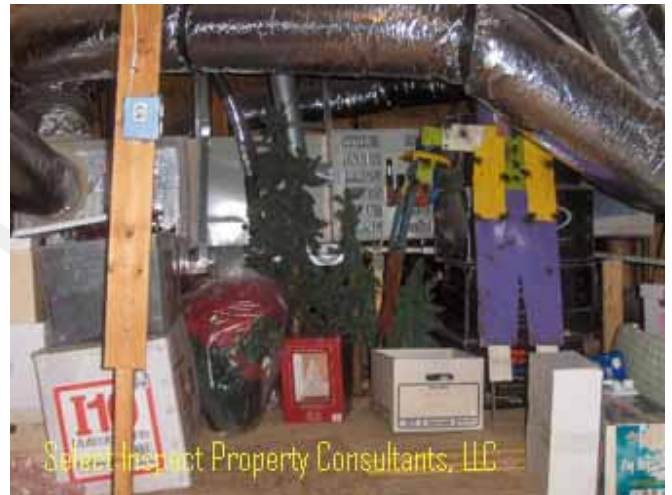
↑ 30" unobstructed service area was amiss at the HVAC

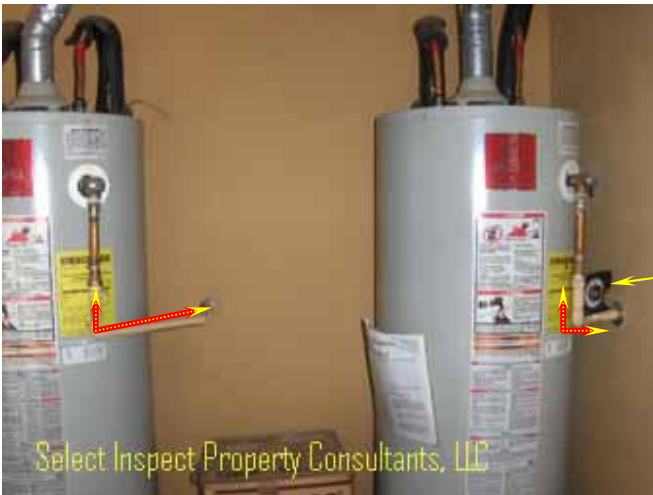
↑ cpvc sections of water heater temperature/pressure relief piping was smaller than required by the device manufacturer
