## Property Inspection Report

### PROPERTY INSPECTION REPORT

123 street

Friday, May 06, 2011

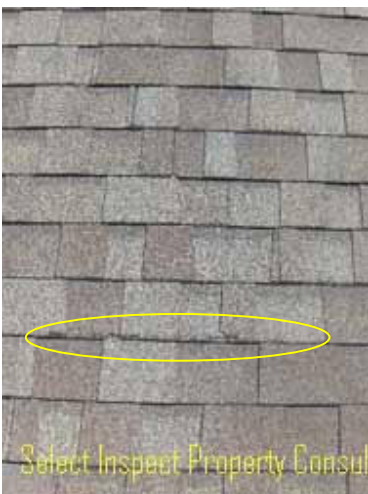
↑ close view of image above

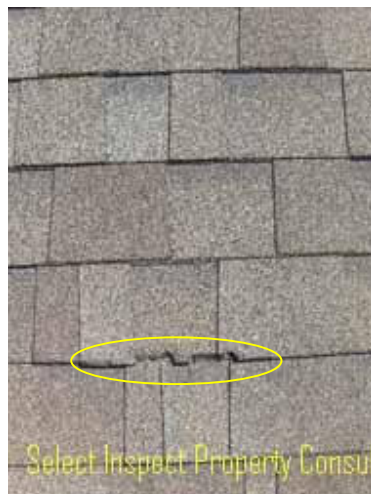
↑ close view of image above

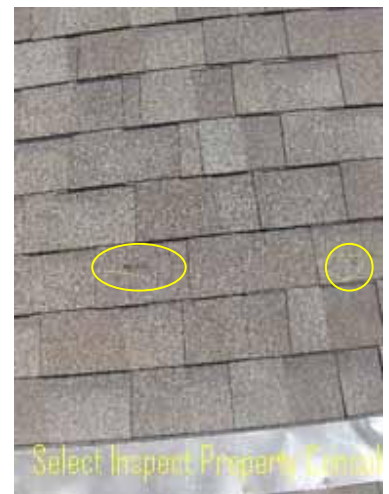
↑ close view of image above; right circle may be from hail
