Property Inspection Report

Concerning: 123 street McKinney, Texas
(Address or Other Identification of Inspected Property)

By: Bruce W. Carr; TREC #5281 ASHI Member # 211804 Thursday, April 28, 2011
(Name and License Number of Inspector) (Date)

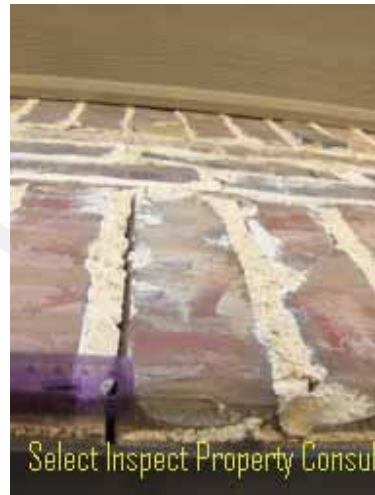
↑ close view of image at left

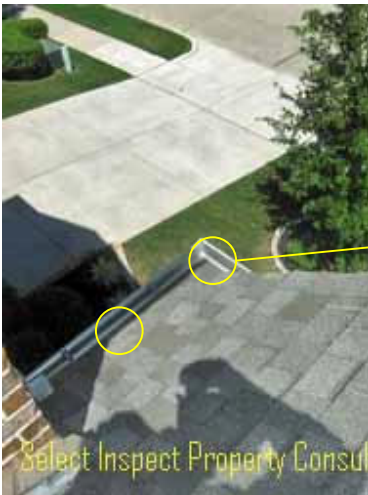
↑ protruding nail; split shingle

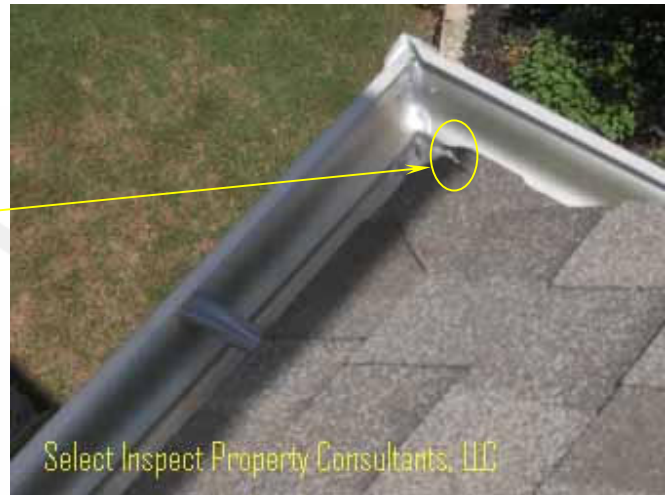
↑ close view of image at left

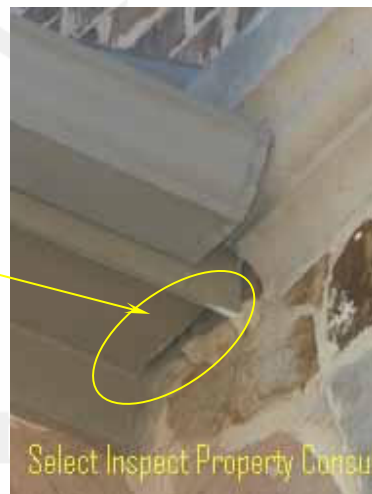
↑ close view of image at left; visible framing

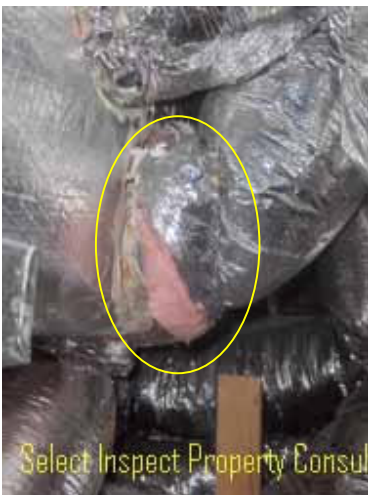
↑ close view of image above

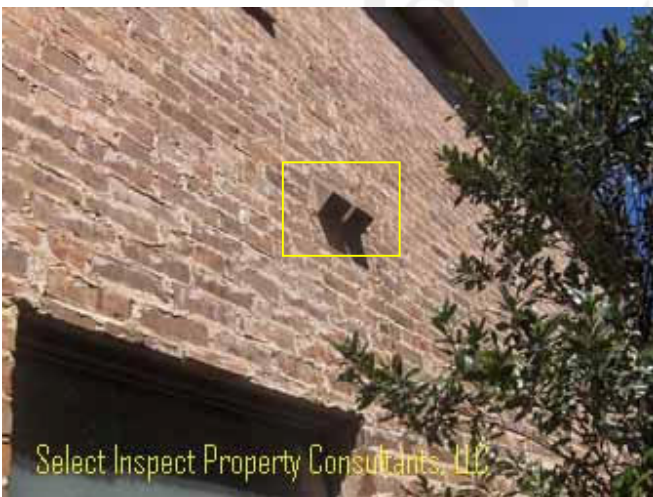
↑ some exhaust fans appeared to terminate at the exterior- correct

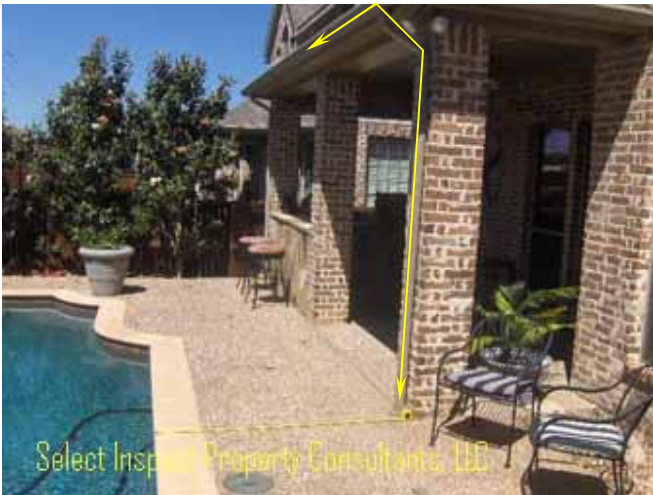
↑ metal gutter near pool; refer to an electrician for bonding options
