New Home Punch-out Inspection

Custom Home Builder

at: **2009 New Street; Flower Mound, TX 76051**

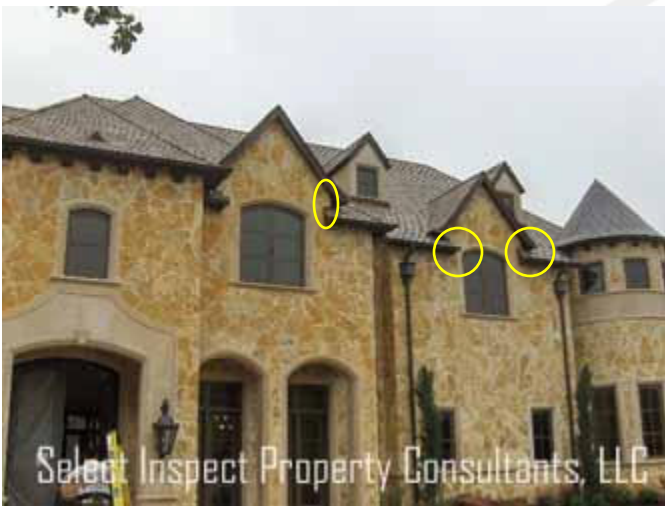
- Minimally chipped slate corner was noted at the peak above the media room
- Flashing at a eave wall / roof joint is amiss / incorrect at multiple front gable "eyebrows, and is a potential moisture intrusion risk. Sealing is recommended.

↑ same as above; seal flashing details

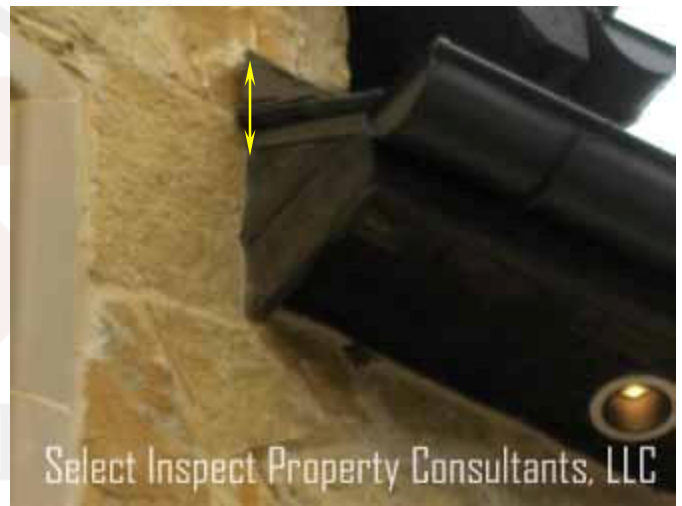
↑ close view of image at left

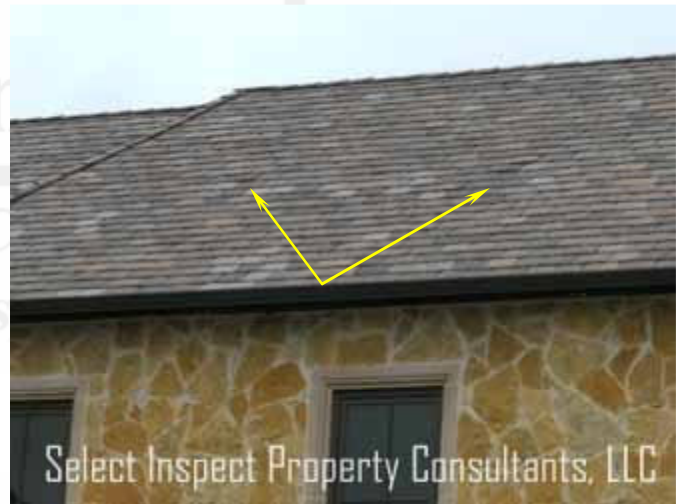
↑ close view of image at left

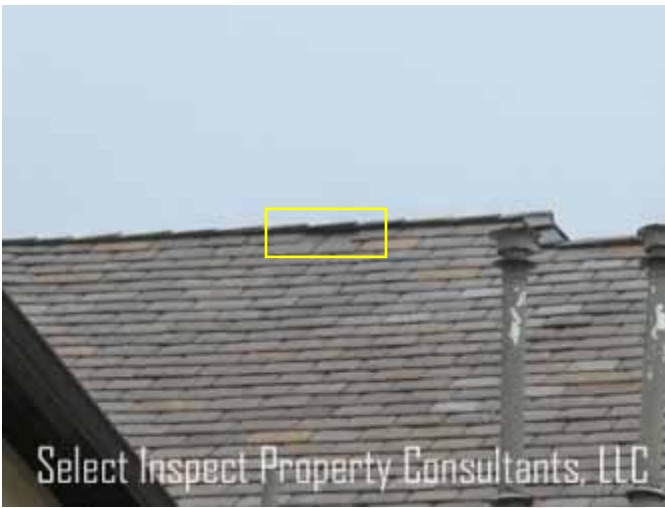
↑ close view of image above

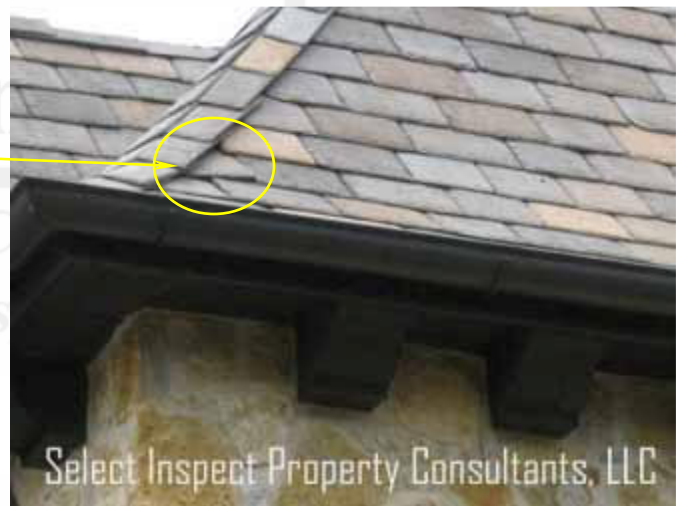
↑ close view of image at left

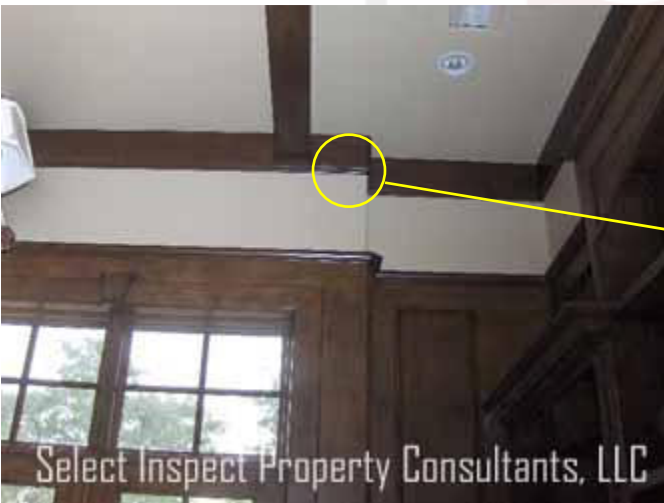
↑ wasp nest at office/study

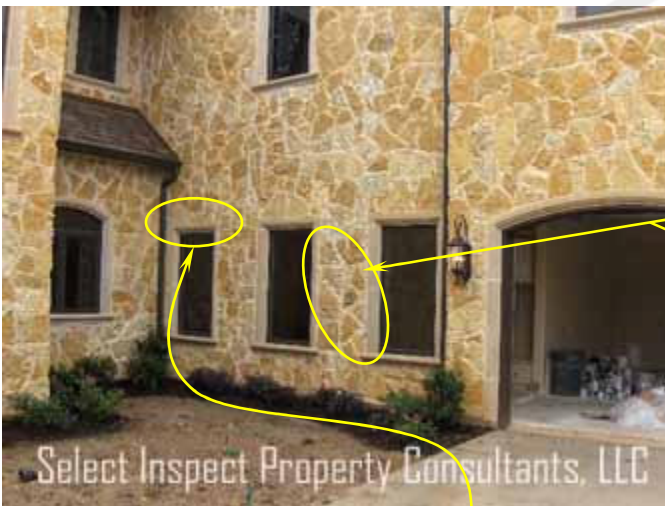
↑ brick ties; opening at north garden

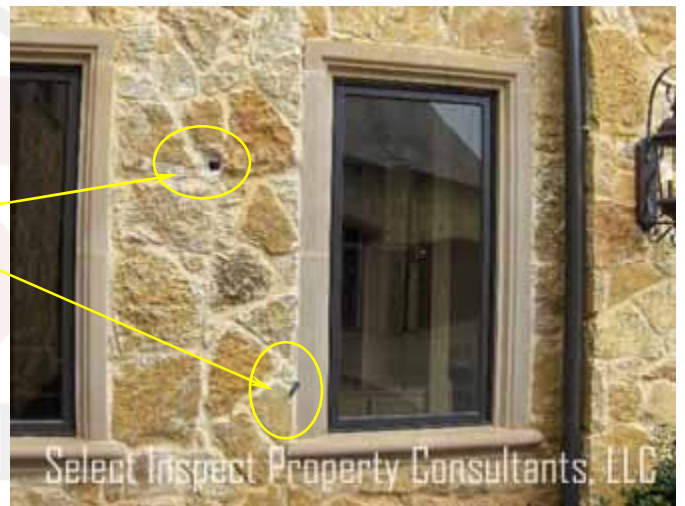
↑ close view of image at left

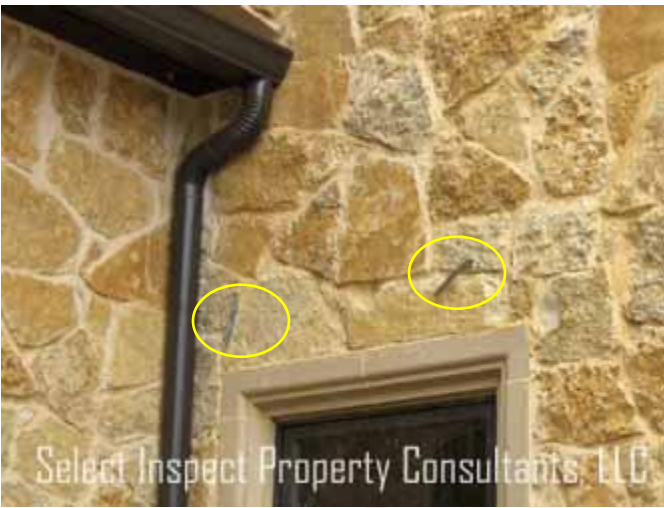
↑ close view of image above

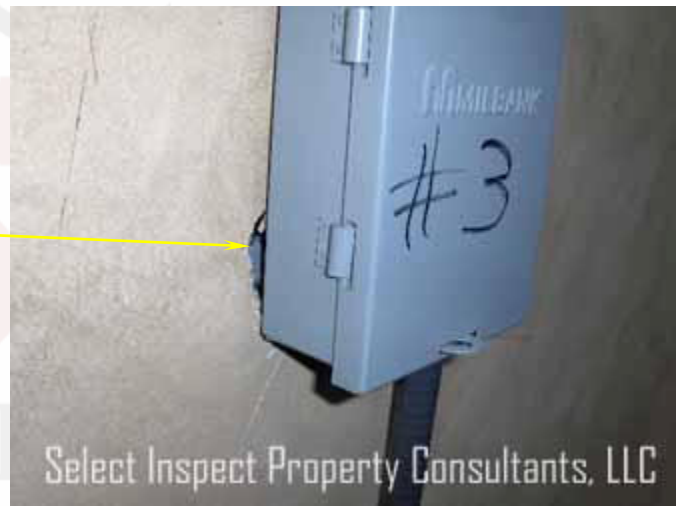
↑ close view of image at left

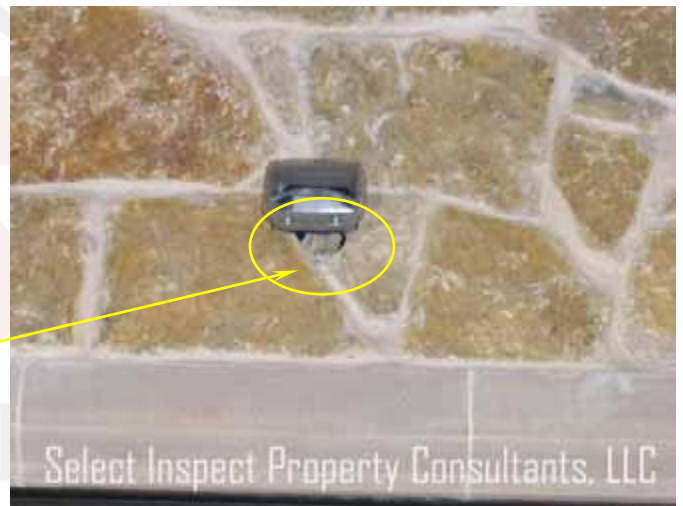
↑ close view of image at left
