Select Inspect

New Home Punch-out Inspection

at: **12345 YourStreet; Frisco, TX 75035**

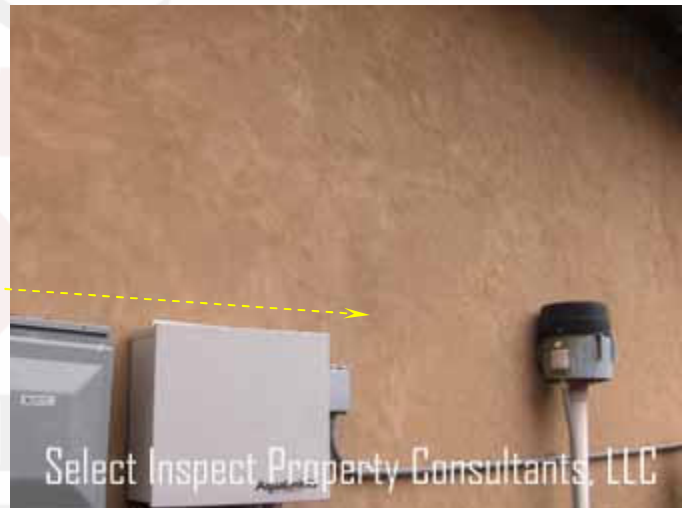
↑ close view of image at left; example location

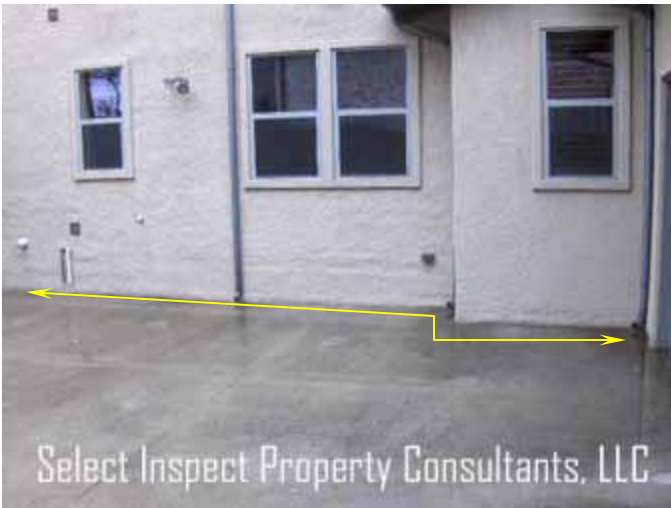
Stucco is lower than recommended, where it meets the driveway surfaces. Technically the siding and trim should be at least two or more inches above the grade surface to allow proper drainage of moisture and avoid subsequent moisture damage. Low stucco also obstructs inspection for termites and appropriate drainage provisions. Repair options are limited. Consult the stucco manufacturer for acceptability. When other drainage work is done at the south, you should consider channel drains around the perimeter of the low stucco adjacent the home at driveway locations. Currently, the stucco drain edge appeared to be at or slightly below the driveway concrete; this may cause inability of condensate to properly drain from these walls; if such occurred, there is a chance of moisture/fungal accumulation within the wall voids.

↑ stucco drainage plane/screed at/below concrete grade

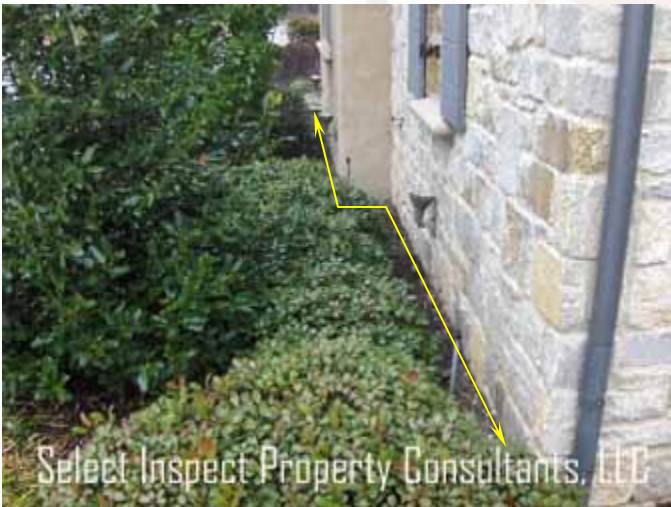
- The grade/soil level at the front right (library/single garage), northwest patio area (dining room), & part of the north-northwest (living room/kitchen) was at or above the bottom of the veneer (stucco, brick, stone, siding, etc). Repair is recommended. This may obstruct weep openings and is conducive to moisture intrusion, rot, and termites. Ideally, the brick / stone joint at the foundation would be four to six inches above soil and at least one inch minimum from adjacent concrete slabs. This would allow the edge of the foundation to be visible for inspection of termites and moisture intrusion conditions. It is common for this standard to be frequently ignored. If repairs are made, the substrate should be examined for wood rot and termites. If undesirable conditions are found, further repairs should be arranged. If soil/bark/mulch is lowered or removed, ensure the areas will have proper drainage away from the structure; ideally 6" drop in slope within the first 10 feet from the structure; or to an appropriate drain to not allow excess moisture within 6 feet of the home.

↑ high soil; example

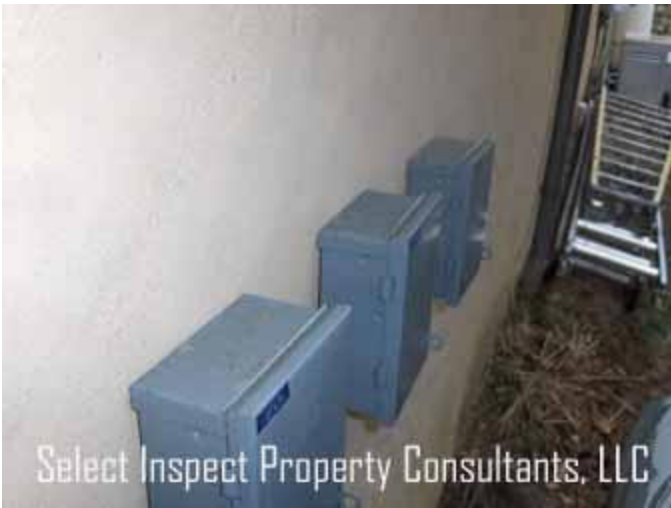
↑ sealant needed at all equipment boxes/penetrations

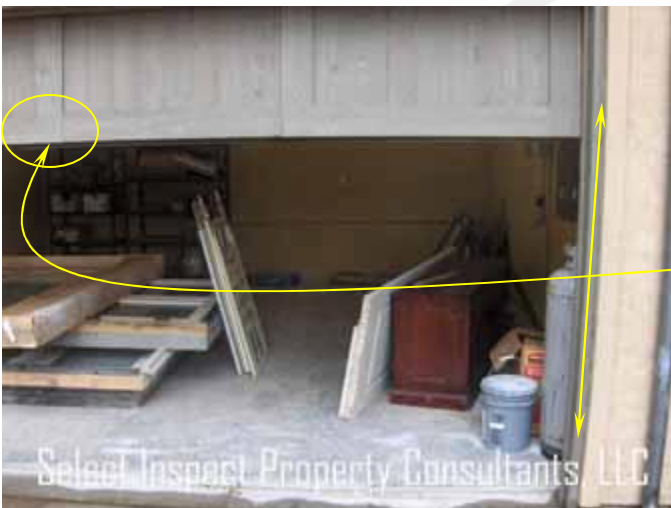
↑ sealant needed & protruding nails
