Select Inspect

New Construction Phase Inspection

at: **123 New Street; McKinney, TX 75071**

Thursday, October 21, 2010

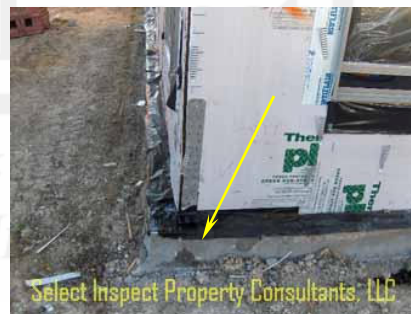
- Anchor bolt nut was missing at the single garage southeast corner.
- Unworkmanlike/bent holdown anchor at the exterior fireplace. Refer to the architect &/or manufacturer for approved correction
- Exposed post tension end(s) cap at the northwest corner should be sealed in an approved method.
- Regularly monitor the property and its components and arrange for repair if / when needed. Repairs should be made by qualified specialists whenever possible.
- Refer to your "Guide to Your Home Inspection" at the web link emailed with your report, for information regarding foundation maintenance and monitoring.

Exposed post tension end(s) at the master bedroom northwest corner

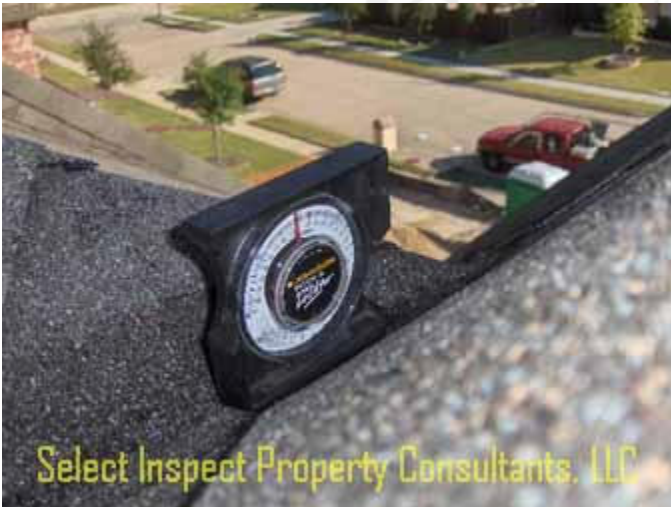
- Converging valley at the upper southeast has inadequate slope; this small section was holding water during the inspection, & will be prone to moisture intrusion *if* there is not an adequate membrane below the shingles (such could not be visually confirmed from the roof or attic). Refer to the builder for related information & have these items documented as warrantable or arrange improvement
- Toe boards should be removed; openings in the roof surface from prior use of toe boards should be sealed.
- Debris should be cleared from the roof, as to not congest gutters (installed later) & to avoid nails from washing off & being an injury risk after future rains.
- Uncaulked, exposed fasteners noted at the upper south-southeast exposure(s).
- Chimney cap not present at this phase

↑ less than 1 ° pitch; close view of image above

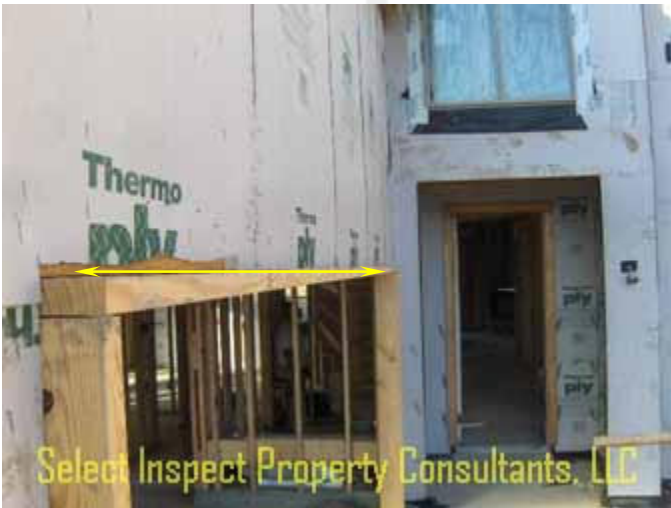
↑ lintel/flashing incomplete at this phase; both garages

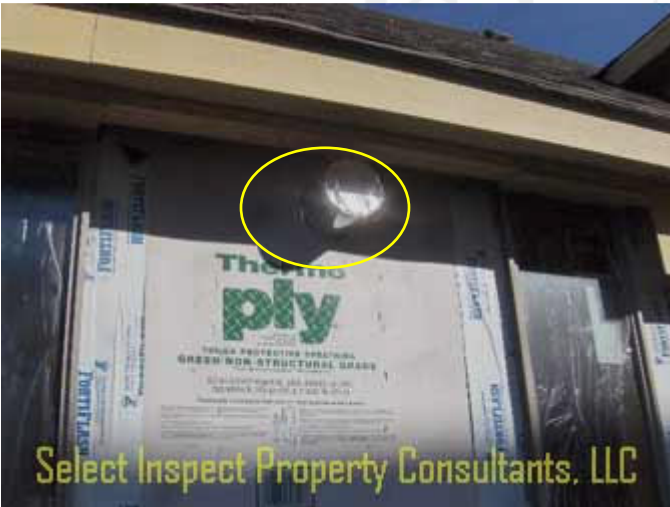
↑ kitchen vent not yet flashed/sealed during the inspection

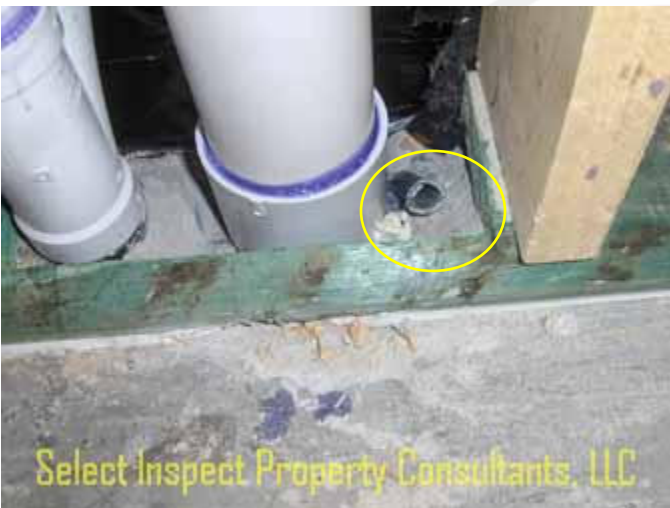
- Hollow plumbing stakes are a potential future entry point for termites. Recommend the pest control company performing the pretreat seal these hollow stakes and or treat the interiors with an appropriate foam termiticide or similar approved chemical for wood destroying insect protection.
- Evidence of wood destroying insect pretreatment was not discovered. Refer to your builder for documentation after treatment is made. Pretreat for wood destroying insects should be performed prior to laying of plastic (vapor barrier) on the pad site, before the foundation is poured.
- Treatment of the lower wood framing is commonly indicated by colored (dyed termiticide) framing at the lower 18-24 inches of framing. This was not discovered. Refer to the builder for information regarding this item & related documentation.

↑ hollow tube for plumbing support; example at master bathroom; may be a potential access location for termite(s) in the future.
