Select Inspect
Property Consultants, LLC

Inspection of New Property

at: **123 street; McKinney, TX 75071**

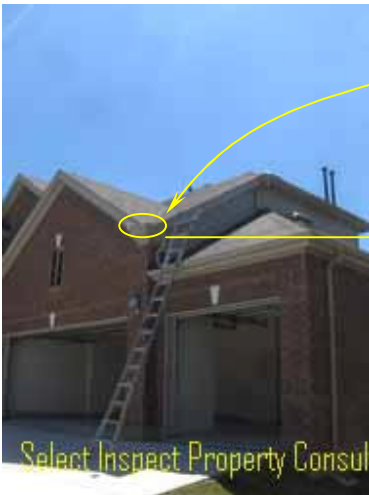
↑ short roof underlayment & short drip edge flashing lap

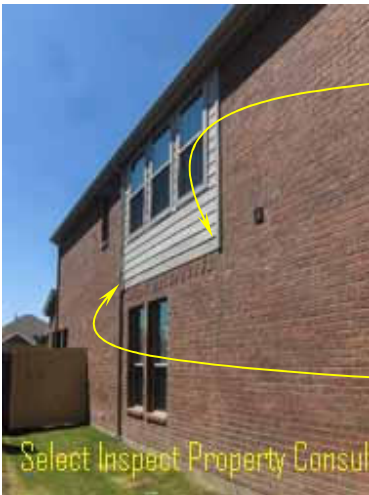
↑ openings & inverted trim
