Select Inspect
Property Consultants, LLC

Inspection of New Property

at: 123 street; Parker, TX 75002

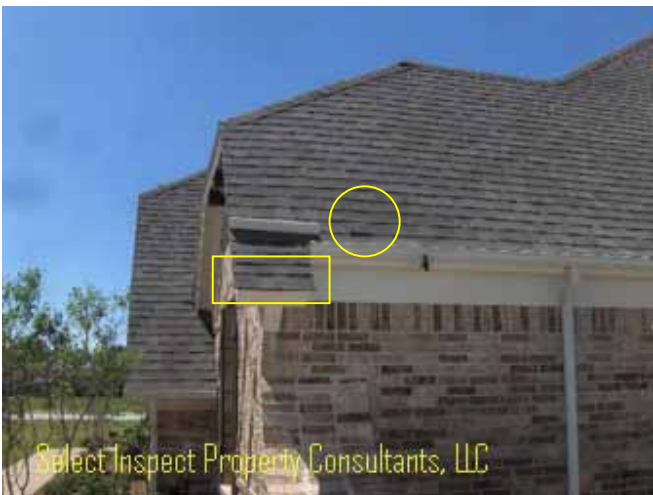
↑ example-unworkmanlike drip edge/felt; corners should have no gaps; rake (diagonal) edge & roof felt should be atop the eave (lower) edge flashing; roof underlayment should be under rake flashing. Also shown- metal protruding below shingle

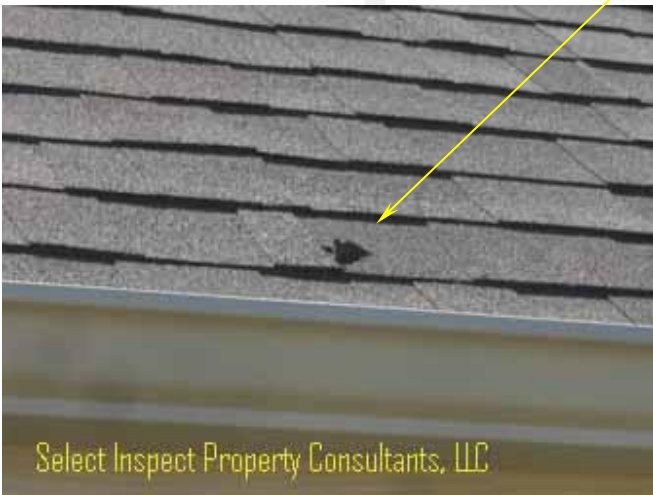
↑ close view of image above right

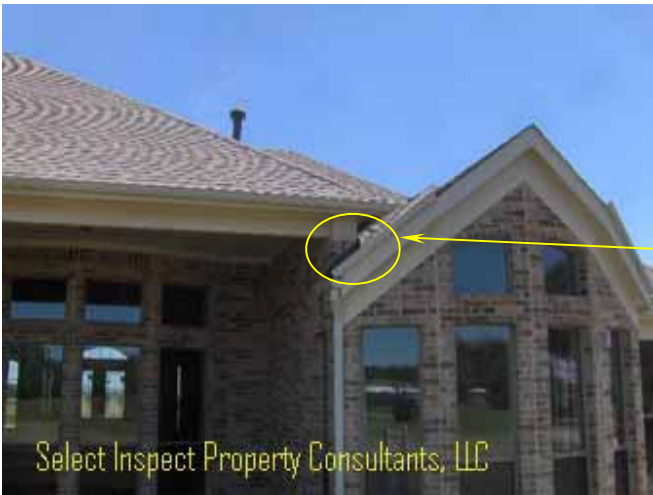
↑ incomplete wall; incomplete unworkmanlike roof & flashing; openings; moisture damage & fungus concern

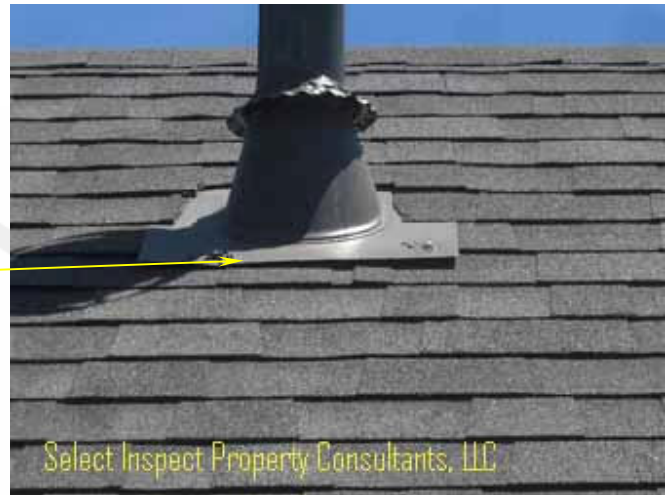
↑ close view of image at left

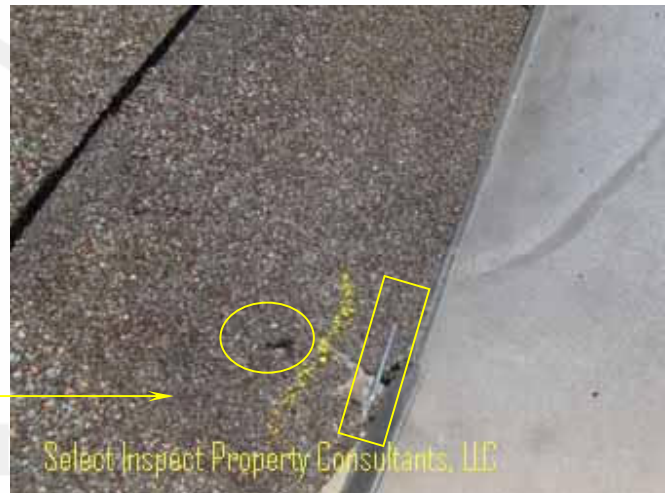
↑ close view of image at left

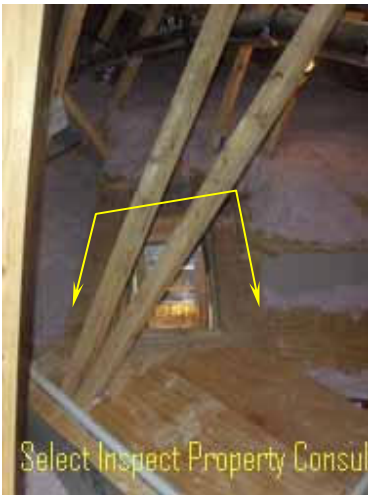
↑ there should be a minimum 24" pathway to the HVAC from the top of the access, with no gaps or obstructions; need to add appropriate decking at sides or reverse the stair/ladder

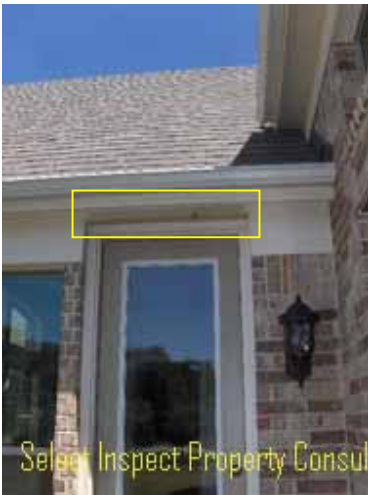
↑ unpainted exterior eave

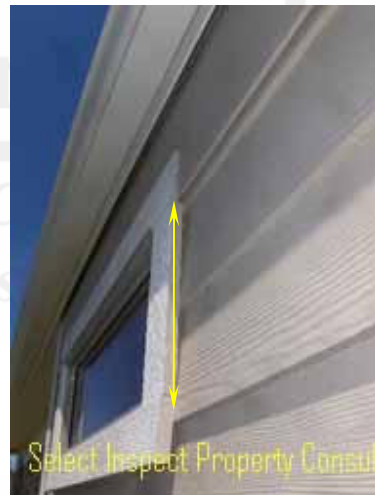
↑ close view of image at left

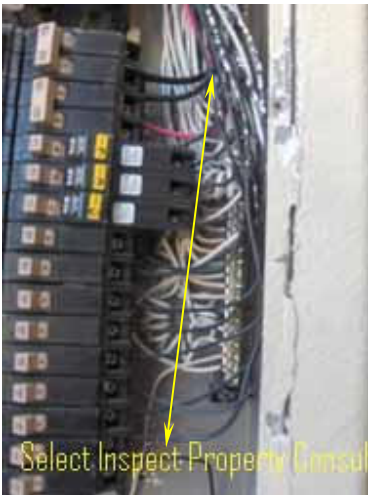
↑ paint/texture overspray in electrical cabinet
